Profile/Photo Observation Report

Street:	E RAND ST & RUSH ST	Flow Control:	Not Controlled
City:	Hobart, IN	Year Renewed:	
Location:	Other	Tape/Media #:	
Purpose:	Not Known	Dia/Height:	12"
Use:	Sanitary	Material:	VCP
Drain Area:	NA	Lining:	
Category:	NA		
Comment:

Location Details:		Direction of Survey:	Downstream
US MH:	M-903-021	DS MH:	M-903-024
		Total Length Surveyed (ft):	64.4

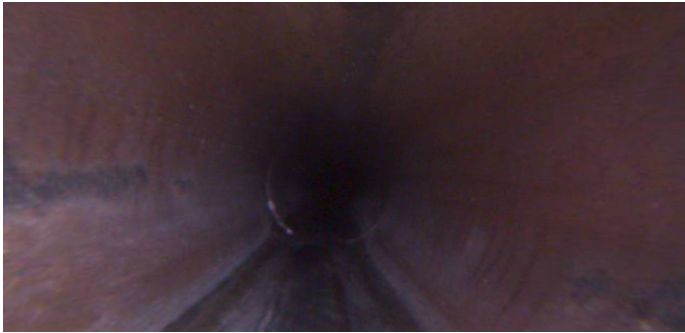
Code:	MWL
Description:	Water Level

Distance (ft):	.0
Structural Grade:	0
O&M Grade:	0
Clock Start/From:	
Clock To:	
1st Value:	
2nd Value:	
Value Percent:	5.000
Continuous Index:	
Within 8" of Joint:	NO
Remarks:

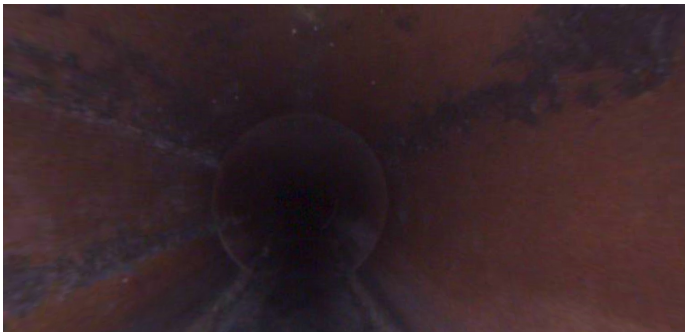
Code:	DAGS
Description:	Deposits Attached Grease

Distance (ft):	7.4
Structural Grade:	0
O&M Grade:	2
Clock Start/From:	8
Clock To:	4
1st Value:	
2nd Value:	
Value Percent:	5.000
Continuous Index:	S01
Within 8" of Joint:	NO
Remarks:

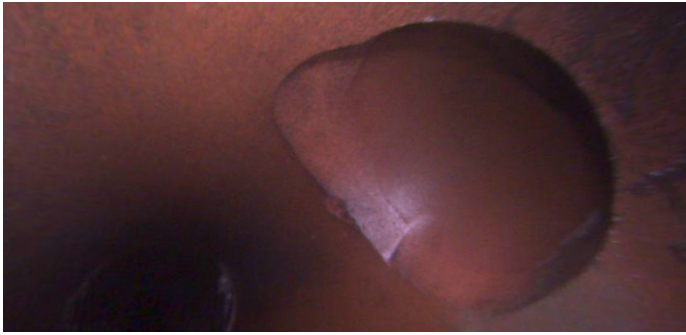
Code: **TF**
Description: **Tap Factory**

Distance (ft): **33.3**
Structural Grade: **0**
O&M Grade: **0**
Clock Start/From: **2**
Clock To:
1st Value: **4.000**
2nd Value:
Value Percent:
Continuous Index:
Within 8" of Joint:
Remarks:

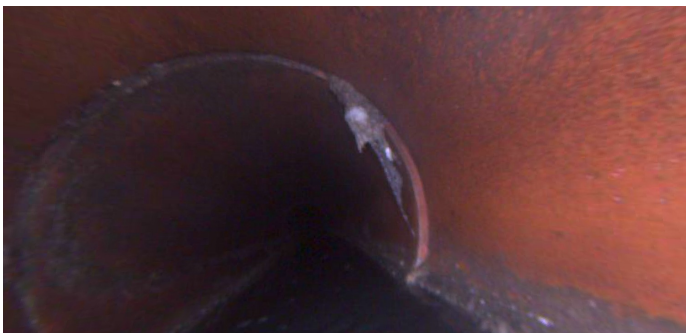
Code: **DAR**
Description: **Deposits Attached Ragging**

Distance (ft): **35.0**
Structural Grade: **0**
O&M Grade: **2**
Clock Start/From: **2**
Clock To:
1st Value:
2nd Value:
Value Percent: **5.000**
Continuous Index:
Within 8" of Joint: **YES**
Remarks:

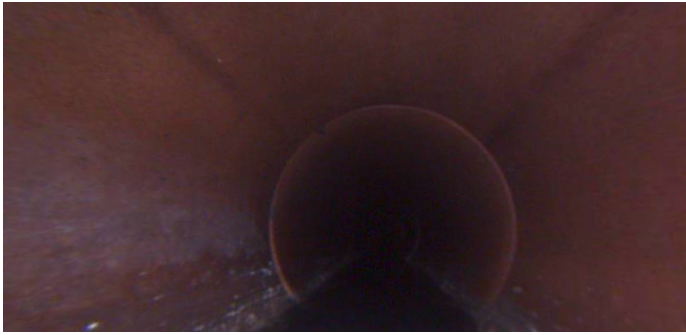
Code: **DAGS**
Description: **Deposits Attached Grease**

Distance (ft): **64.4**
Structural Grade: **0**
O&M Grade: **2**
Clock Start/From: **8**
Clock To: **4**
1st Value:
2nd Value:
Value Percent: **5.000**
Continuous Index: **F01**
Within 8" of Joint: **NO**
Remarks:

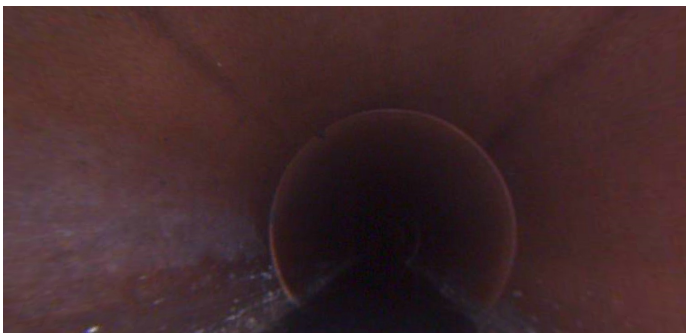
Code: **MSA**
Description: **Abandoned Survey**

Distance (ft): **64.4**
Structural Grade: **0**
O&M Grade: **0**
Clock Start/From:
Clock To:
1st Value:
2nd Value:
Value Percent:
Continuous Index:
Within 8" of Joint: **NO**
Remarks: **UNKNOWN**
