## Profile/Photo Observation Report

Date:	<b>10/02/2018</b>	Weather:		Coding:	<b>PACP 6.0</b>
Pipe Length (ft):	<b>167.1</b>	Owner:	<b>NA</b>	Pre Clean:	<b>Not Known</b>
P.O.#:		Surveyor:	<b>Justin Gonzales</b>	PSR:	<b>P-903-021-024</b>
Customer:		Clean Date:	<b>01/01/1900</b>	Shape:	<b>C</b>

Street:	<b>Rand St.</b>	Flow Control:	<b>Not Controlled</b>
City:	<b>Hobart, IN</b>	Year Renewed:	
Location:	<b>Light Highway</b>	Tape/Media #:	
Purpose:	<b>Routine Assessment</b>	Dia/Height:	<b>12"</b>
Use:	<b>Sanitary</b>	Material:	<b>VCP</b>
Drain Area:	<b>NA</b>	Lining:	
Category:	<b>NA</b>		
Comment:

Location Details:		Direction of Survey:	<b>Upstream</b>
US MH:	<b>M-903-021</b>	DS MH:	<b>M-903-024</b>
		Total Length Surveyed (ft):	<b>163.9</b>

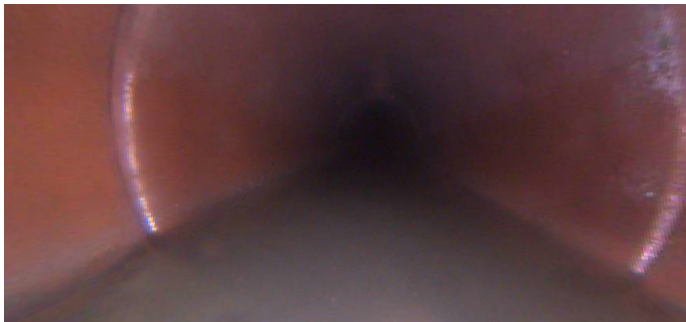
Code: **AMH**  
Description: **Manhole**

Distance (ft): **.0**  
Structural Grade: **0**  
O&M Grade: **0**  
Clock Start/From:  
Clock To:  
1st Value:  
2nd Value:  
Value Percent:  
Continuous Index:  
Within 8" of Joint: **NO**  
Remarks: **M-903-024**

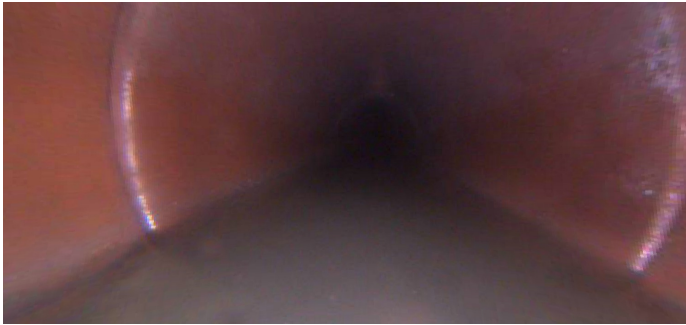
Code:	<b>MWL</b>
Description:	<b>Water Level</b>

Distance (ft):	<b>.0</b>
Structural Grade:	<b>0</b>
O&M Grade:	<b>0</b>
Clock Start/From:	
Clock To:	
1st Value:	
2nd Value:	
Value Percent:	<b>10.000</b>
Continuous Index:	
Within 8" of Joint:	<b>NO</b>
Remarks:

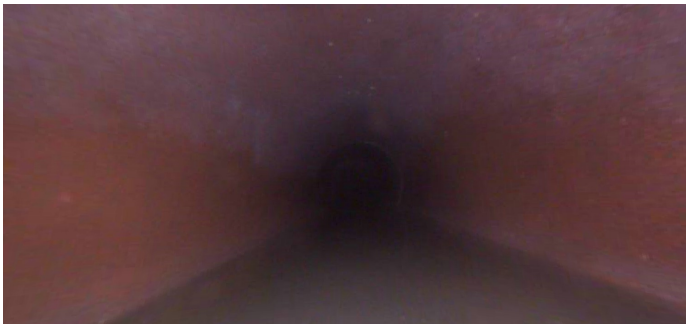
Code:	<b>DAGS</b>
Description:	<b>Deposits Attached Grease</b>

Distance (ft):	<b>4.2</b>
Structural Grade:	<b>0</b>
O&M Grade:	<b>2</b>
Clock Start/From:	<b>7</b>
Clock To:	<b>5</b>
1st Value:	
2nd Value:	
Value Percent:	<b>5.000</b>
Continuous Index:	
Within 8" of Joint:	<b>YES</b>
Remarks:	<b>WANDER</b>

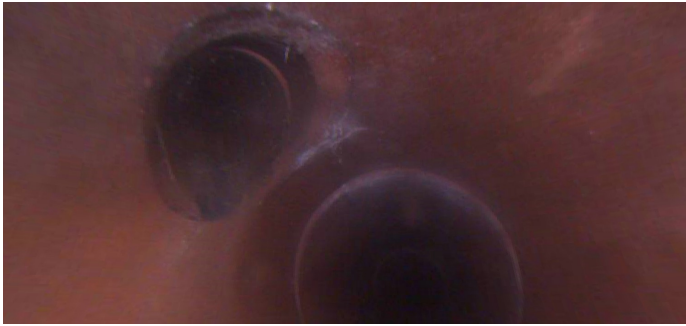
Code: **TF**  
Description: **Tap Factory**

Distance (ft): **9.0**  
Structural Grade: **0**  
O&M Grade: **0**  
Clock Start/From: **10**  
Clock To:  
1st Value: **4.000**  
2nd Value:  
Value Percent:  
Continuous Index:  
Within 8" of Joint:  
Remarks:

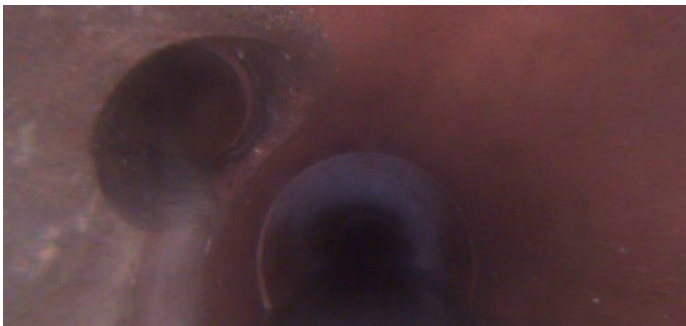
Code: **TF**  
Description: **Tap Factory**

Distance (ft): **81.5**  
Structural Grade: **0**  
O&M Grade: **0**  
Clock Start/From: **10**  
Clock To:  
1st Value: **4.000**  
2nd Value:  
Value Percent:  
Continuous Index:  
Within 8" of Joint:  
Remarks:

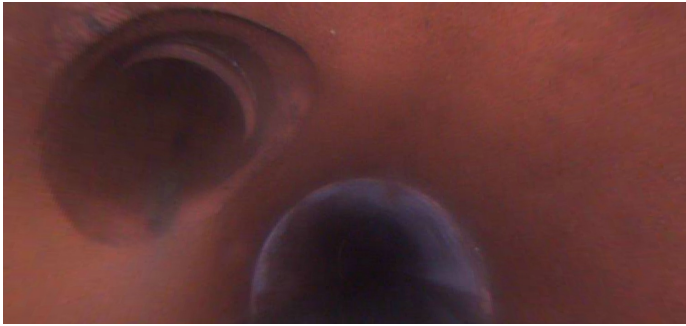
Code: **TF**  
Description: **Tap Factory**

Distance (ft): **126.7**  
Structural Grade: **0**  
O&M Grade: **0**  
Clock Start/From: **10**  
Clock To:  
1st Value: **4.000**  
2nd Value:  
Value Percent:  
Continuous Index:  
Within 8" of Joint:  
Remarks:

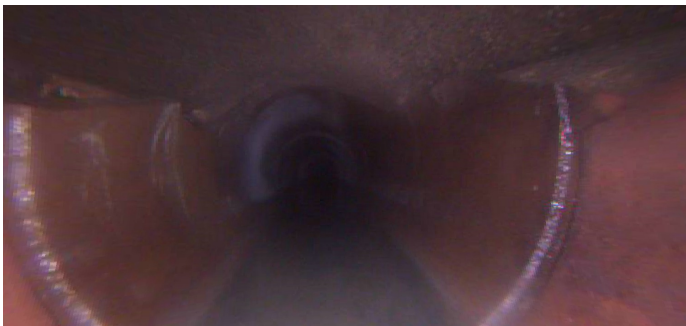
Code: **AMH**  
Description: **Manhole**

Distance (ft): **163.9**  
Structural Grade: **0**  
O&M Grade: **0**  
Clock Start/From:  
Clock To:  
1st Value:  
2nd Value:  
Value Percent:  
Continuous Index:  
Within 8" of Joint: **NO**  
Remarks: **M-903-021**
