## Profile/Photo Observation Report

Street:	<b>brandit st</b>	Flow Control:	<b>Not Controlled</b>
City:	<b>Hobart, IN</b>	Year Renewed:	
Location:	<b>Other</b>	Tape/Media #:	
Purpose:	<b>Not Known</b>	Dia/Height:	<b>10"</b>
Use:	<b>Sanitary</b>	Material:	<b>PVC</b>
Drain Area:	<b>NA</b>	Lining:	
Category:	<b>NA</b>		
Comment:

Location Details:		Direction of Survey:	<b>Downstream</b>
US MH:	<b>M-903-022</b>	DS MH:	<b>M-903-023</b>
		Total Length Surveyed (ft):	<b>73.1</b>

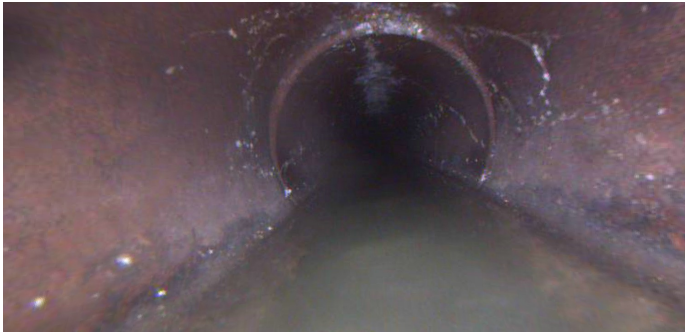
Code:	<b>MWL</b>
Description:	<b>Water Level</b>

Distance (ft):	<b>.0</b>
Structural Grade:	<b>0</b>
O&M Grade:	<b>0</b>
Clock Start/From:	
Clock To:	
1st Value:	
2nd Value:	
Value Percent:	<b>10.000</b>
Continuous Index:	
Within 8" of Joint:	<b>NO</b>
Remarks:

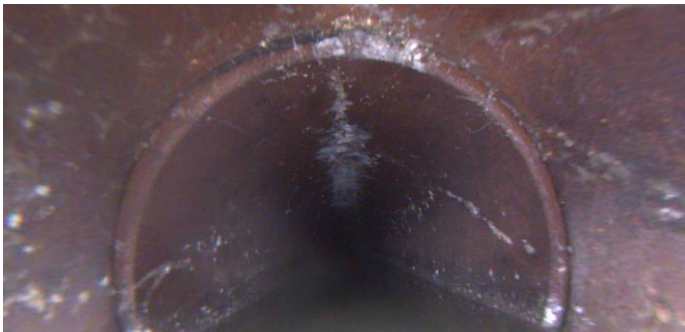
Code:	<b>CM</b>
Description:	<b>Crack Multiple</b>

Distance (ft):	<b>1.2</b>
Structural Grade:	<b>3</b>
O&M Grade:	<b>0</b>
Clock Start/From:	<b>8</b>
Clock To:	<b>4</b>
1st Value:	
2nd Value:	
Value Percent:	
Continuous Index:	
Within 8" of Joint:	<b>YES</b>
Remarks:

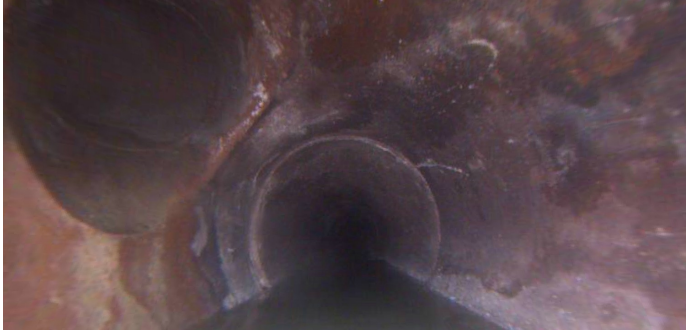
Code: **TF**  
Description: **Tap Factory**

Distance (ft): **27.4**  
Structural Grade: **0**  
O&M Grade: **0**  
Clock Start/From: **10**  
Clock To:  
1st Value: **4.000**  
2nd Value:  
Value Percent:  
Continuous Index:  
Within 8" of Joint:  
Remarks:

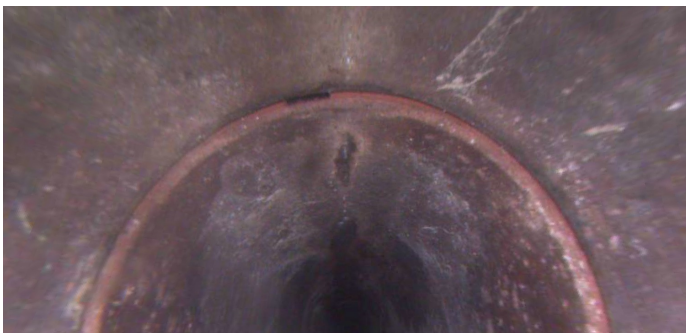
Code: **CM**  
Description: **Crack Multiple**

Distance (ft): **31.1**  
Structural Grade: **3**  
O&M Grade: **0**  
Clock Start/From: **8**  
Clock To: **4**  
1st Value:  
2nd Value:  
Value Percent:  
Continuous Index:  
Within 8" of Joint: **YES**  
Remarks:

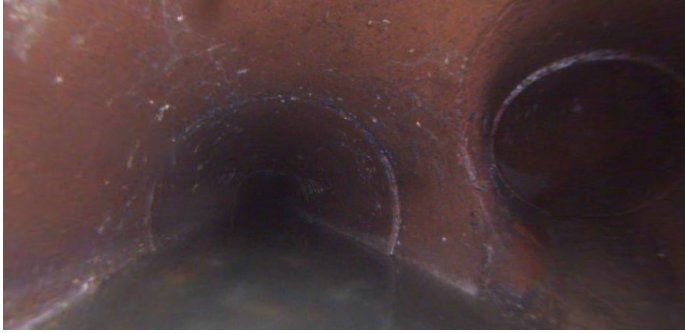
Code: **TFA**  
Description: **Tap Factory Active**

Distance (ft): **66.4**  
Structural Grade: **0**  
O&M Grade: **0**  
Clock Start/From: **3**  
Clock To:  
1st Value: **4.000**  
2nd Value:  
Value Percent:  
Continuous Index:  
Within 8" of Joint:  
Remarks:

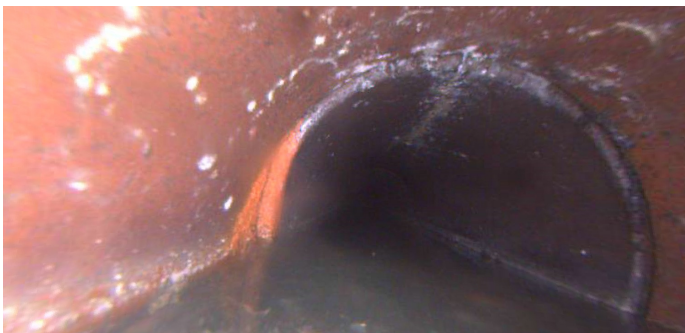
Code: **IW**  
Description: **Infil Weeper**

Distance (ft): **69.8**  
Structural Grade: **0**  
O&M Grade: **2**  
Clock Start/From: **8**  
Clock To: **9**  
1st Value:  
2nd Value:  
Value Percent:  
Continuous Index:  
Within 8" of Joint: **YES**  
Remarks:

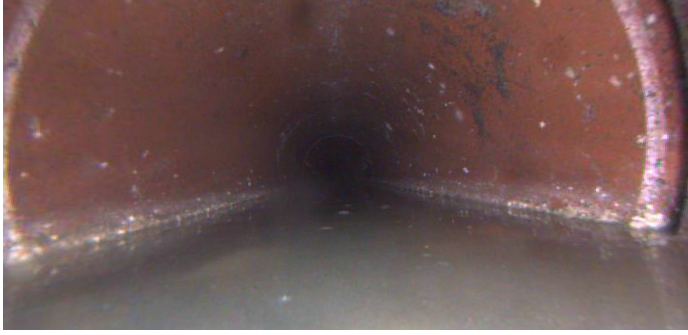
Code:	<b>MSA</b>
Description:	<b>Abandoned Survey</b>
Distance (ft):	<b>73.1</b>
Structural Grade:	<b>0</b>
O&M Grade:	<b>0</b>
Clock Start/From:	
Clock To:	
1st Value:	
2nd Value:	
Value Percent:	
Continuous Index:	
Within 8" of Joint:	<b>NO</b>
Remarks:	<b>debris under water</b>
