Profile/Photo Observation Report

Street:	Rand St.	Flow Control:	Not Controlled
City:	Hobart, IN	Year Renewed:	
Location:	Light Highway	Tape/Media #:	
Purpose:	Routine Assessment	Dia/Height:	10"
Use:	Sanitary	Material:	VCP
Drain Area:	NA	Lining:	
Category:	NA		
Comment:

Location Details:		Direction of Survey:	Downstream
US MH:	M-903-022	DS MH:	M-903-023
		Total Length Surveyed (ft):	145.8

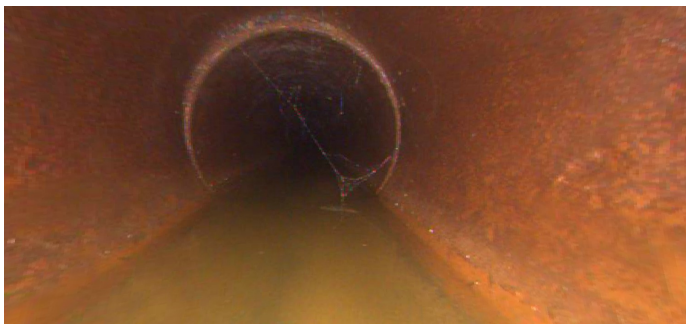
Code: **AMH**
Description: **Manhole**

Distance (ft): **.0**
Structural Grade: **0**
O&M Grade: **0**
Clock Start/From:
Clock To:
1st Value:
2nd Value:
Value Percent:
Continuous Index:
Within 8" of Joint: **NO**
Remarks: **M-903-022**

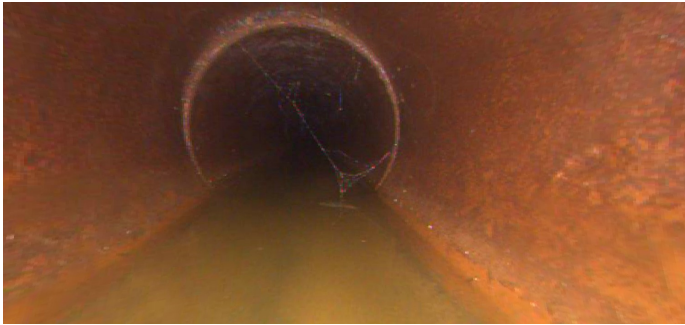
Code:	MWL
Description:	Water Level

Distance (ft):	.0
Structural Grade:	0
O&M Grade:	0
Clock Start/From:	
Clock To:	
1st Value:	
2nd Value:	
Value Percent:	10.000
Continuous Index:	
Within 8" of Joint:	NO
Remarks:

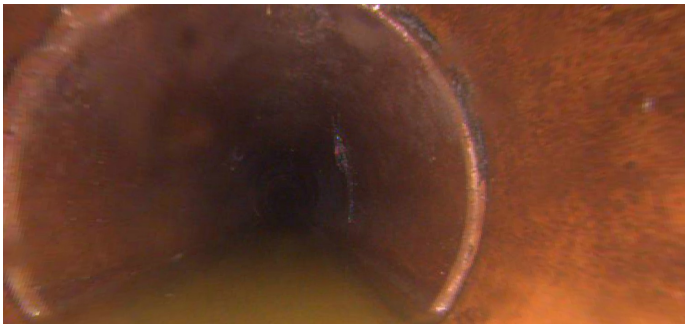
Code:	DAGS
Description:	Deposits Attached Grease

Distance (ft):	21.2
Structural Grade:	0
O&M Grade:	2
Clock Start/From:	7
Clock To:	5
1st Value:	
2nd Value:	
Value Percent:	5.000
Continuous Index:	S01
Within 8" of Joint:	YES
Remarks:	WANDER

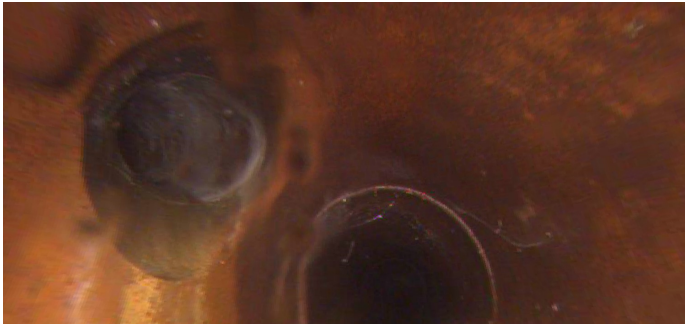
Code: **TF**
Description: **Tap Factory**

Distance (ft): **26.3**
Structural Grade: **0**
O&M Grade: **0**
Clock Start/From: **10**
Clock To:
1st Value: **4.000**
2nd Value:
Value Percent:
Continuous Index:
Within 8" of Joint:
Remarks:

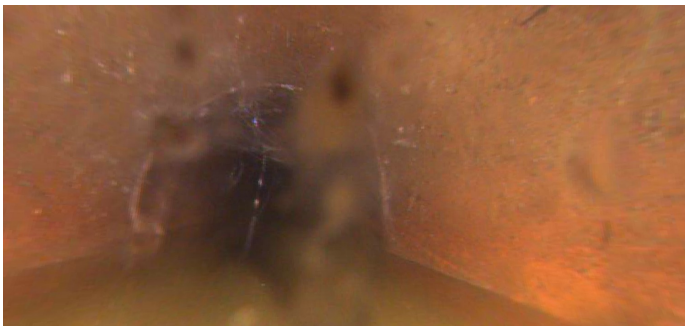
Code: **MGO**
Description: **General Observation**

Distance (ft): **49.7**
Structural Grade: **0**
O&M Grade: **0**
Clock Start/From:
Clock To:
1st Value:
2nd Value:
Value Percent:
Continuous Index:
Within 8" of Joint: **NO**
Remarks: **LARVAE ON LENS**

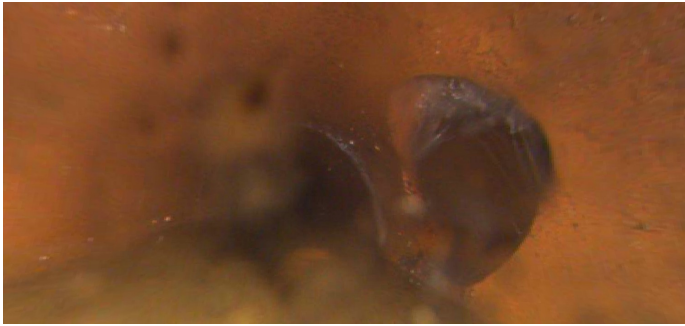
Code: **TF**
Description: **Tap Factory**

Distance (ft): **63.9**
Structural Grade: **0**
O&M Grade: **0**
Clock Start/From: **3**
Clock To:
1st Value: **4.000**
2nd Value:
Value Percent:
Continuous Index:
Within 8" of Joint:
Remarks:

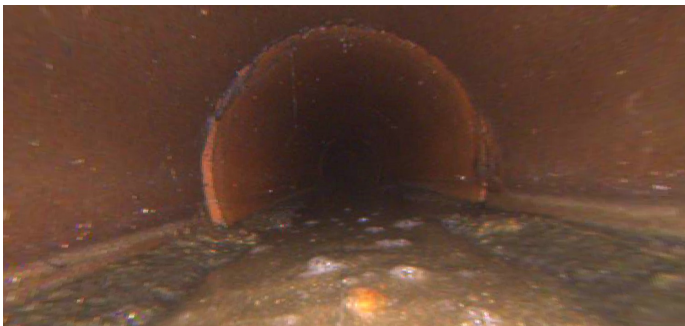
Code: **DAZ**
Description: **Deposits Attached Other**

Distance (ft): **68.9**
Structural Grade: **0**
O&M Grade: **2**
Clock Start/From: **7**
Clock To: **5**
1st Value:
2nd Value:
Value Percent: **5.000**
Continuous Index:
Within 8" of Joint: **YES**
Remarks:

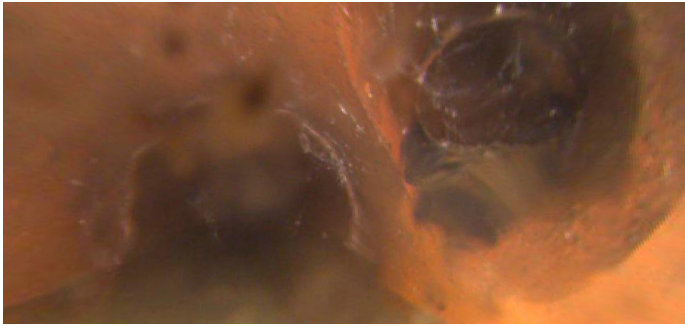
Code: **TF**
Description: **Tap Factory**

Distance (ft): **96.0**
Structural Grade: **0**
O&M Grade: **0**
Clock Start/From: **3**
Clock To:
1st Value: **4.000**
2nd Value:
Value Percent:
Continuous Index:
Within 8" of Joint:
Remarks:

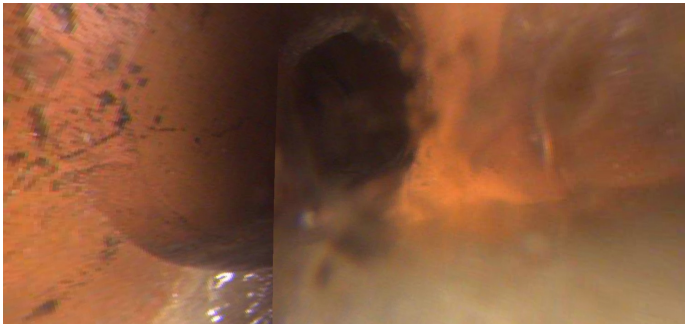
Code: **TFA**
Description: **Tap Factory Active**

Distance (ft): **116.4**
Structural Grade: **0**
O&M Grade: **0**
Clock Start/From: **9**
Clock To:
1st Value: **4.000**
2nd Value:
Value Percent:
Continuous Index:
Within 8" of Joint:
Remarks:

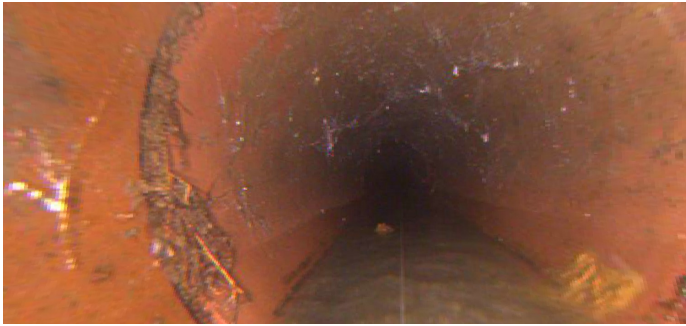
Code: **RFJ**
Description: **Roots Fine Joint**

Distance (ft): **120.5**
Structural Grade: **0**
O&M Grade: **1**
Clock Start/From: **2**
Clock To: **5**
1st Value:
2nd Value:
Value Percent:
Continuous Index:
Within 8" of Joint: **YES**
Remarks:

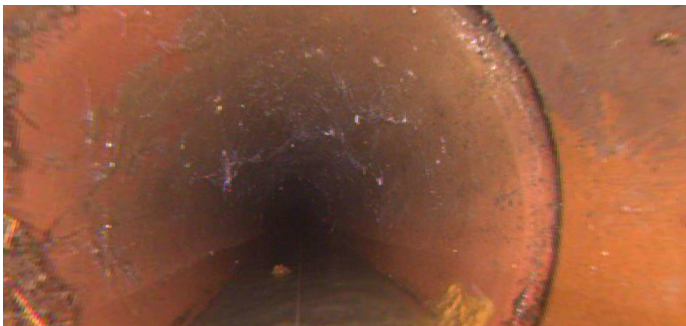
Code: **MGO**
Description: **General Observation**

Distance (ft): **120.5**
Structural Grade: **0**
O&M Grade: **0**
Clock Start/From:
Clock To:
1st Value:
2nd Value:
Value Percent:
Continuous Index:
Within 8" of Joint: **NO**
Remarks: **FRONT LENS OBSTRUCTED**

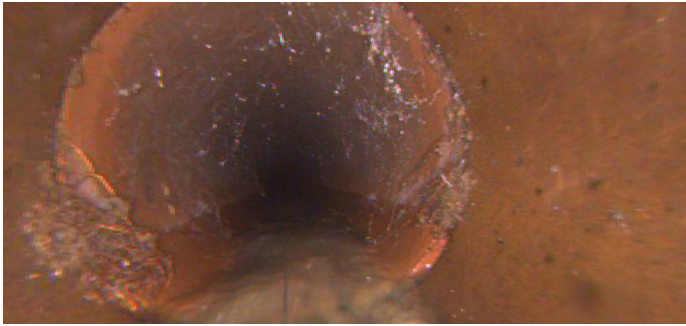
Code: **RFJ**
Description: **Roots Fine Joint**

Distance (ft): **123.6**
Structural Grade: **0**
O&M Grade: **1**
Clock Start/From: **8**
Clock To: **5**
1st Value:
2nd Value:
Value Percent:
Continuous Index:
Within 8" of Joint: **YES**
Remarks:

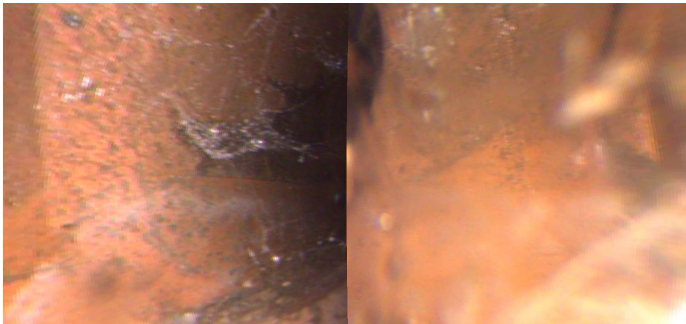
Code: **TF**
Description: **Tap Factory**

Distance (ft): **141.5**
Structural Grade: **0**
O&M Grade: **0**
Clock Start/From: **9**
Clock To:
1st Value: **4.000**
2nd Value:
Value Percent:
Continuous Index:
Within 8" of Joint:
Remarks:

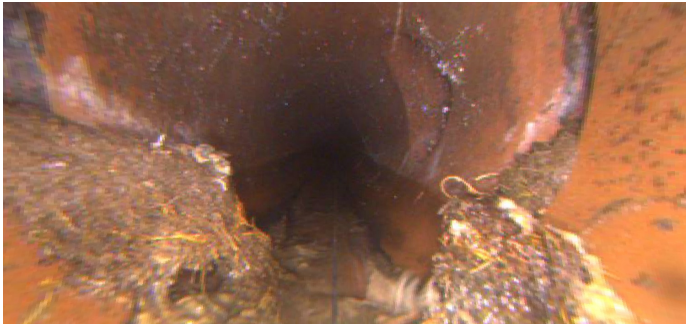
Code: **RMJ**
Description: **Roots Medium Joint**

Distance (ft): **142.5**
Structural Grade: **0**
O&M Grade: **3**
Clock Start/From: **7**
Clock To: **5**
1st Value:
2nd Value:
Value Percent: **10.000**
Continuous Index:
Within 8" of Joint: **YES**
Remarks:

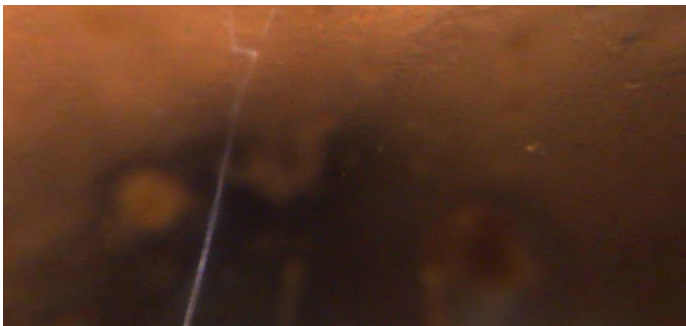
Code: **MSA**
Description: **Abandoned Survey**

Distance (ft): **145.8**
Structural Grade: **0**
O&M Grade: **0**
Clock Start/From:
Clock To:
1st Value:
2nd Value:
Value Percent:
Continuous Index:
Within 8" of Joint: **NO**
Remarks: **ROBOT HAS STOPPED**

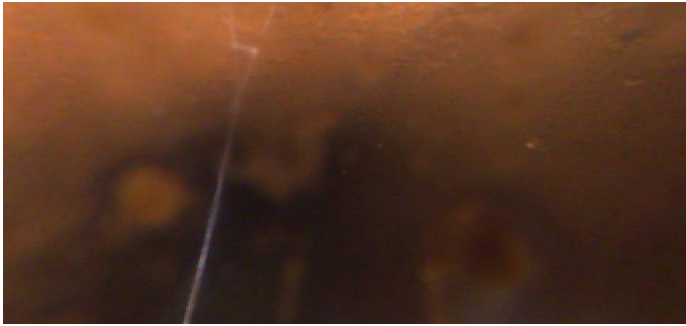
Code:	DAGS
Description:	Deposits Attached Grease
Distance (ft):	145.8
Structural Grade:	0
O&M Grade:	2
Clock Start/From:	7
Clock To:	5
1st Value:	
2nd Value:	
Value Percent:	5.000
Continuous Index:	F01
Within 8" of Joint:	YES
Remarks:	WANDER
