Profile/Photo Observation Report

Street:	ALLEY BETWEEN BRANDT ST & RUSH	Flow Control:	Not Controlled
City:	Hobart, IN	Year Renewed:	
Location:	Light Highway	Tape/Media #:	
Purpose:	Routine Assessment	Dia/Height:	10"
Use:	Sanitary	Material:	VCP
Drain Area:	NA	Lining:	
Category:	NA		
Comment:

Location Details:		Direction of Survey:	Upstream
US MH:	M-903-022	DS MH:	M-903-023
		Total Length Surveyed (ft):	2.2

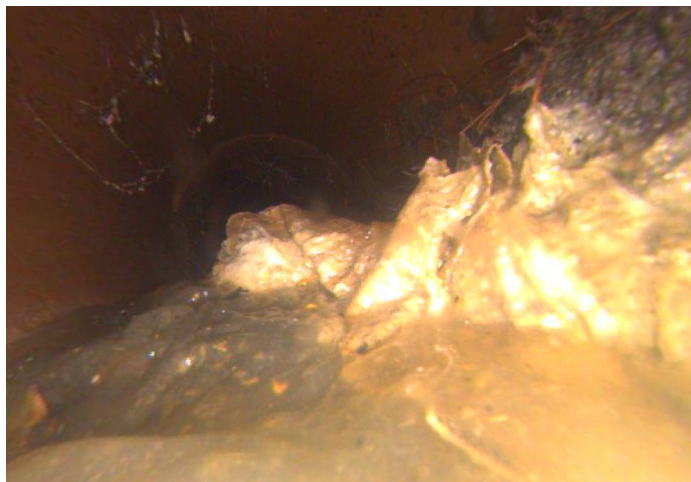
Code: **AMH**
Description: **Manhole**

Distance (ft): **.0**
Structural Grade: **0**
O&M Grade: **0**
Clock Start/From:
Clock To:
1st Value:
2nd Value:
Value Percent:
Continuous Index:
Within 8" of Joint: **NO**
Remarks: **M-903-023**

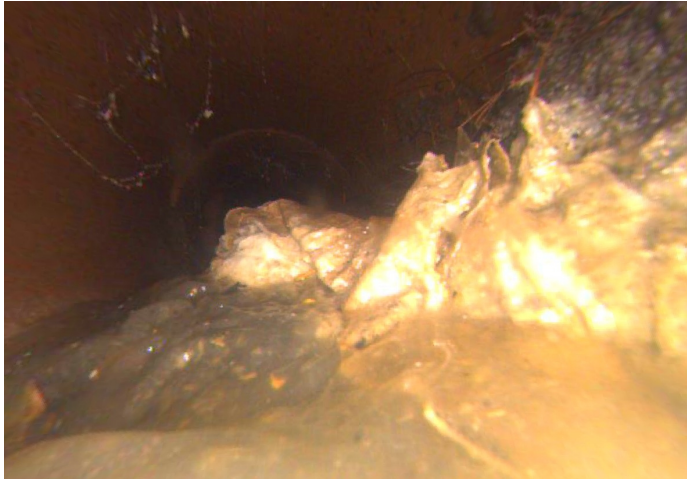
Code: **MWL**
Description: **Water Level**

Distance (ft): **.0**
Structural Grade: **0**
O&M Grade: **0**
Clock Start/From:
Clock To:
1st Value:
2nd Value:
Value Percent: **10.000**
Continuous Index:
Within 8" of Joint: **NO**
Remarks:

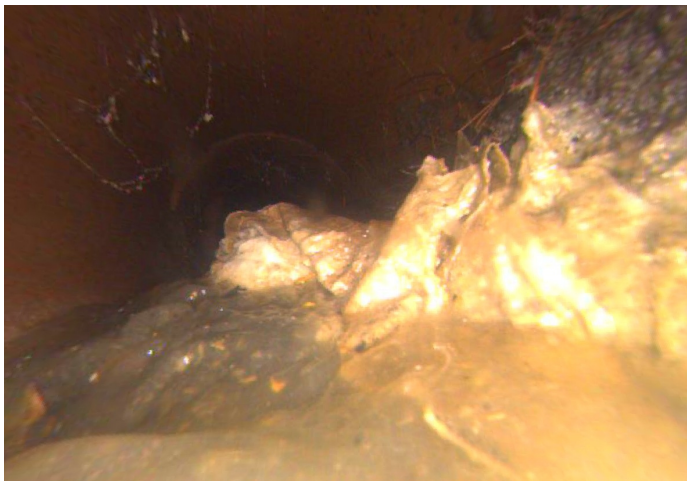
Code: **OBZ**
Description: **Obstacle Other**

Distance (ft): **.0**
Structural Grade: **0**
O&M Grade: **4**
Clock Start/From: **3**
Clock To: **6**
1st Value:
2nd Value:
Value Percent: **30.000**
Continuous Index:
Within 8" of Joint: **NO**
Remarks: **Mixed Materials**

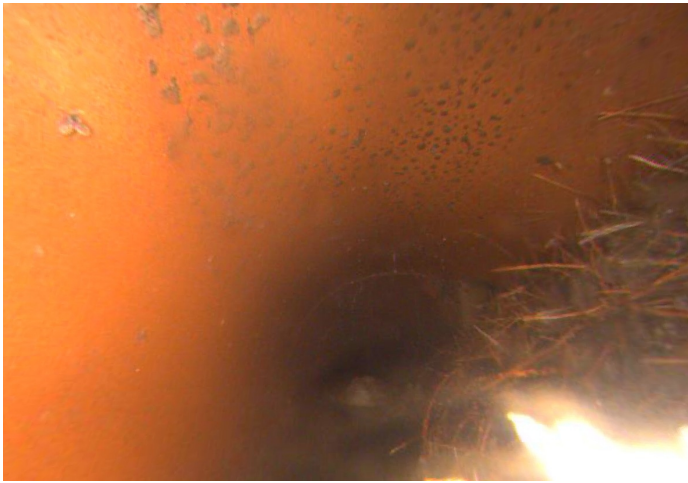
Code:	MSA
Description:	Abandoned Survey
Distance (ft):	2.2
Structural Grade:	0
O&M Grade:	0
Clock Start/From:	
Clock To:	
1st Value:	
2nd Value:	
Value Percent:	
Continuous Index:	
Within 8" of Joint:	NO
Remarks:	OBZ
