Profile/Photo Observation Report

Street:	Rand St.	Flow Control:	Not Controlled
City:	Hobart, IN	Year Renewed:	
Location:	Light Highway	Tape/Media #:	
Purpose:	Routine Assessment	Dia/Height:	10"
Use:	Sanitary	Material:	VCP
Drain Area:	NA	Lining:	
Category:	NA		
Comment:

Location Details:		Direction of Survey:	Upstream
US MH:	M-903-022	DS MH:	M-903-023
		Total Length Surveyed (ft):	2.2

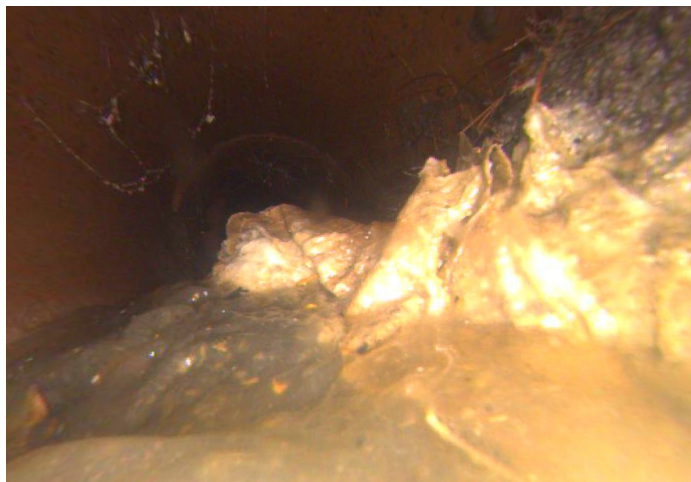
Code: **AMH**
Description: **Manhole**

Distance (ft): **.0**
Structural Grade: **0**
O&M Grade: **0**
Clock Start/From:
Clock To:
1st Value:
2nd Value:
Value Percent:
Continuous Index:
Within 8" of Joint: **NO**
Remarks: **M-903-023**

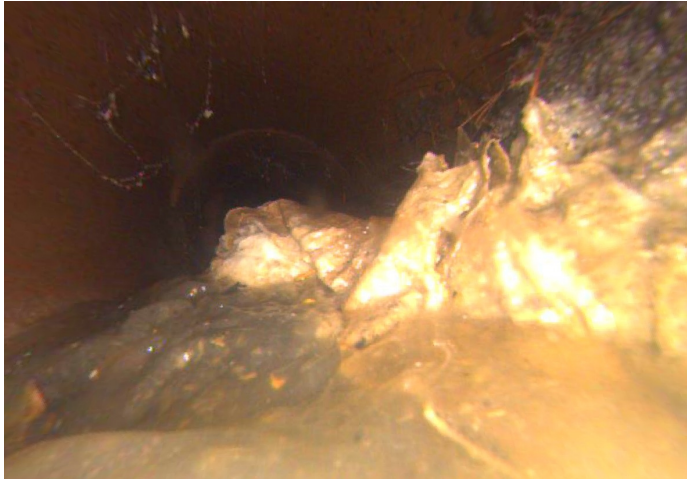
Code: **MWL**
Description: **Water Level**

Distance (ft): **.0**
Structural Grade: **0**
O&M Grade: **0**
Clock Start/From:
Clock To:
1st Value:
2nd Value:
Value Percent: **10.000**
Continuous Index:
Within 8" of Joint: **NO**
Remarks:

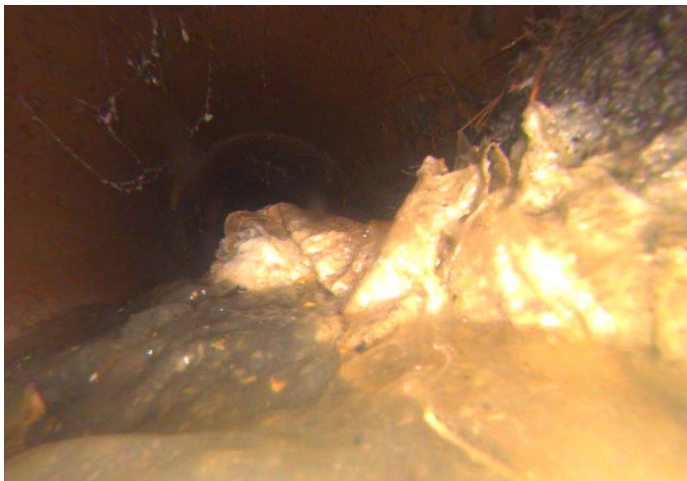
Code: **OBZ**
Description: **Obstacle Other**

Distance (ft): **.0**
Structural Grade: **0**
O&M Grade: **4**
Clock Start/From: **3**
Clock To: **6**
1st Value:
2nd Value:
Value Percent: **30.000**
Continuous Index:
Within 8" of Joint: **NO**
Remarks: **Mixed Materials**

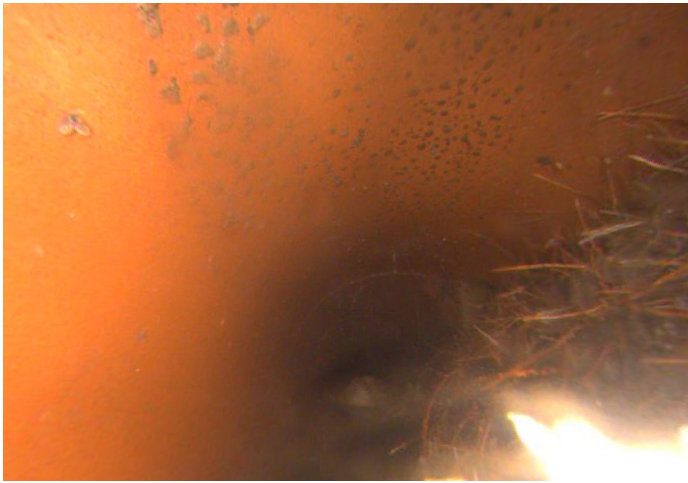
Code:	MSA
Description:	Abandoned Survey
Distance (ft):	2.2
Structural Grade:	0
O&M Grade:	0
Clock Start/From:	
Clock To:	
1st Value:	
2nd Value:	
Value Percent:	
Continuous Index:	
Within 8" of Joint:	NO
Remarks:	OBZ
