Profile/Photo Observation Report

Date:	10/02/2018	Weather:		Coding:	PACP 6.0
Pipe Length (ft):	168.3	Owner:	NA	Pre Clean:	Not Known
P.O.#:		Surveyor:	Justin Gonzales	PSR:	P-903-024-025
Customer:		Clean Date:	01/01/1900	Shape:	C

Street:	E RAND ST & RUSH ST	Flow Control:	Not Controlled
City:	Hobart, IN	Year Renewed:	
Location:	Light Highway	Tape/Media #:	
Purpose:	Routine Assessment	Dia/Height:	12"
Use:	Sanitary	Material:	VCP
Drain Area:	NA	Lining:	
Category:	NA		
Comment:

Location Details:		Direction of Survey:	Upstream
US MH:	M-903-024	DS MH:	M-903-025
		Total Length Surveyed (ft):	163.0

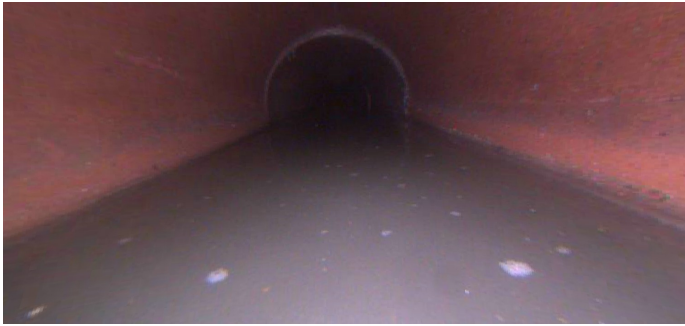
Code: **AMH**
Description: **Manhole**

Distance (ft): **.0**
Structural Grade: **0**
O&M Grade: **0**
Clock Start/From:
Clock To:
1st Value:
2nd Value:
Value Percent:
Continuous Index:
Within 8" of Joint: **NO**
Remarks: **M-903-025**

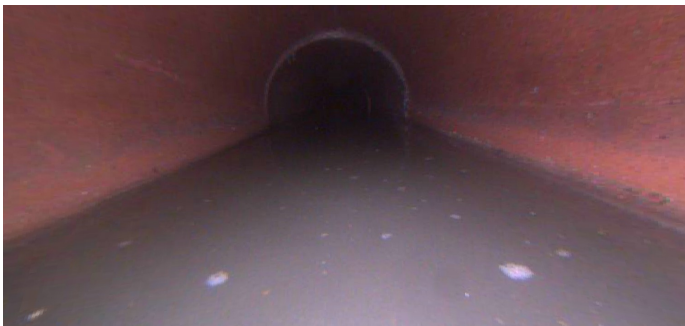
Code: **MWL**
Description: **Water Level**

Distance (ft): **.0**
Structural Grade: **0**
O&M Grade: **0**
Clock Start/From:
Clock To:
1st Value:
2nd Value:
Value Percent: **15.000**
Continuous Index:
Within 8" of Joint: **NO**
Remarks:

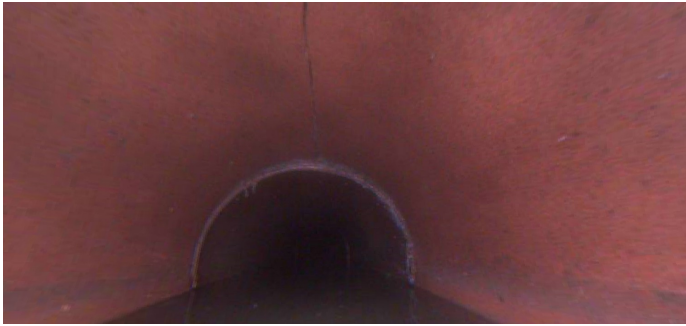
Code: **FL**
Description: **Fracture Longitudinal**

Distance (ft): **2.0**
Structural Grade: **3**
O&M Grade: **0**
Clock Start/From: **12**
Clock To:
1st Value:
2nd Value:
Value Percent:
Continuous Index:
Within 8" of Joint: **YES**
Remarks:

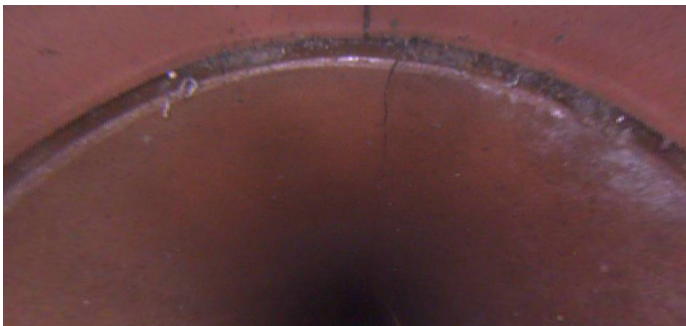
Code: **RFJ**
Description: **Roots Fine Joint**

Distance (ft): **2.9**
Structural Grade: **0**
O&M Grade: **1**
Clock Start/From: **11**
Clock To: **1**
1st Value:
2nd Value:
Value Percent:
Continuous Index:
Within 8" of Joint: **YES**
Remarks:

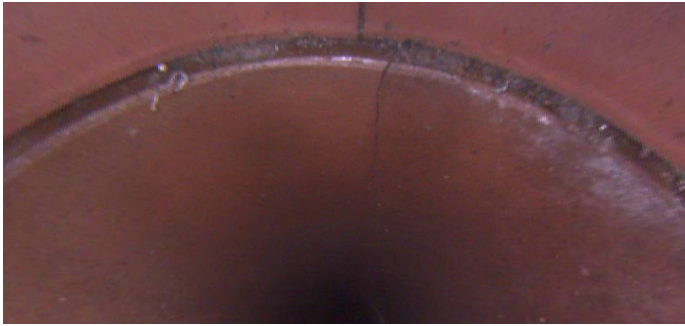
Code: **FL**
Description: **Fracture Longitudinal**

Distance (ft): **2.9**
Structural Grade: **3**
O&M Grade: **0**
Clock Start/From: **12**
Clock To:
1st Value:
2nd Value:
Value Percent:
Continuous Index:
Within 8" of Joint: **YES**
Remarks:

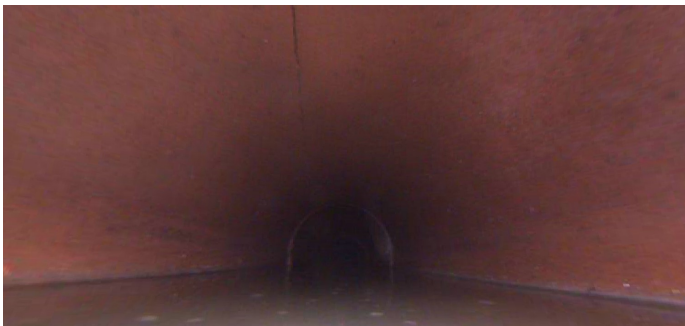
Code: **FL**
Description: **Fracture Longitudinal**

Distance (ft): **6.2**
Structural Grade: **3**
O&M Grade: **0**
Clock Start/From: **12**
Clock To:
1st Value:
2nd Value:
Value Percent:
Continuous Index:
Within 8" of Joint: **YES**
Remarks:

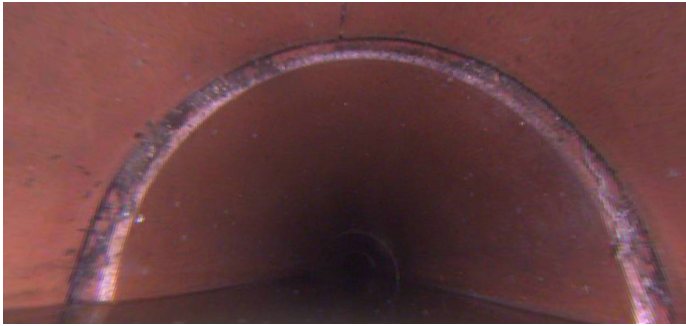
Code: **RFJ**
Description: **Roots Fine Joint**

Distance (ft): **8.7**
Structural Grade: **0**
O&M Grade: **1**
Clock Start/From: **7**
Clock To: **5**
1st Value:
2nd Value:
Value Percent:
Continuous Index:
Within 8" of Joint: **YES**
Remarks:

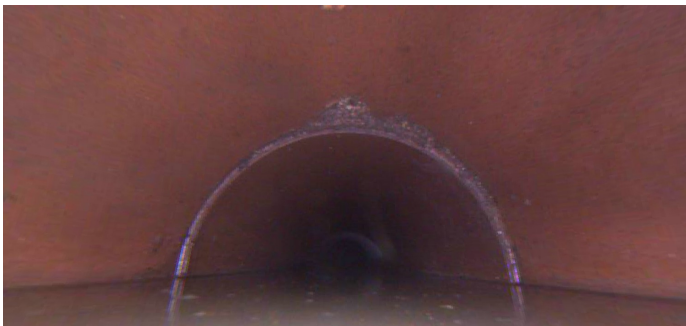
Code: **RFJ**
Description: **Roots Fine Joint**

Distance (ft): **11.2**
Structural Grade: **0**
O&M Grade: **1**
Clock Start/From: **11**
Clock To: **1**
1st Value:
2nd Value:
Value Percent:
Continuous Index:
Within 8" of Joint: **YES**
Remarks:

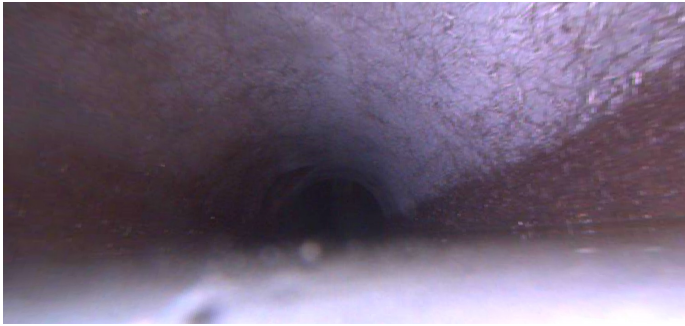
Code: **DAGS**
Description: **Deposits Attached Grease**

Distance (ft): **15.2**
Structural Grade: **0**
O&M Grade: **2**
Clock Start/From: **7**
Clock To: **5**
1st Value:
2nd Value:
Value Percent: **5.000**
Continuous Index:
Within 8" of Joint: **NO**
Remarks:

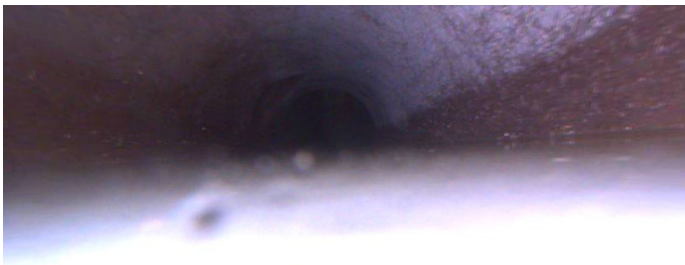
Code: **MWLS**
Description: **Water Level Sag**

Distance (ft): **15.2**
Structural Grade: **2**
O&M Grade: **3**
Clock Start/From:
Clock To:
1st Value:
2nd Value:
Value Percent: **20.000**
Continuous Index:
Within 8" of Joint: **NO**
Remarks:

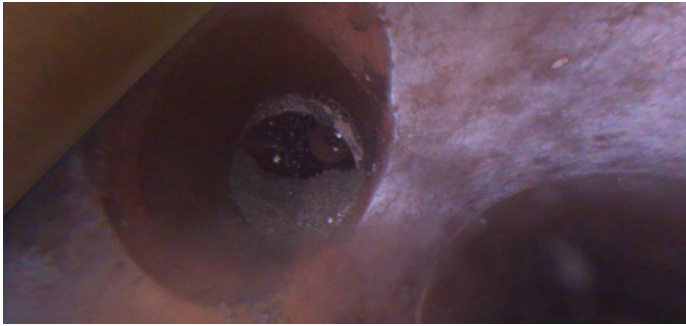
Code: **TF**
Description: **Tap Factory**

Distance (ft): **17.1**
Structural Grade: **0**
O&M Grade: **0**
Clock Start/From: **10**
Clock To:
1st Value: **4.000**
2nd Value:
Value Percent:
Continuous Index:
Within 8" of Joint:
Remarks:

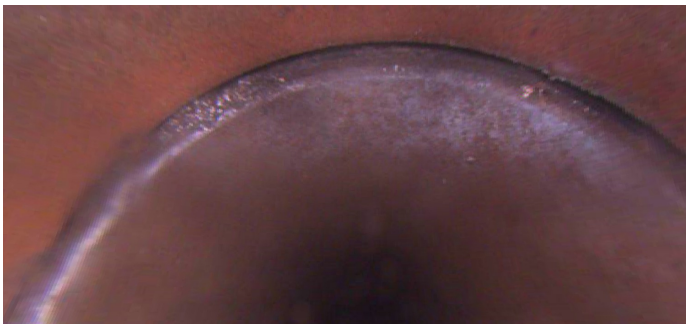
Code: **DAGS**
Description: **Deposits Attached Grease**

Distance (ft): **35.9**
Structural Grade: **0**
O&M Grade: **2**
Clock Start/From: **7**
Clock To: **5**
1st Value:
2nd Value:
Value Percent: **5.000**
Continuous Index: **S01**
Within 8" of Joint: **YES**
Remarks: **WANDER**

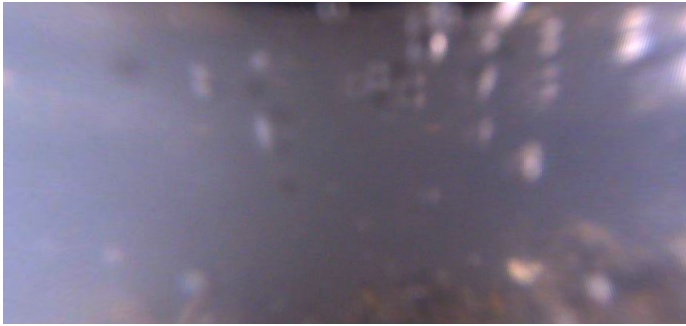
Code: **MCU**
Description: **Camera Underwater**

Distance (ft): **40.5**
Structural Grade: **0**
O&M Grade: **4**
Clock Start/From:
Clock To:
1st Value:
2nd Value:
Value Percent:
Continuous Index:
Within 8" of Joint: **NO**
Remarks:

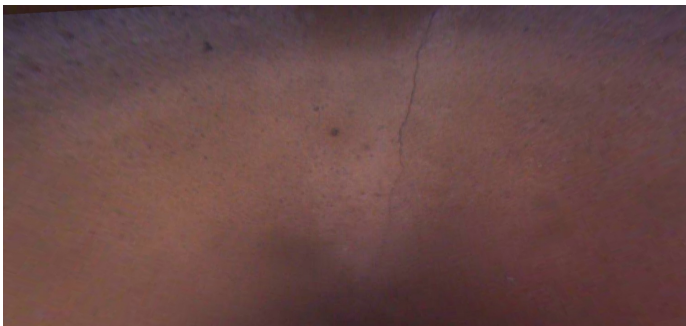
Code: **CL**
Description: **Crack Longitudinal**

Distance (ft): **51.8**
Structural Grade: **2**
O&M Grade: **0**
Clock Start/From: **12**
Clock To:
1st Value:
2nd Value:
Value Percent:
Continuous Index:
Within 8" of Joint: **YES**
Remarks:

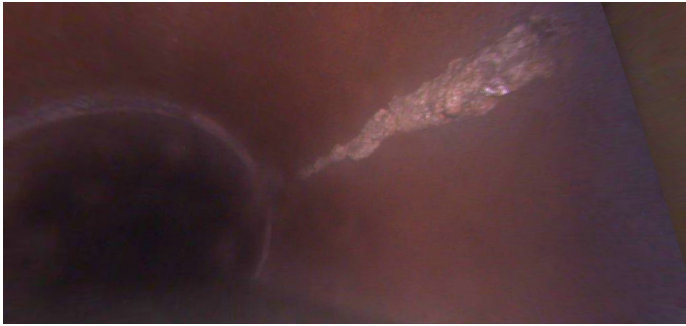
Code: **DAGS**
Description: **Deposits Attached Grease**

Distance (ft): **53.1**
Structural Grade: **0**
O&M Grade: **2**
Clock Start/From: **2**
Clock To:
1st Value:
2nd Value:
Value Percent: **5.000**
Continuous Index:
Within 8" of Joint: **NO**
Remarks:

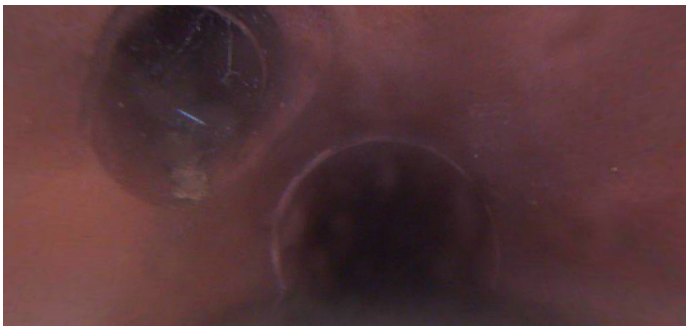
Code: **TF**
Description: **Tap Factory**

Distance (ft): **59.0**
Structural Grade: **0**
O&M Grade: **0**
Clock Start/From: **10**
Clock To:
1st Value: **4.000**
2nd Value:
Value Percent:
Continuous Index:
Within 8" of Joint:
Remarks:

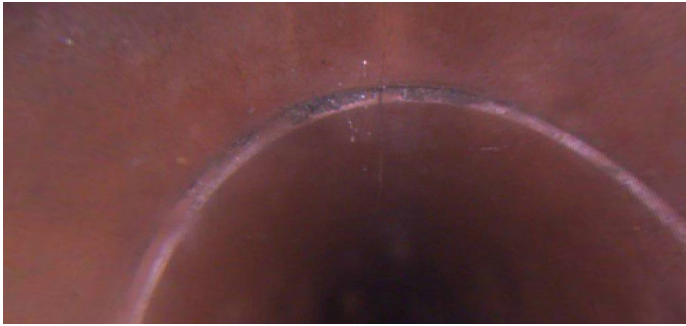
Code: **CL**
Description: **Crack Longitudinal**

Distance (ft): **59.8**
Structural Grade: **2**
O&M Grade: **0**
Clock Start/From: **12**
Clock To:
1st Value:
2nd Value:
Value Percent:
Continuous Index:
Within 8" of Joint: **YES**
Remarks:

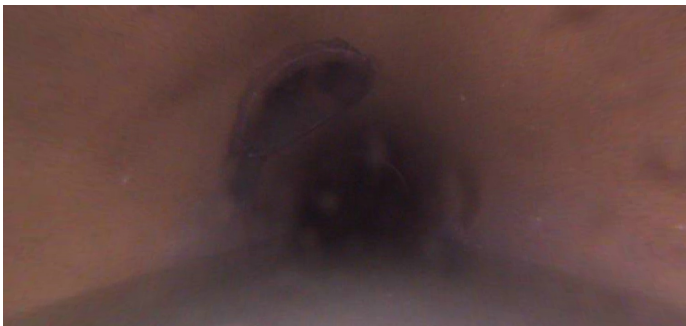
Code: **TFI**
Description: **Tap Factory Intruding**

Distance (ft): **69.6**
Structural Grade: **0**
O&M Grade: **2**
Clock Start/From: **10**
Clock To:
1st Value: **4.000**
2nd Value: **0.500**
Value Percent:
Continuous Index:
Within 8" of Joint:
Remarks:

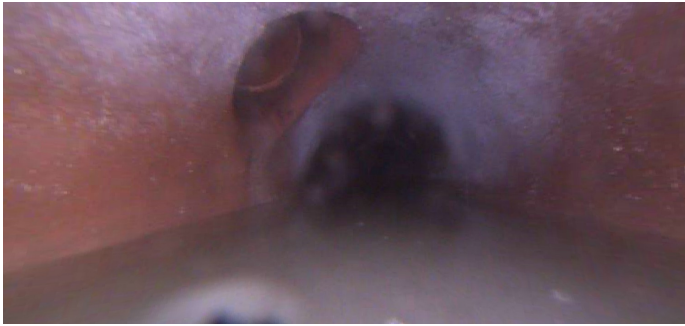
Code: **TF**
Description: **Tap Factory**

Distance (ft): **92.2**
Structural Grade: **0**
O&M Grade: **0**
Clock Start/From: **10**
Clock To:
1st Value: **4.000**
2nd Value:
Value Percent:
Continuous Index:
Within 8" of Joint:
Remarks:

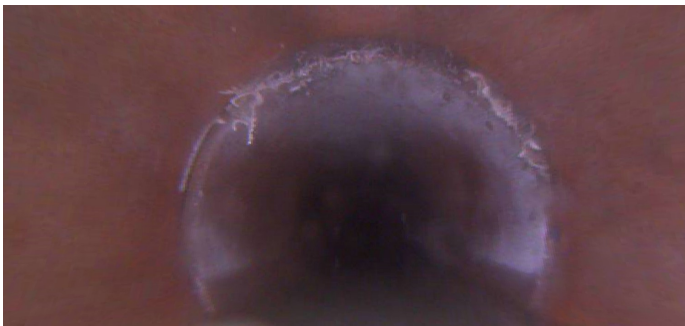
Code: **RFJ**
Description: **Roots Fine Joint**

Distance (ft): **96.4**
Structural Grade: **0**
O&M Grade: **1**
Clock Start/From: **10**
Clock To: **3**
1st Value:
2nd Value:
Value Percent:
Continuous Index:
Within 8" of Joint: **YES**
Remarks:

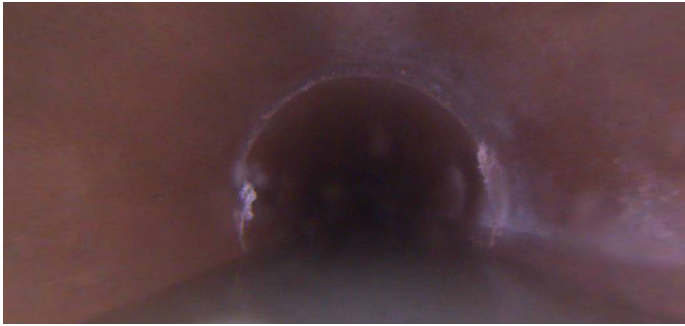
Code: **RFJ**
Description: **Roots Fine Joint**

Distance (ft): **99.0**
Structural Grade: **0**
O&M Grade: **1**
Clock Start/From: **7**
Clock To: **5**
1st Value:
2nd Value:
Value Percent:
Continuous Index:
Within 8" of Joint: **YES**
Remarks:

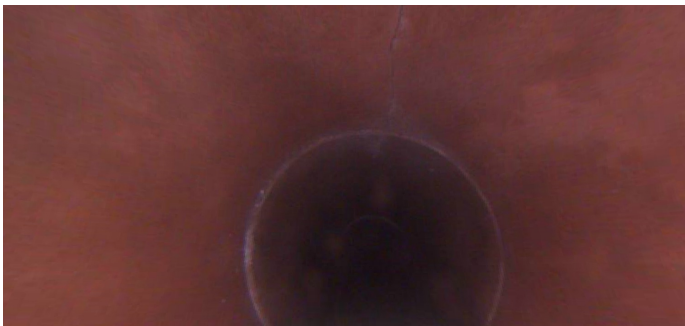
Code: **FL**
Description: **Fracture Longitudinal**

Distance (ft): **132.0**
Structural Grade: **3**
O&M Grade: **0**
Clock Start/From: **12**
Clock To:
1st Value:
2nd Value:
Value Percent:
Continuous Index:
Within 8" of Joint: **YES**
Remarks:

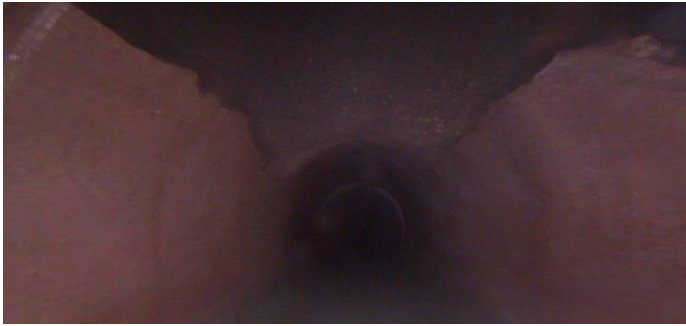
Code: **AMH**
Description: **Manhole**

Distance (ft): **163.0**
Structural Grade: **0**
O&M Grade: **0**
Clock Start/From:
Clock To:
1st Value:
2nd Value:
Value Percent:
Continuous Index:
Within 8" of Joint: **NO**
Remarks: **M-903-024**

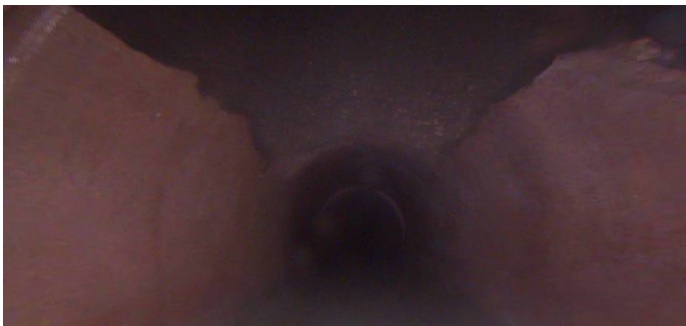
Code: **DAGS**
Description: **Deposits Attached Grease**

Distance (ft): **163.0**
Structural Grade: **0**
O&M Grade: **2**
Clock Start/From: **7**
Clock To: **5**
1st Value:
2nd Value:
Value Percent: **5.000**
Continuous Index: **F01**
Within 8" of Joint: **YES**
Remarks: **WANDER**
