Profile/Photo Observation Report

Date:	04/02/2018	Weather:		Coding:	PACP 6.0
Pipe Length (ft):	225.3	Owner:	NA	Pre Clean:	Not Known
P.O.#:		Surveyor:	Jen Costello	PSR:	P-903-026-025
Customer:		Clean Date:	01/01/1900	Shape:	C

Street:	E RAND ST	Flow Control:	Not Controlled
City:	Hobart, IN	Year Renewed:	
Location:	Other	Tape/Media #:	
Purpose:	Not Known	Dia/Height:	10"
Use:	Sanitary	Material:	VCP
Drain Area:	NA	Lining:	
Category:	NA		
Comment:

Location Details:		Direction of Survey:	Downstream
US MH:	M-903-025	DS MH:	M-903-026
		Total Length Surveyed (ft):	70.8

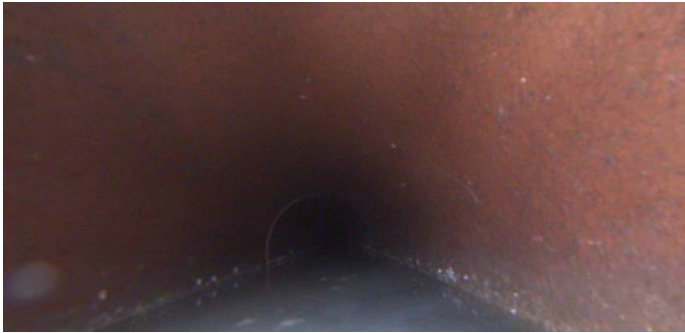
Code:	MWL
Description:	Water Level

Distance (ft):	.0
Structural Grade:	0
O&M Grade:	0
Clock Start/From:	
Clock To:	
1st Value:	
2nd Value:	
Value Percent:	30.000
Continuous Index:	
Within 8" of Joint:	NO
Remarks:

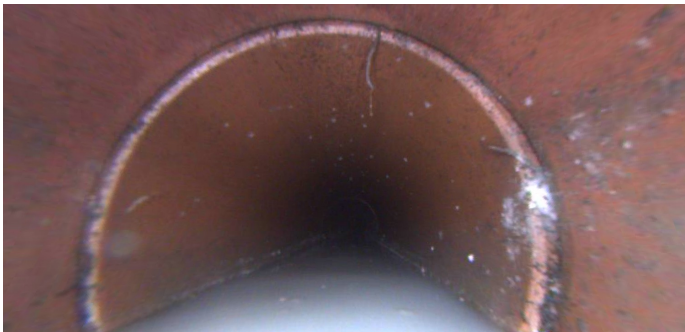
Code:	RFJ
Description:	Roots Fine Joint

Distance (ft):	20.8
Structural Grade:	0
O&M Grade:	1
Clock Start/From:	8
Clock To:	4
1st Value:	
2nd Value:	
Value Percent:	
Continuous Index:	
Within 8" of Joint:	YES
Remarks:

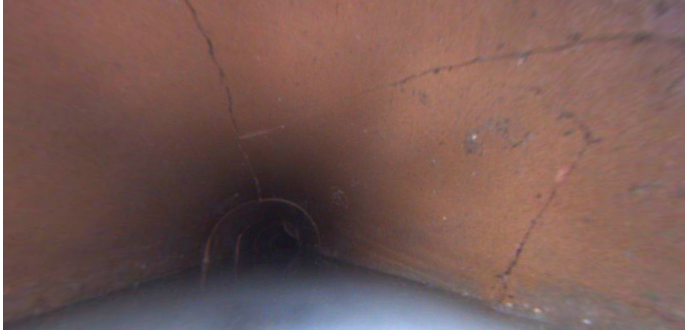
Code: **FM**
Description: **Fracture Multiple**

Distance (ft): **60.9**
Structural Grade: **4**
O&M Grade: **0**
Clock Start/From: **8**
Clock To: **4**
1st Value:
2nd Value:
Value Percent:
Continuous Index: **S01**
Within 8" of Joint: **YES**
Remarks:

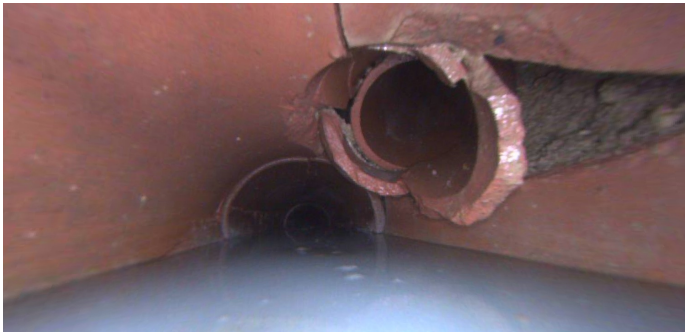
Code: **TBD**
Description: **Tap Break-in Defective**

Distance (ft): **64.5**
Structural Grade: **0**
O&M Grade: **3**
Clock Start/From: **2**
Clock To:
1st Value: **4.000**
2nd Value:
Value Percent:
Continuous Index:
Within 8" of Joint:
Remarks: **broken**

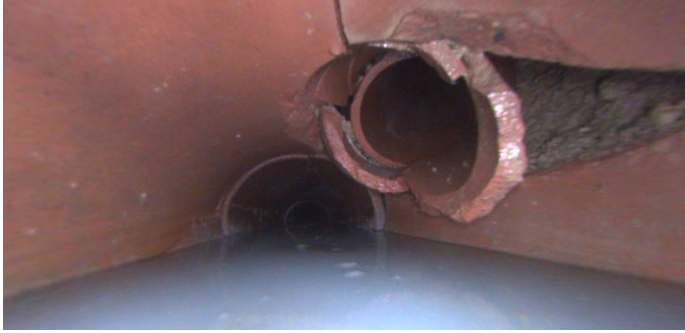
Code: **HVV**
Description: **Hole Void Visible**

Distance (ft): **64.5**
Structural Grade: **5**
O&M Grade: **0**
Clock Start/From: **1**
Clock To: **4**
1st Value:
2nd Value:
Value Percent:
Continuous Index:
Within 8" of Joint:
Remarks:

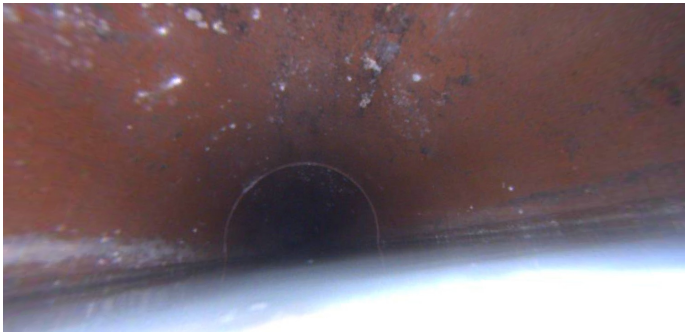
Code: **FM**
Description: **Fracture Multiple**

Distance (ft): **70.8**
Structural Grade: **4**
O&M Grade: **0**
Clock Start/From: **8**
Clock To: **4**
1st Value:
2nd Value:
Value Percent:
Continuous Index: **F01**
Within 8" of Joint: **YES**
Remarks:

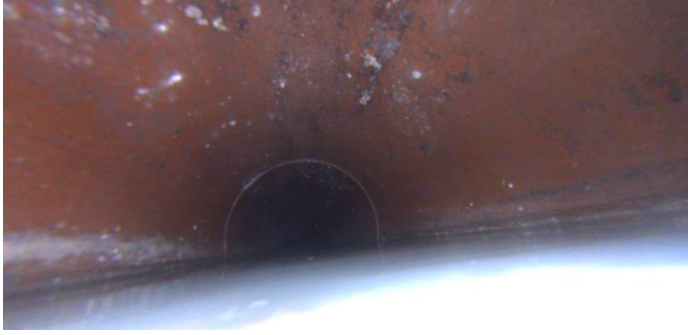
Code:	MSA
Description:	Abandoned Survey
Distance (ft):	70.8
Structural Grade:	0
O&M Grade:	0
Clock Start/From:	
Clock To:	
1st Value:	
2nd Value:	
Value Percent:	
Continuous Index:	
Within 8" of Joint:	NO
Remarks:	debris under water
