Profile/Photo Observation Report

Street:	Rand St.	Flow Control:	Not Controlled
City:	Hobart, IN	Year Renewed:	
Location:	Other	Tape/Media #:	
Purpose:	Not Known	Dia/Height:	10"
Use:	Sanitary	Material:	VCP
Drain Area:	NA	Lining:	
Category:	NA		
Comment:

Location Details:		Direction of Survey:	Downstream
US MH:	M-903-025	DS MH:	M-903-026
		Total Length Surveyed (ft):	70.8

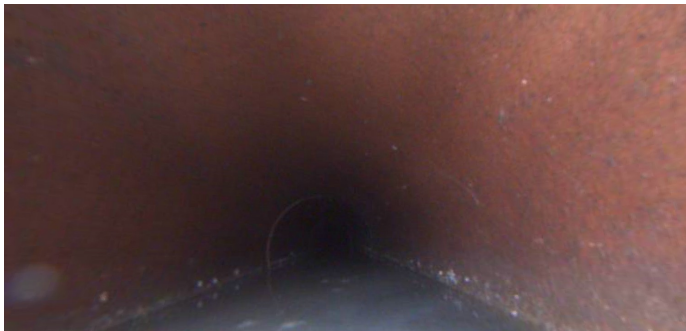
Code: **AMH**
Description: **Manhole**

Distance (ft): **.0**
Structural Grade: **0**
O&M Grade: **0**
Clock Start/From:
Clock To:
1st Value:
2nd Value:
Value Percent:
Continuous Index:
Within 8" of Joint: **NO**
Remarks: **M-903-025**

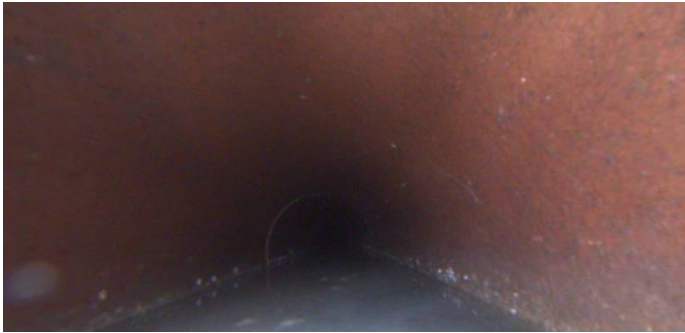
Code:	MWL
Description:	Water Level

Distance (ft):	.0
Structural Grade:	0
O&M Grade:	0
Clock Start/From:	
Clock To:	
1st Value:	
2nd Value:	
Value Percent:	30.000
Continuous Index:	
Within 8" of Joint:	NO
Remarks:

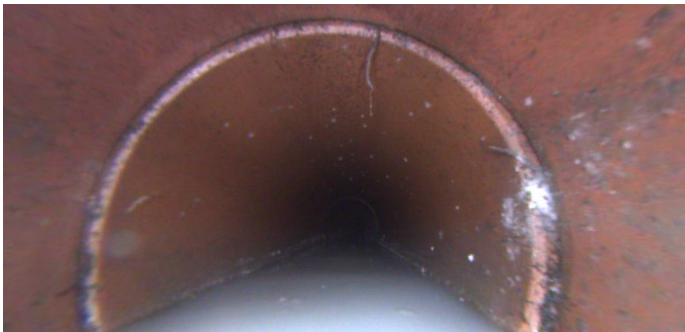
Code:	RFJ
Description:	Roots Fine Joint

Distance (ft):	20.8
Structural Grade:	0
O&M Grade:	1
Clock Start/From:	8
Clock To:	4
1st Value:	
2nd Value:	
Value Percent:	
Continuous Index:	
Within 8" of Joint:	YES
Remarks:

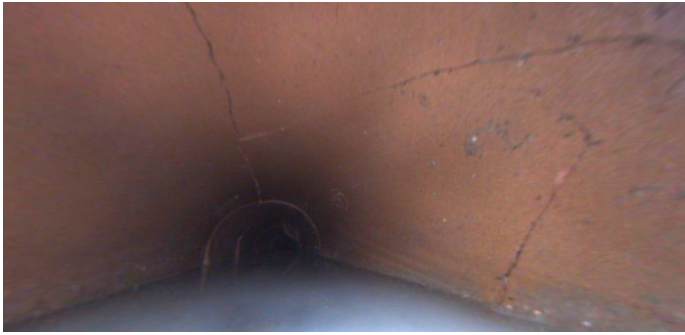
Code: **FM**
Description: **Fracture Multiple**

Distance (ft): **60.9**
Structural Grade: **4**
O&M Grade: **0**
Clock Start/From: **8**
Clock To: **4**
1st Value:
2nd Value:
Value Percent:
Continuous Index: **S01**
Within 8" of Joint: **YES**
Remarks:

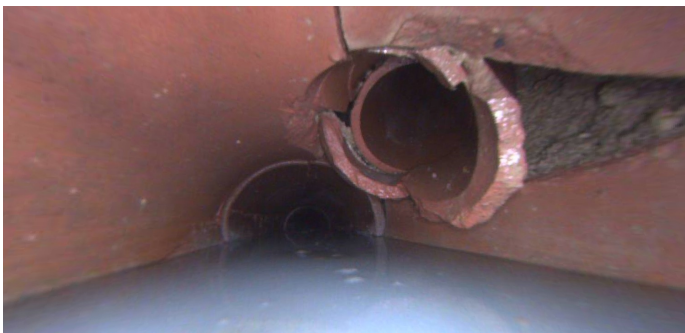
Code: **TBD**
Description: **Tap Break-in Defective**

Distance (ft): **64.5**
Structural Grade: **0**
O&M Grade: **3**
Clock Start/From: **2**
Clock To:
1st Value: **4.000**
2nd Value:
Value Percent:
Continuous Index:
Within 8" of Joint:
Remarks: **broken**

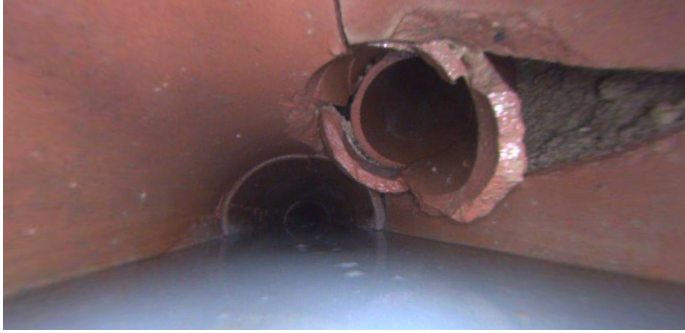
Code: **HVV**
Description: **Hole Void Visible**

Distance (ft): **64.5**
Structural Grade: **5**
O&M Grade: **0**
Clock Start/From: **1**
Clock To: **4**
1st Value:
2nd Value:
Value Percent:
Continuous Index:
Within 8" of Joint:
Remarks:

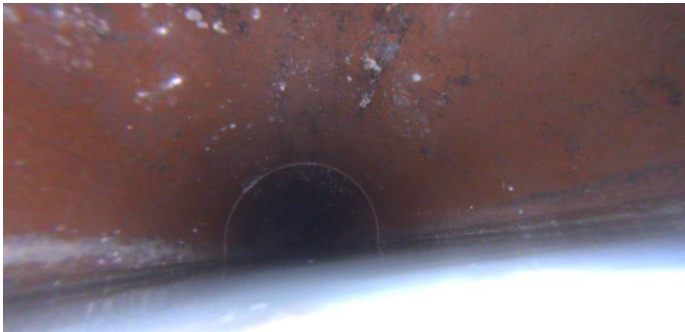
Code: **FM**
Description: **Fracture Multiple**

Distance (ft): **70.8**
Structural Grade: **4**
O&M Grade: **0**
Clock Start/From: **8**
Clock To: **4**
1st Value:
2nd Value:
Value Percent:
Continuous Index: **F01**
Within 8" of Joint: **YES**
Remarks:

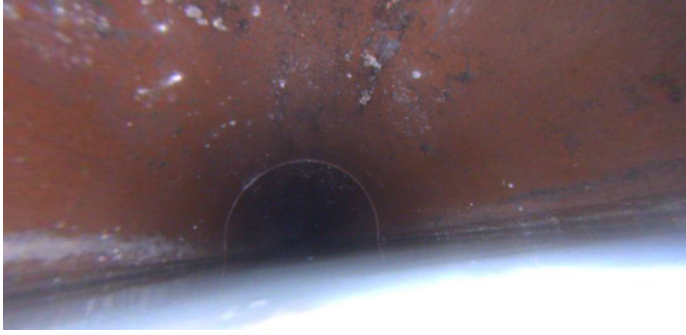
Code:	MSA
Description:	Abandoned Survey
Distance (ft):	70.8
Structural Grade:	0
O&M Grade:	0
Clock Start/From:	
Clock To:	
1st Value:	
2nd Value:	
Value Percent:	
Continuous Index:	
Within 8" of Joint:	NO
Remarks:	debris under water
