## Profile/Photo Observation Report

Street:	<b>E RAND ST</b>	Flow Control:	<b>Not Controlled</b>
City:	<b>Hobart, IN</b>	Year Renewed:	
Location:	<b>Other</b>	Tape/Media #:	
Purpose:	<b>Not Known</b>	Dia/Height:	<b>10"</b>
Use:	<b>Sanitary</b>	Material:	<b>VCP</b>
Drain Area:	<b>NA</b>	Lining:	
Category:	<b>NA</b>		
Comment:

Location Details:		Direction of Survey:	<b>Upstream</b>
US MH:	<b>M-903-025</b>	DS MH:	<b>M-903-026</b>
		Total Length Surveyed (ft):	<b>96.2</b>

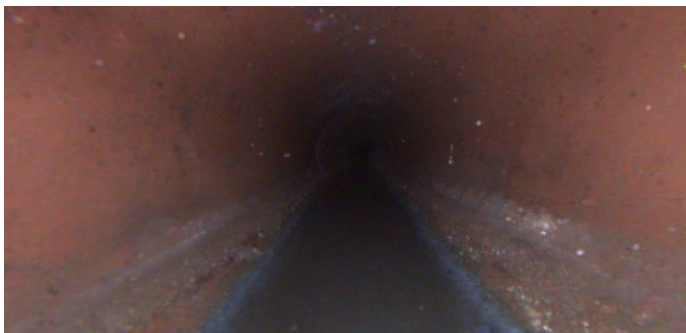
Code: **AMH**  
Description: **Manhole**

Distance (ft): **.0**  
Structural Grade: **0**  
O&M Grade: **0**  
Clock Start/From:  
Clock To:  
1st Value:  
2nd Value:  
Value Percent:  
Continuous Index:  
Within 8" of Joint: **NO**  
Remarks: **M-903-026**

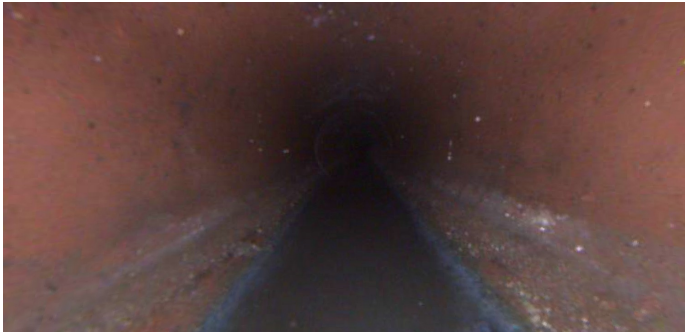
Code:	<b>MWL</b>
Description:	<b>Water Level</b>

Distance (ft):	<b>.0</b>
Structural Grade:	<b>0</b>
O&M Grade:	<b>0</b>
Clock Start/From:	
Clock To:	
1st Value:	
2nd Value:	
Value Percent:	<b>5.000</b>
Continuous Index:	
Within 8" of Joint:	<b>NO</b>
Remarks:

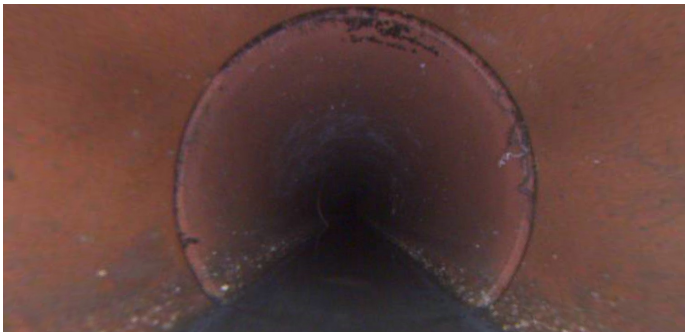
Code:	<b>RFJ</b>
Description:	<b>Roots Fine Joint</b>

Distance (ft):	<b>6.3</b>
Structural Grade:	<b>0</b>
O&M Grade:	<b>1</b>
Clock Start/From:	<b>8</b>
Clock To:	<b>4</b>
1st Value:	
2nd Value:	
Value Percent:	
Continuous Index:	
Within 8" of Joint:	<b>YES</b>
Remarks:

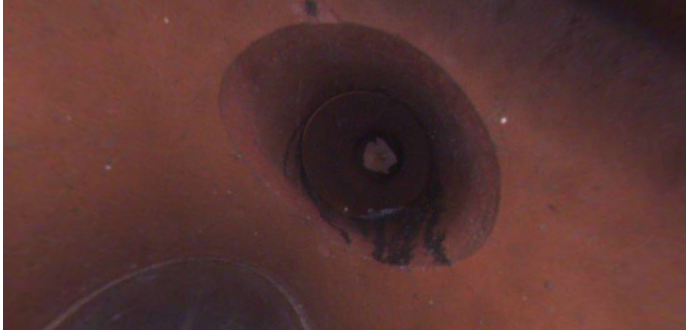
Code: **TF**  
Description: **Tap Factory**

Distance (ft): **14.2**  
Structural Grade: **0**  
O&M Grade: **0**  
Clock Start/From: **10**  
Clock To:  
1st Value: **4.000**  
2nd Value:  
Value Percent:  
Continuous Index:  
Within 8" of Joint:  
Remarks:

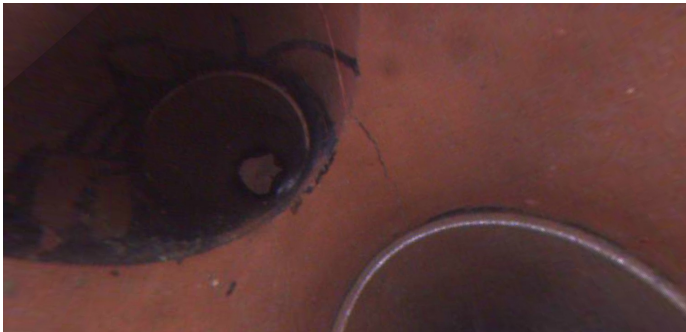
Code: **TFD**  
Description: **Tap Factory Defective**

Distance (ft): **17.0**  
Structural Grade: **0**  
O&M Grade: **2**  
Clock Start/From: **2**  
Clock To:  
1st Value: **4.000**  
2nd Value:  
Value Percent:  
Continuous Index:  
Within 8" of Joint:  
Remarks: **fl**

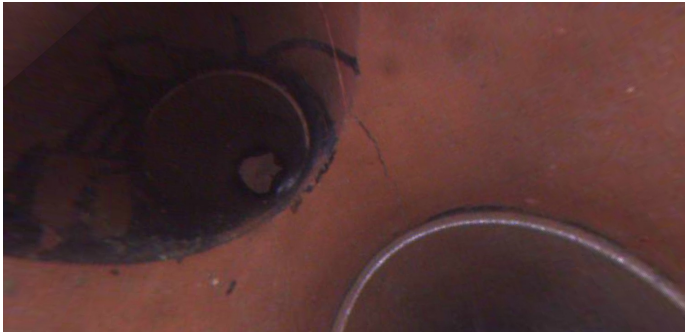
Code: **FL**  
Description: **Fracture Longitudinal**

Distance (ft): **17.0**  
Structural Grade: **3**  
O&M Grade: **0**  
Clock Start/From: **1**  
Clock To:  
1st Value:  
2nd Value:  
Value Percent:  
Continuous Index:  
Within 8" of Joint:  
Remarks:

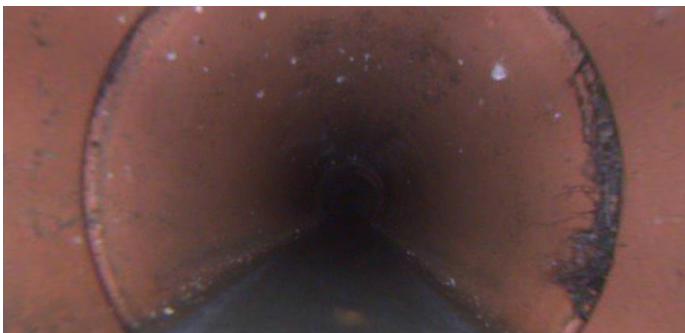
Code: **RFJ**  
Description: **Roots Fine Joint**

Distance (ft): **39.6**  
Structural Grade: **0**  
O&M Grade: **1**  
Clock Start/From: **2**  
Clock To: **4**  
1st Value:  
2nd Value:  
Value Percent:  
Continuous Index:  
Within 8" of Joint: **YES**  
Remarks:

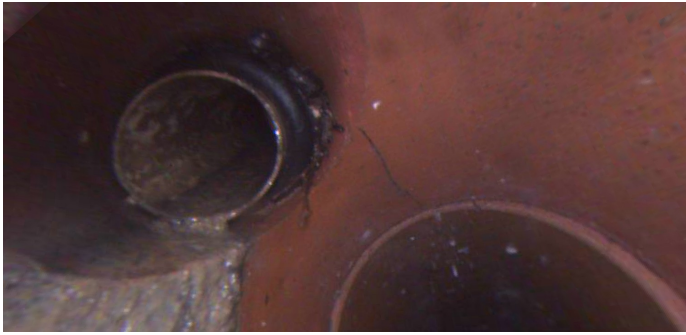
Code: **TFD**  
Description: **Tap Factory Defective**

Distance (ft): **44.0**  
Structural Grade: **0**  
O&M Grade: **2**  
Clock Start/From: **2**  
Clock To:  
1st Value: **4.000**  
2nd Value:  
Value Percent:  
Continuous Index:  
Within 8" of Joint:  
Remarks: **ROOTS**

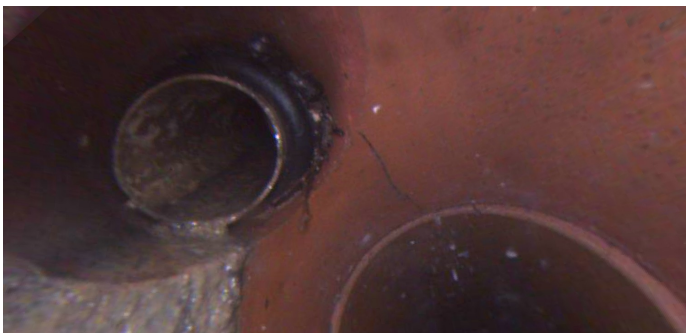
Code: **RFL**  
Description: **Roots Fine Lateral**

Distance (ft): **44.0**  
Structural Grade: **0**  
O&M Grade: **1**  
Clock Start/From: **1**  
Clock To:  
1st Value:  
2nd Value:  
Value Percent:  
Continuous Index:  
Within 8" of Joint: **NO**  
Remarks:

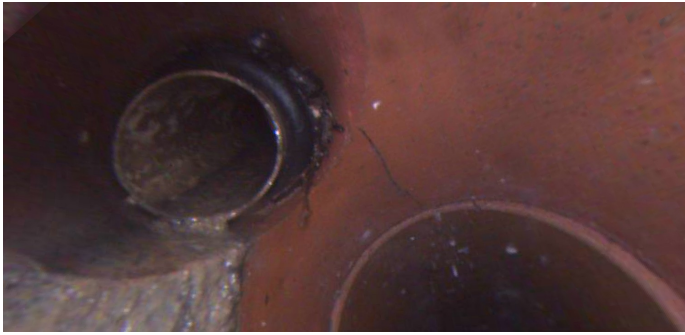
Code: **FL**  
Description: **Fracture Longitudinal**

Distance (ft): **44.0**  
Structural Grade: **3**  
O&M Grade: **0**  
Clock Start/From: **1**  
Clock To:  
1st Value:  
2nd Value:  
Value Percent:  
Continuous Index:  
Within 8" of Joint:  
Remarks:

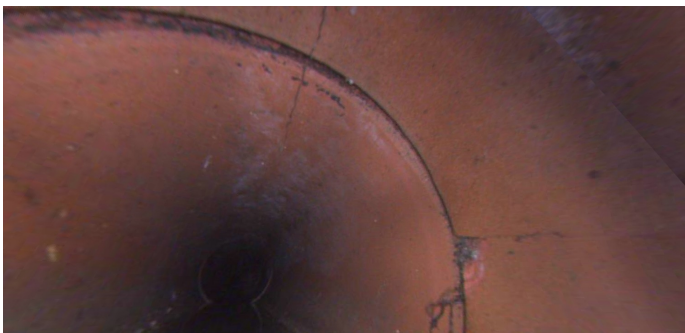
Code: **FM**  
Description: **Fracture Multiple**

Distance (ft): **45.8**  
Structural Grade: **4**  
O&M Grade: **0**  
Clock Start/From: **1**  
Clock To: **3**  
1st Value:  
2nd Value:  
Value Percent:  
Continuous Index:  
Within 8" of Joint: **YES**  
Remarks:

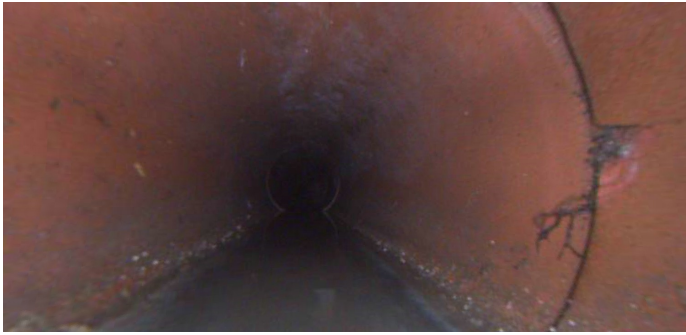
Code: **RFJ**  
Description: **Roots Fine Joint**

Distance (ft): **45.8**  
Structural Grade: **0**  
O&M Grade: **1**  
Clock Start/From: **3**  
Clock To:  
1st Value:  
2nd Value:  
Value Percent:  
Continuous Index:  
Within 8" of Joint: **YES**  
Remarks:

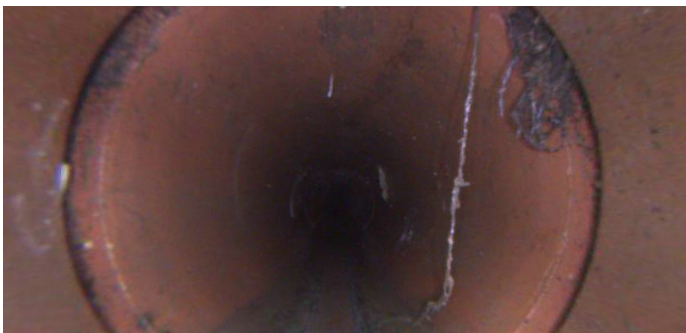
Code: **RFJ**  
Description: **Roots Fine Joint**

Distance (ft): **51.7**  
Structural Grade: **0**  
O&M Grade: **1**  
Clock Start/From: **12**  
Clock To: **3**  
1st Value:  
2nd Value:  
Value Percent:  
Continuous Index:  
Within 8" of Joint: **YES**  
Remarks:

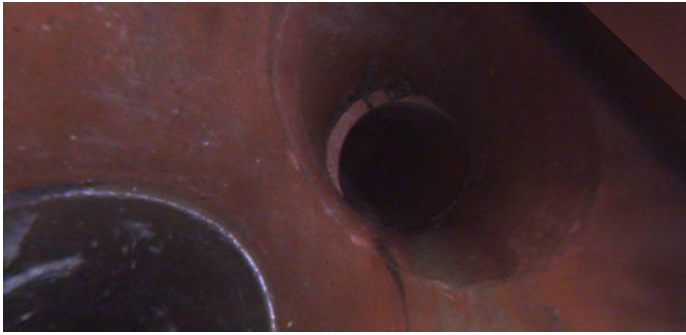
Code: **TFD**  
Description: **Tap Factory Defective**

Distance (ft): **65.0**  
Structural Grade: **0**  
O&M Grade: **2**  
Clock Start/From: **10**  
Clock To:  
1st Value: **4.000**  
2nd Value:  
Value Percent:  
Continuous Index:  
Within 8" of Joint:  
Remarks: **ROOTS**

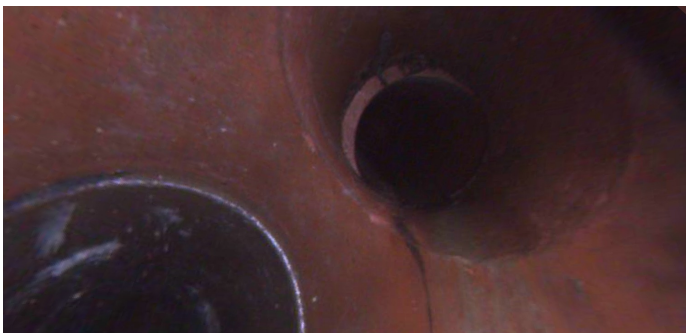
Code: **RFL**  
Description: **Roots Fine Lateral**

Distance (ft): **65.0**  
Structural Grade: **0**  
O&M Grade: **1**  
Clock Start/From: **10**  
Clock To:  
1st Value:  
2nd Value:  
Value Percent:  
Continuous Index:  
Within 8" of Joint: **NO**  
Remarks:

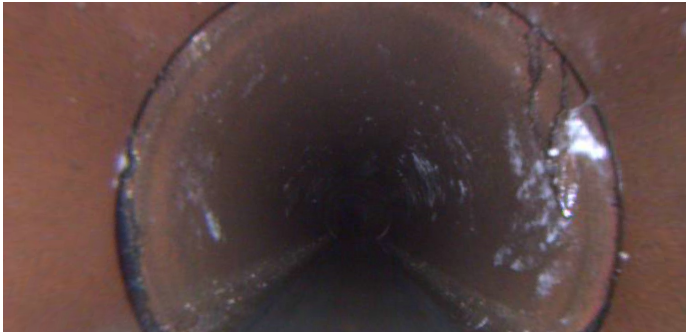
Code: **RFJ**  
Description: **Roots Fine Joint**

Distance (ft): **69.6**  
Structural Grade: **0**  
O&M Grade: **1**  
Clock Start/From: **12**  
Clock To: **3**  
1st Value:  
2nd Value:  
Value Percent:  
Continuous Index:  
Within 8" of Joint: **YES**  
Remarks:

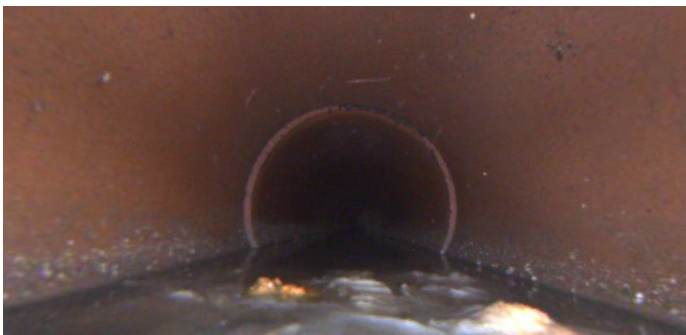
Code: **MSA**  
Description: **Abandoned Survey**

Distance (ft): **96.2**  
Structural Grade: **0**  
O&M Grade: **0**  
Clock Start/From:  
Clock To:  
1st Value:  
2nd Value:  
Value Percent:  
Continuous Index:  
Within 8" of Joint: **NO**  
Remarks: **DEBRIS UNDER WATER**
