Profile/Photo Observation Report

Street:	Rand St. Alley	Flow Control:	Not Controlled
City:	Hobart, IN	Year Renewed:	
Location:	Other	Tape/Media #:	
Purpose:	Not Known	Dia/Height:	10"
Use:	Sanitary	Material:	VCP
Drain Area:	NA	Lining:	
Category:	NA		
Comment:

Location Details:		Direction of Survey:	Upstream
US MH:	M-903-025	DS MH:	M-903-026
		Total Length Surveyed (ft):	96.2

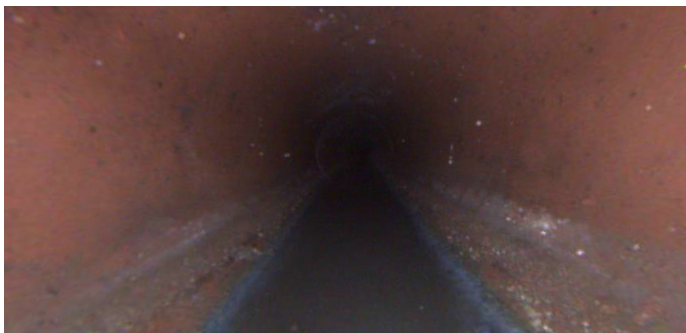
Code: **AMH**
Description: **Manhole**

Distance (ft): **.0**
Structural Grade: **0**
O&M Grade: **0**
Clock Start/From:
Clock To:
1st Value:
2nd Value:
Value Percent:
Continuous Index:
Within 8" of Joint: **NO**
Remarks: **M-903-026**

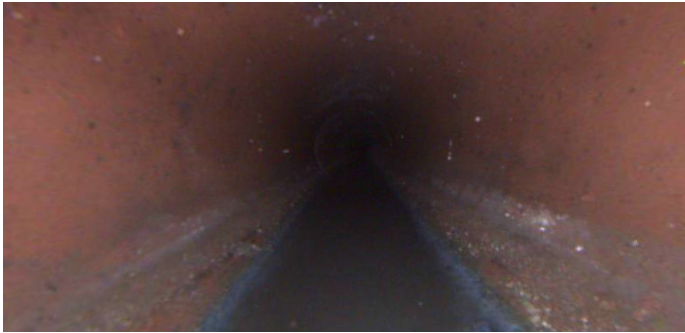
Code:	MWL
Description:	Water Level

Distance (ft):	.0
Structural Grade:	0
O&M Grade:	0
Clock Start/From:	
Clock To:	
1st Value:	
2nd Value:	
Value Percent:	5.000
Continuous Index:	
Within 8" of Joint:	NO
Remarks:

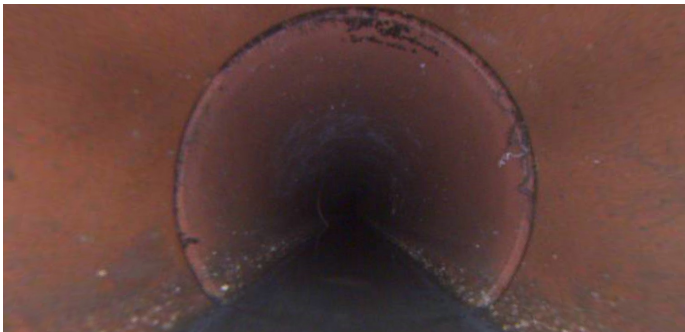
Code:	RFJ
Description:	Roots Fine Joint

Distance (ft):	6.3
Structural Grade:	0
O&M Grade:	1
Clock Start/From:	8
Clock To:	4
1st Value:	
2nd Value:	
Value Percent:	
Continuous Index:	
Within 8" of Joint:	YES
Remarks:

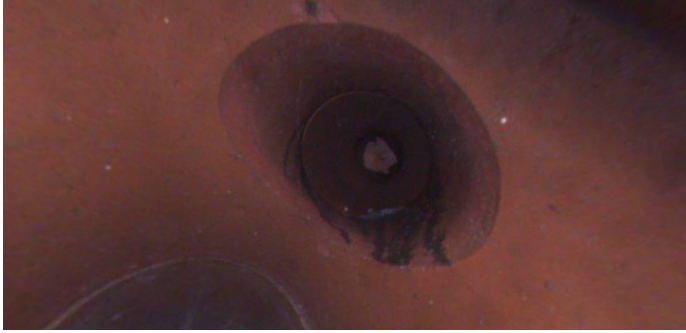
Code: **TF**
Description: **Tap Factory**

Distance (ft): **14.2**
Structural Grade: **0**
O&M Grade: **0**
Clock Start/From: **10**
Clock To:
1st Value: **4.000**
2nd Value:
Value Percent:
Continuous Index:
Within 8" of Joint:
Remarks:

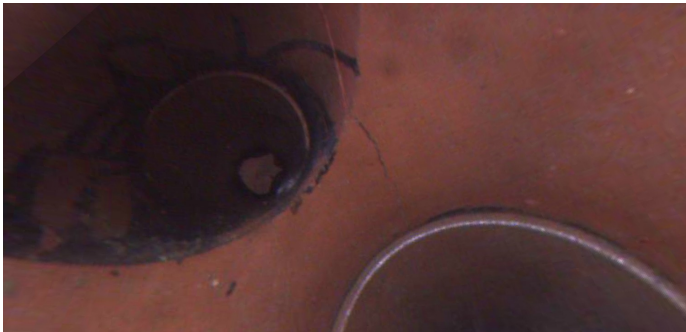
Code: **TFD**
Description: **Tap Factory Defective**

Distance (ft): **17.0**
Structural Grade: **0**
O&M Grade: **2**
Clock Start/From: **2**
Clock To:
1st Value: **4.000**
2nd Value:
Value Percent:
Continuous Index:
Within 8" of Joint:
Remarks: **fl**

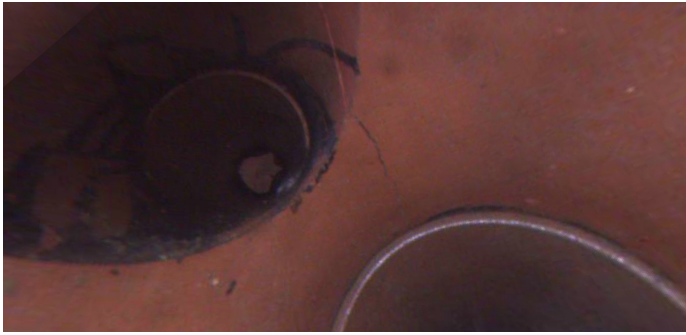
Code: **FL**
Description: **Fracture Longitudinal**

Distance (ft): **17.0**
Structural Grade: **3**
O&M Grade: **0**
Clock Start/From: **1**
Clock To:
1st Value:
2nd Value:
Value Percent:
Continuous Index:
Within 8" of Joint:
Remarks:

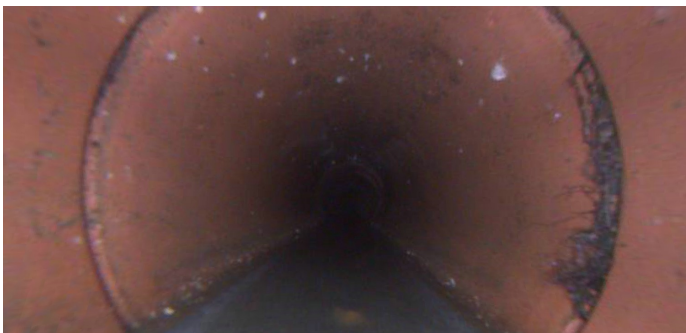
Code: **RFJ**
Description: **Roots Fine Joint**

Distance (ft): **39.6**
Structural Grade: **0**
O&M Grade: **1**
Clock Start/From: **2**
Clock To: **4**
1st Value:
2nd Value:
Value Percent:
Continuous Index:
Within 8" of Joint: **YES**
Remarks:

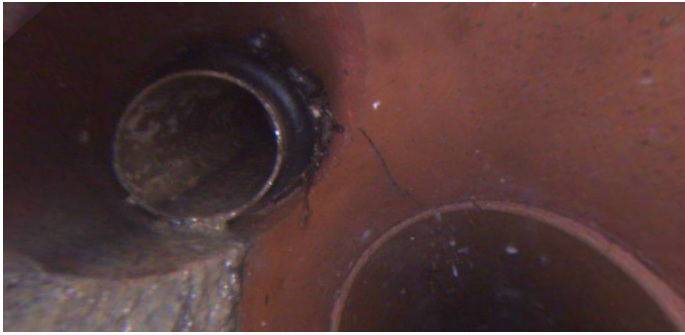
Code: **TFD**
Description: **Tap Factory Defective**

Distance (ft): **44.0**
Structural Grade: **0**
O&M Grade: **2**
Clock Start/From: **2**
Clock To:
1st Value: **4.000**
2nd Value:
Value Percent:
Continuous Index:
Within 8" of Joint:
Remarks: **ROOTS**

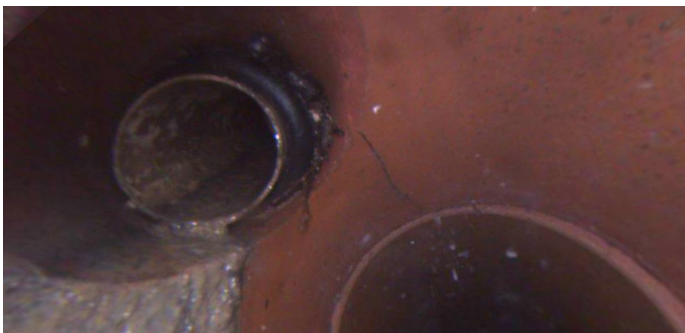
Code: **RFL**
Description: **Roots Fine Lateral**

Distance (ft): **44.0**
Structural Grade: **0**
O&M Grade: **1**
Clock Start/From: **1**
Clock To:
1st Value:
2nd Value:
Value Percent:
Continuous Index:
Within 8" of Joint: **NO**
Remarks:

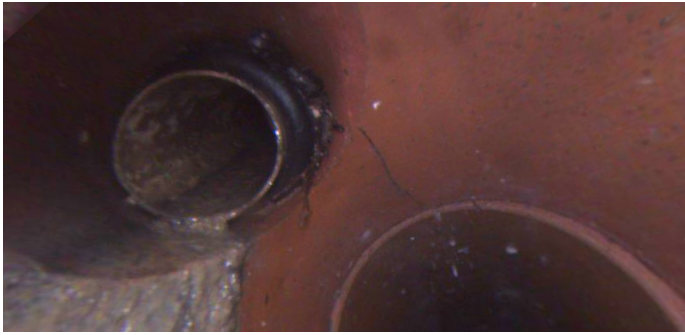
Code: **FL**
Description: **Fracture Longitudinal**

Distance (ft): **44.0**
Structural Grade: **3**
O&M Grade: **0**
Clock Start/From: **1**
Clock To:
1st Value:
2nd Value:
Value Percent:
Continuous Index:
Within 8" of Joint:
Remarks:

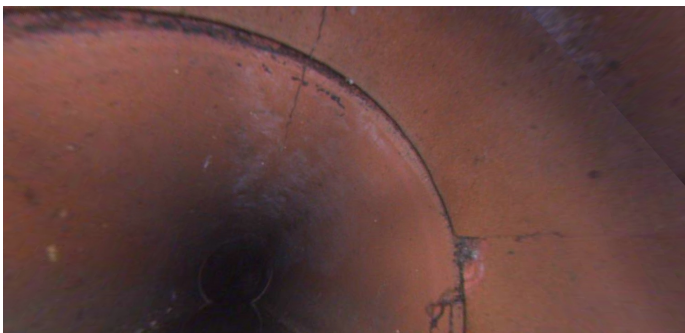
Code: **FM**
Description: **Fracture Multiple**

Distance (ft): **45.8**
Structural Grade: **4**
O&M Grade: **0**
Clock Start/From: **1**
Clock To: **3**
1st Value:
2nd Value:
Value Percent:
Continuous Index:
Within 8" of Joint: **YES**
Remarks:

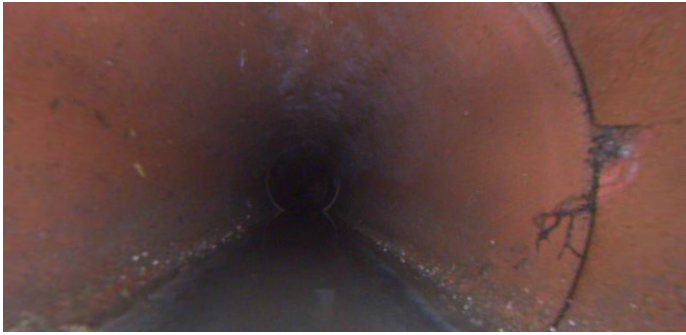
Code: **RFJ**
Description: **Roots Fine Joint**

Distance (ft): **45.8**
Structural Grade: **0**
O&M Grade: **1**
Clock Start/From: **3**
Clock To:
1st Value:
2nd Value:
Value Percent:
Continuous Index:
Within 8" of Joint: **YES**
Remarks:

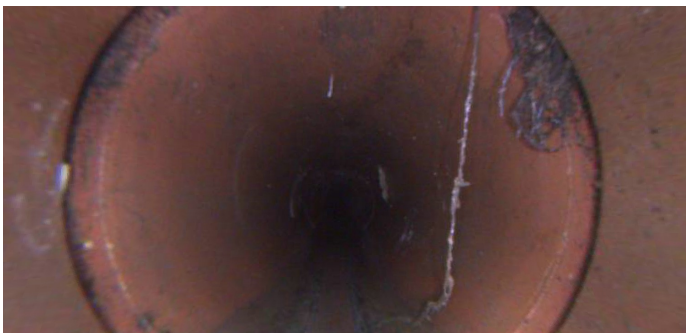
Code: **RFJ**
Description: **Roots Fine Joint**

Distance (ft): **51.7**
Structural Grade: **0**
O&M Grade: **1**
Clock Start/From: **12**
Clock To: **3**
1st Value:
2nd Value:
Value Percent:
Continuous Index:
Within 8" of Joint: **YES**
Remarks:

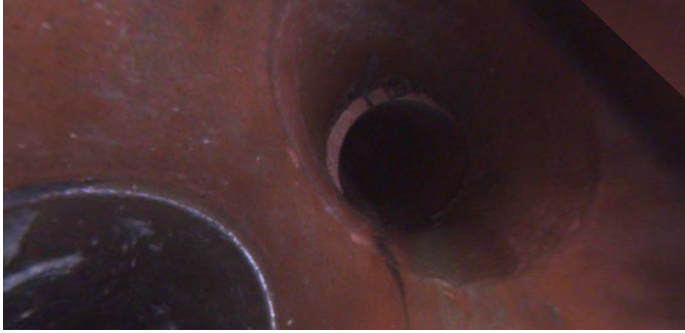
Code: **TFD**
Description: **Tap Factory Defective**

Distance (ft): **65.0**
Structural Grade: **0**
O&M Grade: **2**
Clock Start/From: **10**
Clock To:
1st Value: **4.000**
2nd Value:
Value Percent:
Continuous Index:
Within 8" of Joint:
Remarks: **ROOTS**

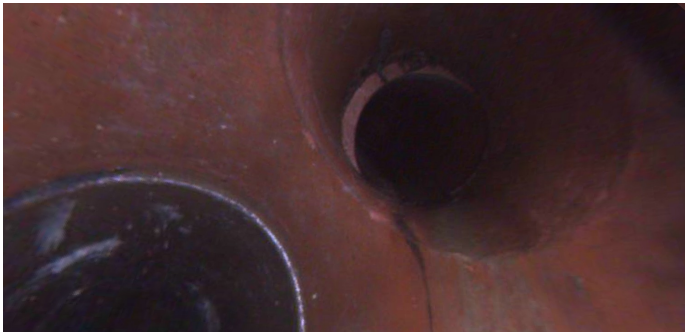
Code: **RFL**
Description: **Roots Fine Lateral**

Distance (ft): **65.0**
Structural Grade: **0**
O&M Grade: **1**
Clock Start/From: **10**
Clock To:
1st Value:
2nd Value:
Value Percent:
Continuous Index:
Within 8" of Joint: **NO**
Remarks:

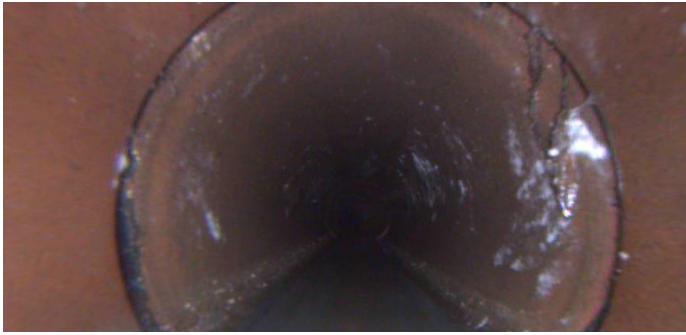
Code: **RFJ**
Description: **Roots Fine Joint**

Distance (ft): **69.6**
Structural Grade: **0**
O&M Grade: **1**
Clock Start/From: **12**
Clock To: **3**
1st Value:
2nd Value:
Value Percent:
Continuous Index:
Within 8" of Joint: **YES**
Remarks:

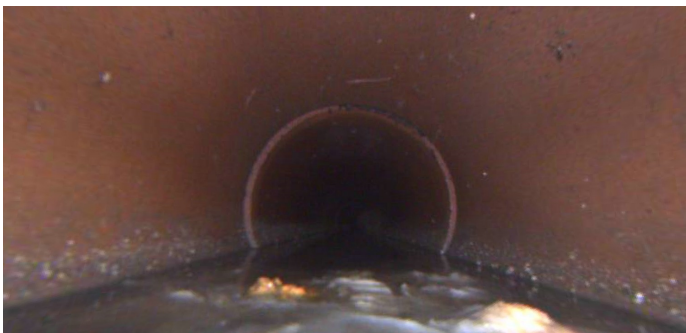
Code: **MSA**
Description: **Abandoned Survey**

Distance (ft): **96.2**
Structural Grade: **0**
O&M Grade: **0**
Clock Start/From:
Clock To:
1st Value:
2nd Value:
Value Percent:
Continuous Index:
Within 8" of Joint: **NO**
Remarks: **DEBRIS UNDER WATER**
