Profile/Photo Observation Report

| Street: | E RAND ST | Flow Control: | Not Controlled |
| City: | Hobart, IN | Year Renewed: | |

| US MH: | M-903-025 | DS MH: | M-903-026 |

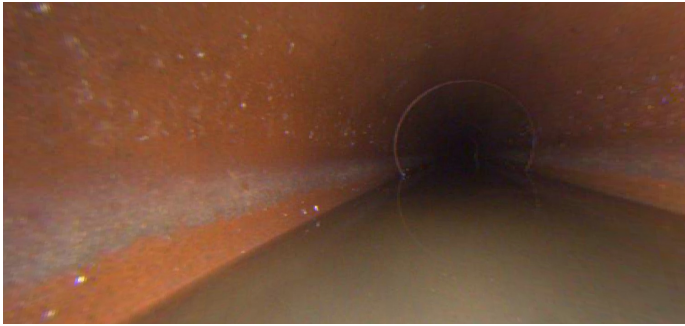
Code: **AMH**
Description: **Manhole**

Distance (ft): **.0**
Structural Grade: **0**
O&M Grade: **0**
Clock Start/From:
Clock To:
1st Value:
2nd Value:
Value Percent:
Continuous Index:
Within 8" of Joint: **NO**
Remarks: **M-903-025**

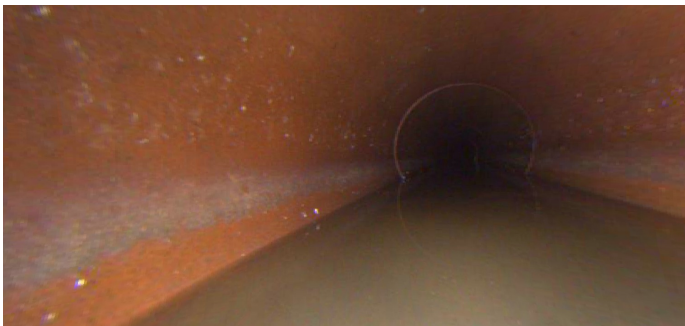
Code: **MWL**
Description: **Water Level**

Distance (ft): **.0**
Structural Grade: **0**
O&M Grade: **0**
Clock Start/From:
Clock To:
1st Value:
2nd Value:
Value Percent: **15.000**
Continuous Index:
Within 8" of Joint: **NO**
Remarks:

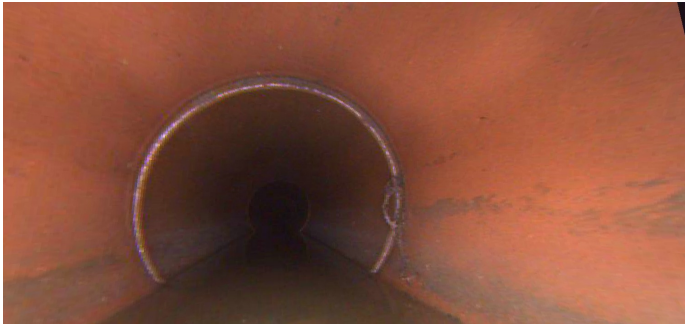
| | Position | Code | Observation | Video (sec) | Grade |
|---|---|---|---|---|---|
| | 16.7 | RFJ | Roots Fine Joint | 66 | M 1 |

Code: **RFJ**
Description: **Roots Fine Joint**

Distance (ft): **16.7**
Structural Grade: **0**
O&M Grade: **1**
Clock Start/From: **3**
Clock To:
1st Value:
2nd Value:
Value Percent:
Continuous Index:
Within 8" of Joint: **YES**
Remarks:

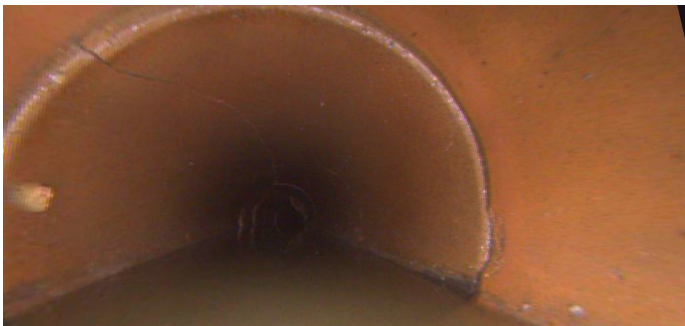
| | Position | Code | Observation | Video (sec) | Grade |
|---|---|---|---|---|---|
| | 58.7 | FM | Fracture Multiple | 162 | S 4 |

Code: **FM**
Description: **Fracture Multiple**

Distance (ft): **58.7**
Structural Grade: **4**
O&M Grade: **0**
Clock Start/From: **10**
Clock To: **5**
1st Value:
2nd Value:
Value Percent:
Continuous Index:
Within 8" of Joint: **YES**
Remarks:

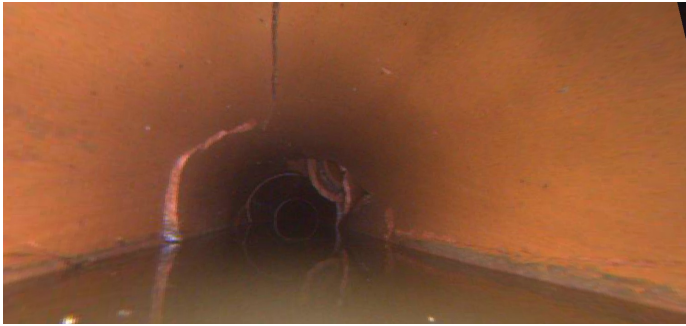
| | Position | Code | Observation | Video (sec) | Grade |
|---|---|---|---|---|---|
| | 62.2 | FM | Fracture Multiple | 182 | S 4 |

Code: **FM**
Description: **Fracture Multiple**

Distance (ft): **62.2**
Structural Grade: **4**
O&M Grade: **0**
Clock Start/From: **7**
Clock To: **5**
1st Value:
2nd Value:
Value Percent:
Continuous Index:
Within 8" of Joint: **YES**
Remarks:

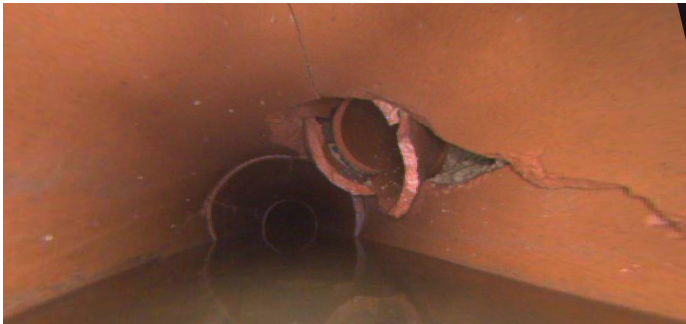
| | Position | Code | Observation | Video (sec) | Grade |
|---|---|---|---|---|---|
| | 63.4 | TFD | Tap Factory Defective | 196 | M 2 |

Code: **TFD**
Description: **Tap Factory Defective**

Distance (ft): **63.4**
Structural Grade: **0**
O&M Grade: **2**
Clock Start/From: **3**
Clock To:
1st Value: **4.000**
2nd Value:
Value Percent:
Continuous Index:
Within 8" of Joint:
Remarks: **MOUTH OF TAP BROKEN**

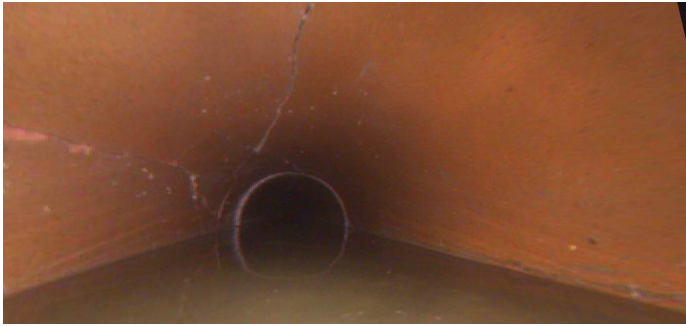
| | Position | Code | Observation | Video (sec) | Grade |
|---|---|---|---|---|---|
| | 65.9 | FM | Fracture Multiple | 213 | S 4 |

Code: **FM**
Description: **Fracture Multiple**

Distance (ft): **65.9**
Structural Grade: **4**
O&M Grade: **0**
Clock Start/From: **7**
Clock To: **12**
1st Value:
2nd Value:
Value Percent:
Continuous Index:
Within 8" of Joint:
Remarks:

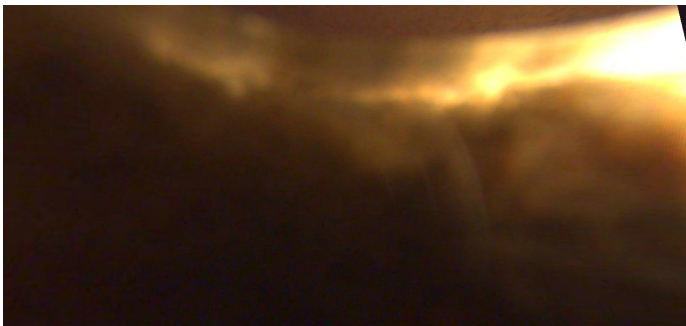
| | Position | Code | Observation | Video (sec) | Grade |
|---|---|---|---|---|---|
| | 68.9 | MCU | Camera Underwater | 231 | M 4 |

Code: **MCU**
Description: **Camera Underwater**

Distance (ft): **68.9**
Structural Grade: **0**
O&M Grade: **4**
Clock Start/From:
Clock To:
1st Value:
2nd Value:
Value Percent:
Continuous Index:
Within 8" of Joint: **NO**
Remarks:

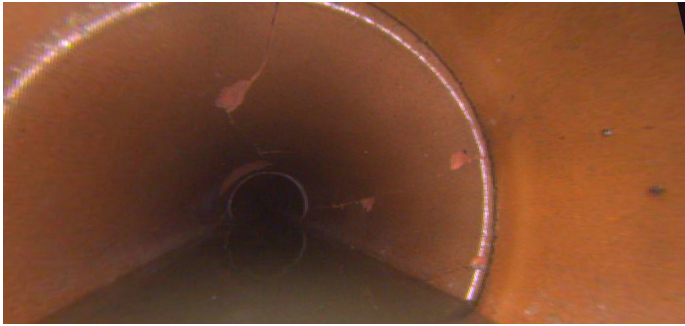
| | Position | Code | Observation | Video (sec) | Grade |
|---|---|---|---|---|---|
| | 76.8 | FM | Fracture Multiple | 259 | S 4 |

Code: **FM**
Description: **Fracture Multiple**

Distance (ft): **76.8**
Structural Grade: **4**
O&M Grade: **0**
Clock Start/From: **12**
Clock To: **3**
1st Value:
2nd Value:
Value Percent:
Continuous Index:
Within 8" of Joint: **YES**
Remarks:

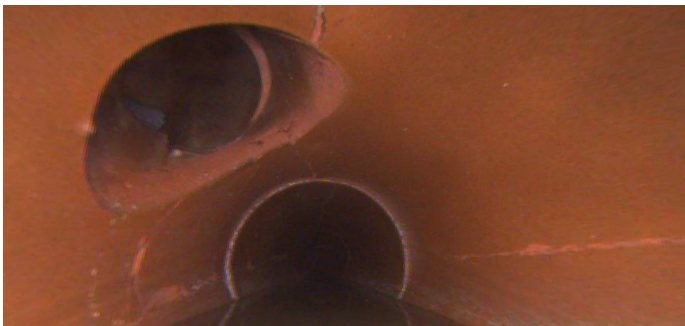
Code: **TF**
Description: **Tap Factory**

Distance (ft): **78.8**
Structural Grade: **0**
O&M Grade: **0**
Clock Start/From: **10**
Clock To:
1st Value: **4.000**
2nd Value:
Value Percent:
Continuous Index:
Within 8" of Joint:
Remarks:

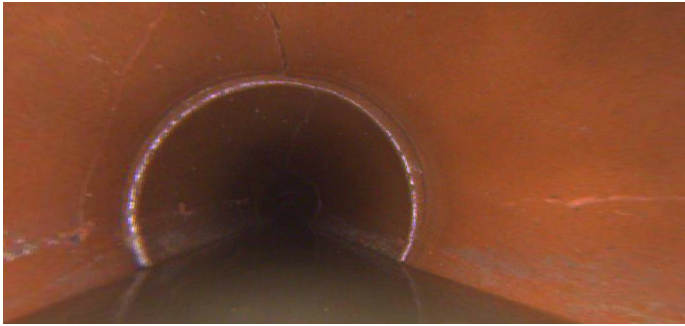
| | Position | Code | Observation | Video (sec) | Grade |
|---|---|---|---|---|---|
| | 79.5 | FM | Fracture Multiple | 289 | S 4 |

Code: **FM**
Description: **Fracture Multiple**

Distance (ft): **79.5**
Structural Grade: **4**
O&M Grade: **0**
Clock Start/From: **7**
Clock To: **5**
1st Value:
2nd Value:
Value Percent:
Continuous Index:
Within 8" of Joint: **YES**
Remarks:

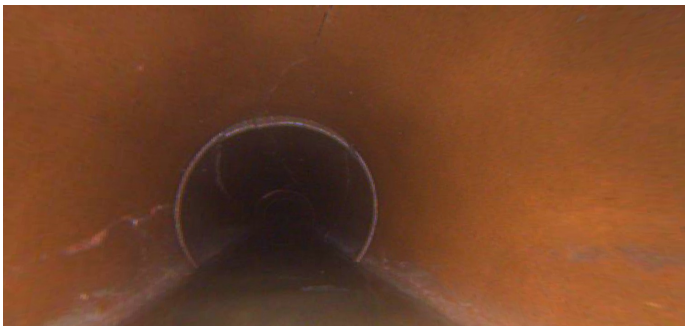
| | Position | Code | Observation | Video (sec) | Grade |
|---|---|---|---|---|---|
| | 85.0 | FM | Fracture Multiple | 312 | S 4 |

Code: **FM**
Description: **Fracture Multiple**

Distance (ft): **85.0**
Structural Grade: **4**
O&M Grade: **0**
Clock Start/From: **7**
Clock To: **5**
1st Value:
2nd Value:
Value Percent:
Continuous Index:
Within 8" of Joint: **YES**
Remarks:

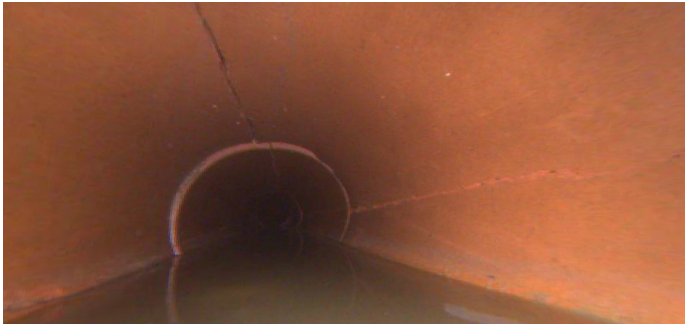
| | Position | Code | Observation | Video (sec) | Grade |
|---|---|---|---|---|---|
| | 90.7 | FM | Fracture Multiple | 335 | S 4 |

Code: **FM**
Description: **Fracture Multiple**

Distance (ft): **90.7**
Structural Grade: **4**
O&M Grade: **0**
Clock Start/From: **7**
Clock To: **5**
1st Value:
2nd Value:
Value Percent:
Continuous Index:
Within 8" of Joint: **YES**
Remarks:

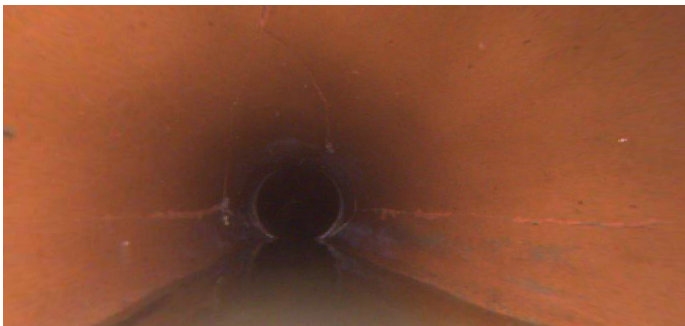
| | Position | Code | Observation | Video (sec) | Grade |
|---|---|---|---|---|---|
| | 95.4 | FM | Fracture Multiple | 357 | S 4 |

Code: **FM**
Description: **Fracture Multiple**

Distance (ft): **95.4**
Structural Grade: **4**
O&M Grade: **0**
Clock Start/From: **7**
Clock To: **5**
1st Value:
2nd Value:
Value Percent:
Continuous Index:
Within 8" of Joint:
Remarks:

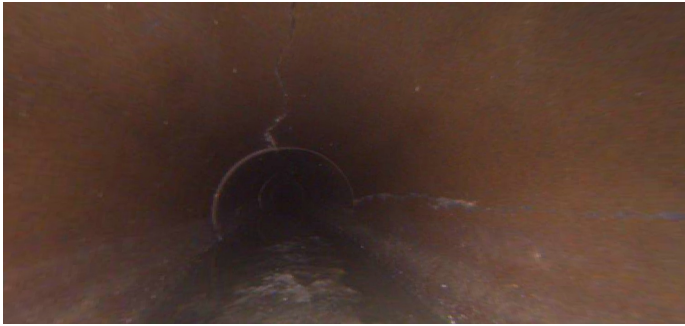
| | Position | Code | Observation | Video (sec) | Grade |
|---|---|---|---|---|---|
| | 99.5 | FM | Fracture Multiple | 377 | S 4 |

Code: **FM**
Description: **Fracture Multiple**

Distance (ft): **99.5**
Structural Grade: **4**
O&M Grade: **0**
Clock Start/From: **7**
Clock To: **5**
1st Value:
2nd Value:
Value Percent:
Continuous Index:
Within 8" of Joint: **YES**
Remarks:

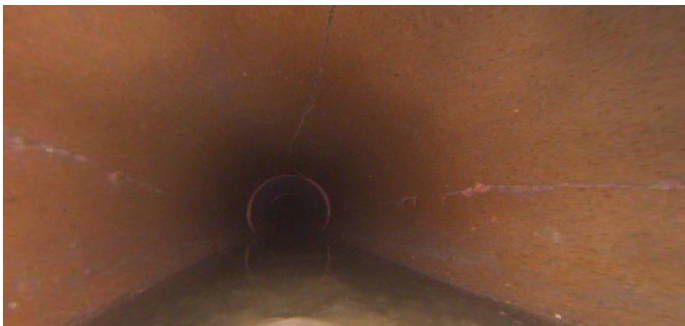
| | Position | Code | Observation | Video (sec) | Grade |
|---|---|---|---|---|---|
| | 104.2 | CH3 | Crack Longitudinal Hinge, 3 | 398 | S 5 |

Code: **CH3**
Description: **Crack Longitudinal Hinge, 3**

Distance (ft): **104.2**
Structural Grade: **5**
O&M Grade: **0**
Clock Start/From: **9**
Clock To: **3**
1st Value:
2nd Value:
Value Percent:
Continuous Index:
Within 8" of Joint: **YES**
Remarks:

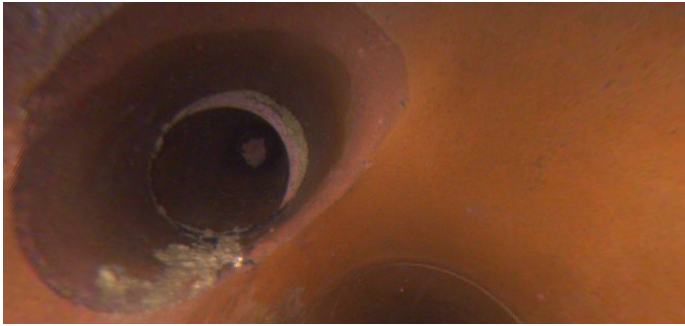
Code: **TF**
Description: **Tap Factory**

Distance (ft): **112.4**
Structural Grade: **0**
O&M Grade: **0**
Clock Start/From: **10**
Clock To:
1st Value: **4.000**
2nd Value:
Value Percent:
Continuous Index:
Within 8" of Joint:
Remarks:

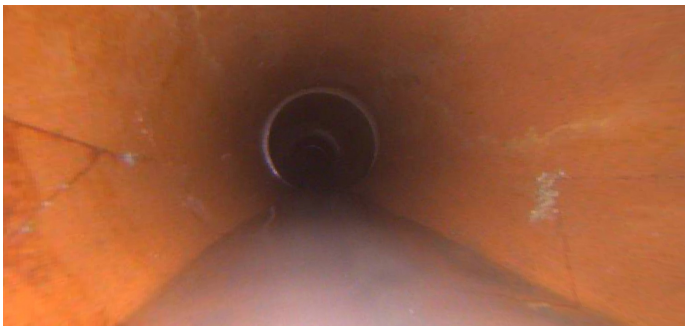
| | Position | Code | Observation | Video (sec) | Grade |
|---|---|---|---|---|---|
| | 114.3 | FM | Fracture Multiple | 443 | S 4 |

Code: **FM**
Description: **Fracture Multiple**

Distance (ft): **114.3**
Structural Grade: **4**
O&M Grade: **0**
Clock Start/From: **7**
Clock To: **5**
1st Value:
2nd Value:
Value Percent:
Continuous Index:
Within 8" of Joint: **YES**
Remarks:

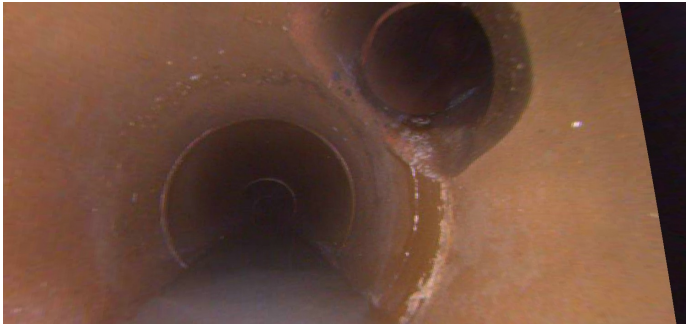
Code: **TF**
Description: **Tap Factory**

Distance (ft): **118.0**
Structural Grade: **0**
O&M Grade: **0**
Clock Start/From: **2**
Clock To:
1st Value: **4.000**
2nd Value:
Value Percent:
Continuous Index:
Within 8" of Joint:
Remarks:

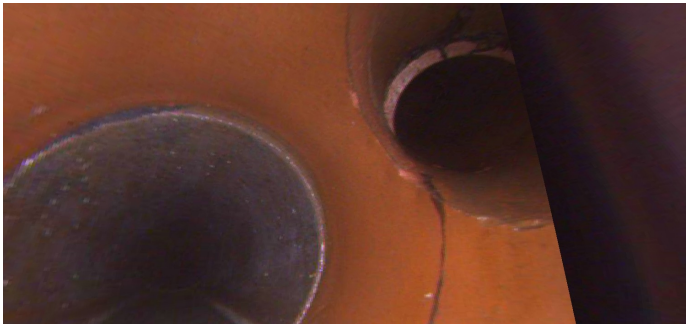
Code: **TF**
Description: **Tap Factory**

Distance (ft): **157.6**
Structural Grade: **0**
O&M Grade: **0**
Clock Start/From: **2**
Clock To:
1st Value: **4.000**
2nd Value:
Value Percent:
Continuous Index:
Within 8" of Joint:
Remarks:

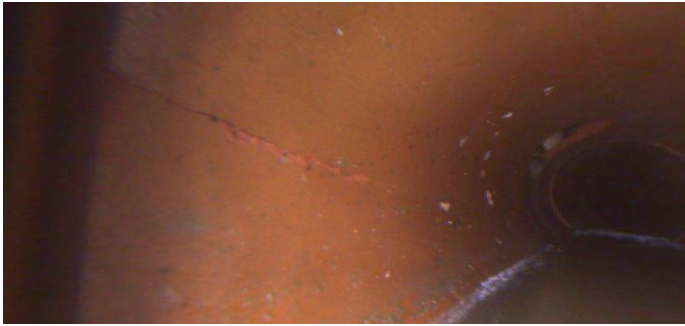
| | Position | Code | Observation | Video (sec) | Grade |
|---|---|---|---|---|---|
| | 176.7 | CL | Crack Longitudinal | 605 | S 2 |

Code: **CL**
Description: **Crack Longitudinal**

Distance (ft): **176.7**
Structural Grade: **2**
O&M Grade: **0**
Clock Start/From: **9**
Clock To:
1st Value:
2nd Value:
Value Percent:
Continuous Index:
Within 8" of Joint:
Remarks:

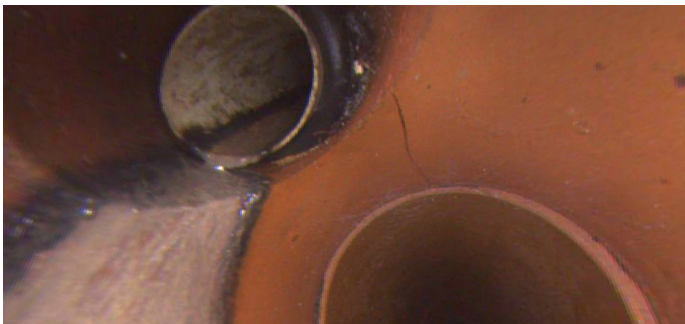
Code: **TF**
Description: **Tap Factory**

Distance (ft): **178.7**
Structural Grade: **0**
O&M Grade: **0**
Clock Start/From: **11**
Clock To:
1st Value: **4.000**
2nd Value:
Value Percent:
Continuous Index:
Within 8" of Joint:
Remarks:

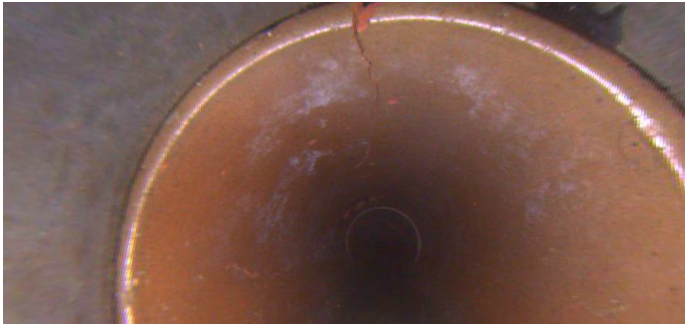
| | Position | Code | Observation | Video (sec) | Grade |
|---|---|---|---|---|---|
| | 203.2 | FL | Fracture Longitudinal | 681 | S 3 |

Code: **FL**
Description: **Fracture Longitudinal**

Distance (ft): **203.2**
Structural Grade: **3**
O&M Grade: **0**
Clock Start/From: **12**
Clock To:
1st Value:
2nd Value:
Value Percent:
Continuous Index:
Within 8" of Joint:
Remarks:

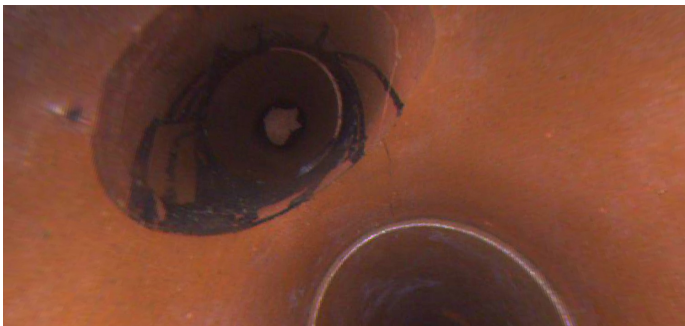
Code: **TF**
Description: **Tap Factory**

Distance (ft): **205.6**
Structural Grade: **0**
O&M Grade: **0**
Clock Start/From: **10**
Clock To:
1st Value: **4.000**
2nd Value:
Value Percent:
Continuous Index:
Within 8" of Joint:
Remarks:

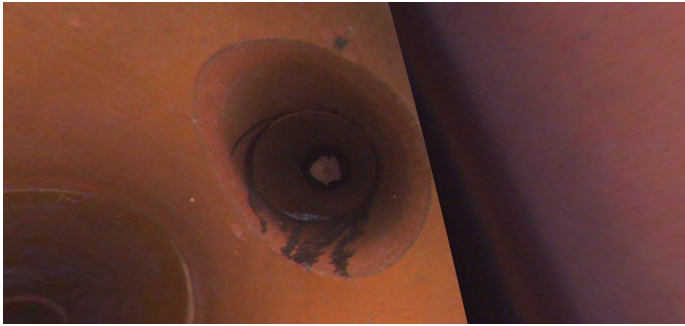
Code: **TF**
Description: **Tap Factory**

Distance (ft): **208.5**
Structural Grade: **0**
O&M Grade: **0**
Clock Start/From: **2**
Clock To:
1st Value: **4.000**
2nd Value:
Value Percent:
Continuous Index:
Within 8" of Joint:
Remarks:

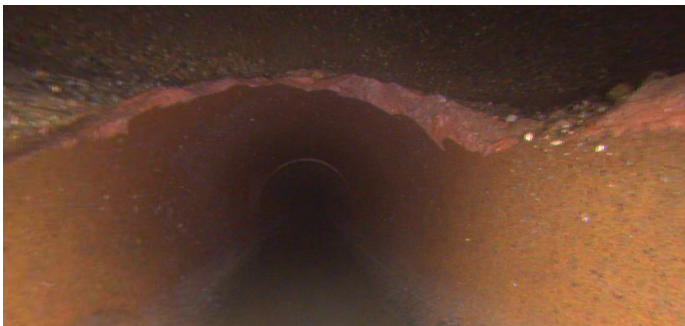
Code: **AMH**
Description: **Manhole**

Distance (ft): **225.3**
Structural Grade: **0**
O&M Grade: **0**
Clock Start/From:
Clock To:
1st Value:
2nd Value:
Value Percent:
Continuous Index:
Within 8" of Joint: **NO**
Remarks: **M-903-026**
