Profile/Photo Observation Report

Street:	Rand St.	Flow Control:	Not Controlled
City:	Hobart, IN	Year Renewed:	
Location:	Other	Tape/Media #:	
Purpose:	Not Known	Dia/Height:	12"
Use:	Sanitary	Material:	VCP
Drain Area:	NA	Lining:	
Category:	NA		
Comment:

Location Details:		Direction of Survey:	Downstream
US MH:	M-903-025	DS MH:	M-903-028
		Total Length Surveyed (ft):	13.1

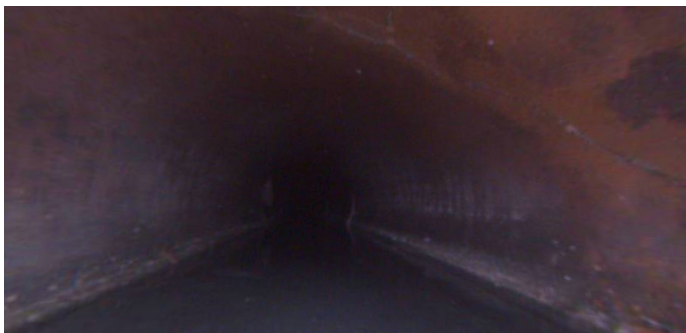
Code: **AMH**
Description: **Manhole**

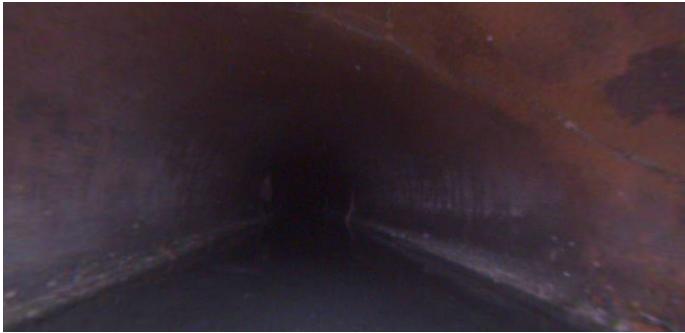
Code:	MWL
Description:	Water Level

Distance (ft):	.0
Structural Grade:	0
O&M Grade:	0
Clock Start/From:	
Clock To:	
1st Value:	
2nd Value:	
Value Percent:	30.000
Continuous Index:	
Within 8" of Joint:	NO
Remarks:

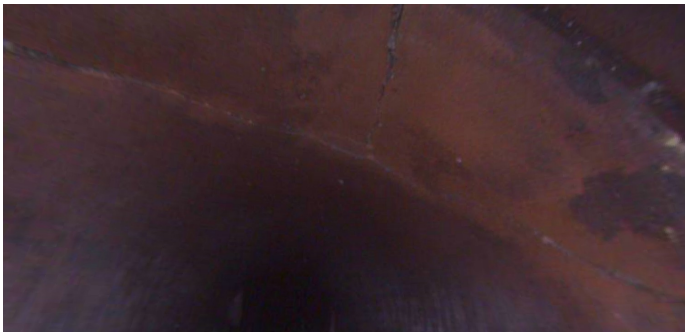
Code:	FM
Description:	Fracture Multiple

Distance (ft):	.0
Structural Grade:	4
O&M Grade:	0
Clock Start/From:	11
Clock To:	3
1st Value:	
2nd Value:	
Value Percent:	
Continuous Index:	
Within 8" of Joint:	YES
Remarks:

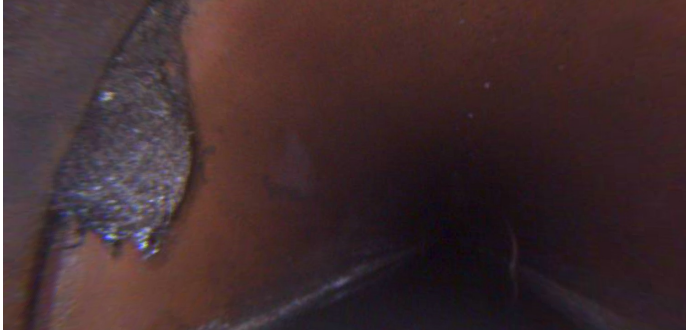
Code: **RMJ**
Description: **Roots Medium Joint**

Distance (ft): **4.1**
Structural Grade: **0**
O&M Grade: **3**
Clock Start/From: **9**
Clock To: **10**
1st Value:
2nd Value:
Value Percent: **5.000**
Continuous Index:
Within 8" of Joint: **YES**
Remarks:

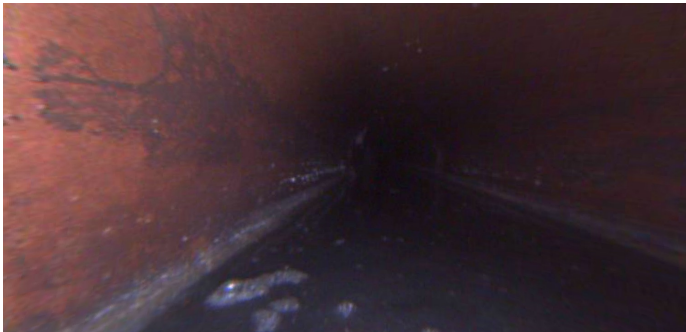
Code: **MSA**
Description: **Abandoned Survey**

Distance (ft): **13.1**
Structural Grade: **0**
O&M Grade: **0**
Clock Start/From:
Clock To:
1st Value:
2nd Value:
Value Percent:
Continuous Index:
Within 8" of Joint: **NO**
Remarks: **DEBRIS UNDER WATER**
