Profile/Photo Observation Report

| Street: | E RAND ST | Flow Control: | Not Controlled |
| City: | Hobart, IN | Year Renewed: | |

| US MH: | M-903-025 | DS MH: | M-903-028 |

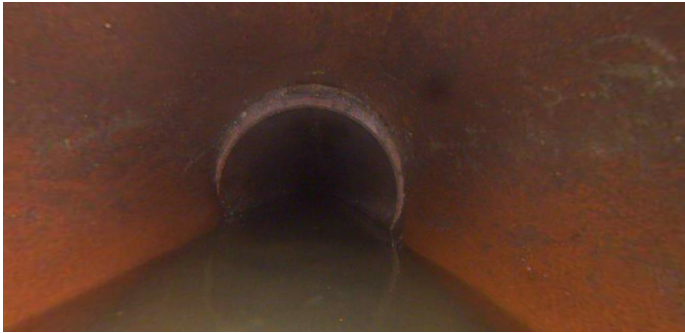
| Code: | MWL |
| Description: | Water Level |

| Value Percent: | 30.000 |

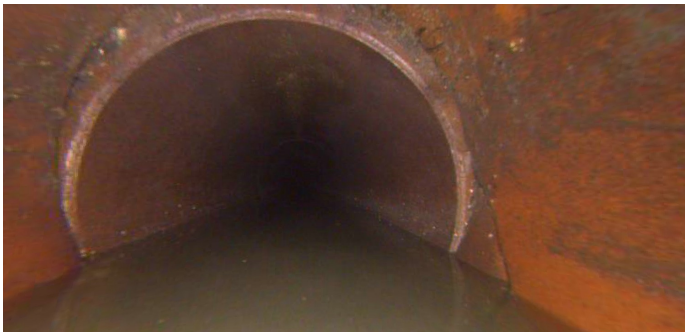
| Code: | FS |
| Description: | Fracture Spiral |

| Structural Grade: | 3 |
| Clock Start/From: | 3 |
| Clock To: | 4 |
| Within 8" of Joint: | YES |

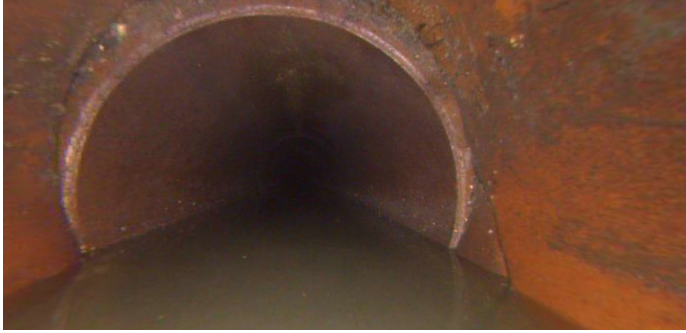
Code: **JOM**
Description: **Joint Offset Medium**

Distance (ft): **.5**
Structural Grade: **1**
O&M Grade: **0**
Clock Start/From:
Clock To:
1st Value:
2nd Value:
Value Percent:
Continuous Index:
Within 8" of Joint: **NO**
Remarks:

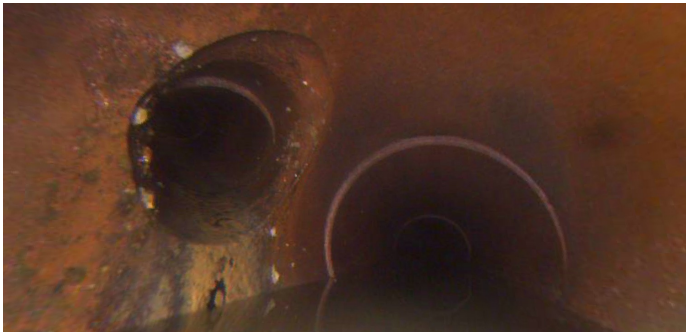
Code: **TF**
Description: **Tap Factory**

Distance (ft): **30.5**
Structural Grade: **0**
O&M Grade: **0**
Clock Start/From: **10**
Clock To:
1st Value: **4.000**
2nd Value:
Value Percent:
Continuous Index:
Within 8" of Joint:
Remarks:

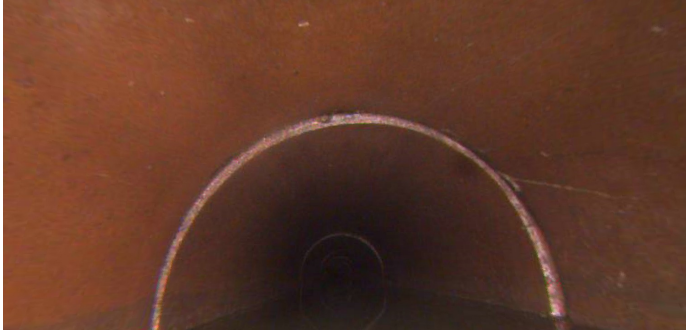
Code: **CL**
Description: **Crack Longitudinal**

Distance (ft): **61.1**
Structural Grade: **2**
O&M Grade: **0**
Clock Start/From: **2**
Clock To:
1st Value:
2nd Value:
Value Percent:
Continuous Index:
Within 8" of Joint: **YES**
Remarks:

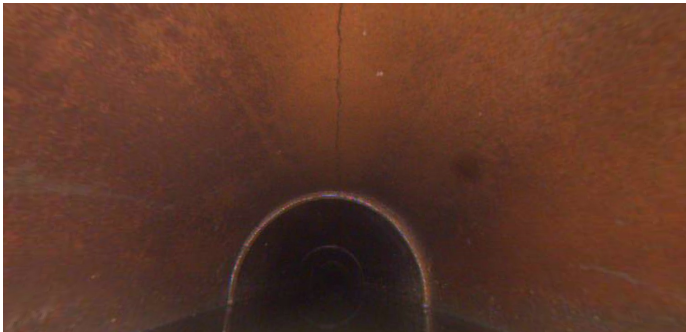
Code: **FL**
Description: **Fracture Longitudinal**

Distance (ft): **72.3**
Structural Grade: **3**
O&M Grade: **0**
Clock Start/From: **12**
Clock To:
1st Value:
2nd Value:
Value Percent:
Continuous Index:
Within 8" of Joint: **YES**
Remarks:

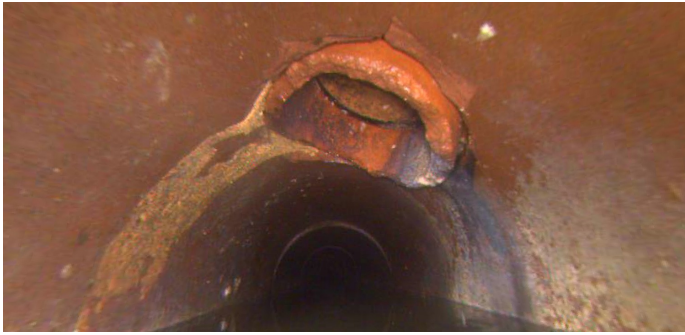
Code: **TBI**
Description: **Tap Break-in Intruding**

Distance (ft): **83.4**
Structural Grade: **0**
O&M Grade: **2**
Clock Start/From: **1**
Clock To:
1st Value: **4.000**
2nd Value: **1.000**
Value Percent:
Continuous Index:
Within 8" of Joint:
Remarks:

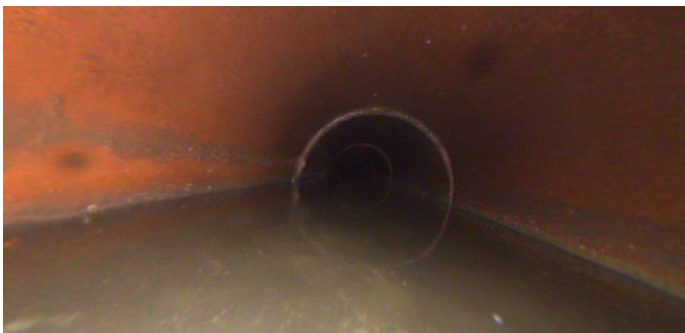
Code: **MSA**
Description: **Abandoned Survey**

Distance (ft): **96.1**
Structural Grade: **0**
O&M Grade: **0**
Clock Start/From:
Clock To:
1st Value:
2nd Value:
Value Percent:
Continuous Index:
Within 8" of Joint: **NO**
Remarks: **DEBRIS UNDER WATER**
