Profile/Photo Observation Report

Street:	Rand St.	Flow Control:	Not Controlled
City:	Hobart, IN	Year Renewed:	
Location:	Other	Tape/Media #:	
Purpose:	Not Known	Dia/Height:	12"
Use:	Sanitary	Material:	VCP
Drain Area:	NA	Lining:	
Category:	NA		
Comment:

Location Details:		Direction of Survey:	Upstream
US MH:	M-903-025	DS MH:	M-903-028
		Total Length Surveyed (ft):	96.1

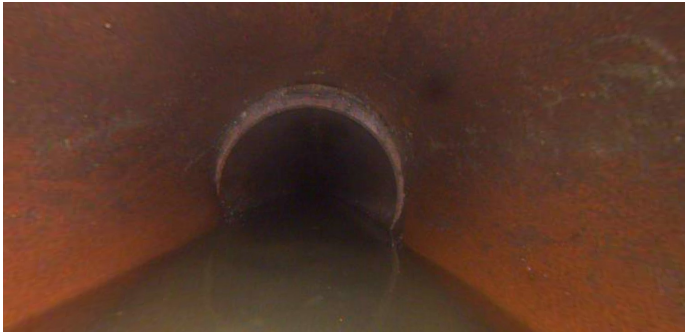
Code:	MWL
Description:	Water Level

Distance (ft):	.0
Structural Grade:	0
O&M Grade:	0
Clock Start/From:	
Clock To:	
1st Value:	
2nd Value:	
Value Percent:	30.000
Continuous Index:	
Within 8" of Joint:	NO
Remarks:

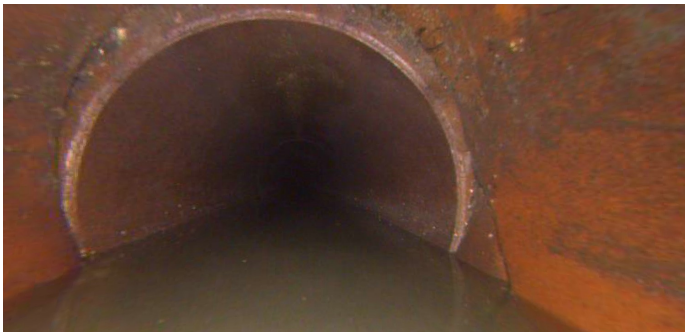
Code:	FS
Description:	Fracture Spiral

Distance (ft):	.5
Structural Grade:	3
O&M Grade:	0
Clock Start/From:	3
Clock To:	4
1st Value:	
2nd Value:	
Value Percent:	
Continuous Index:	
Within 8" of Joint:	YES
Remarks:

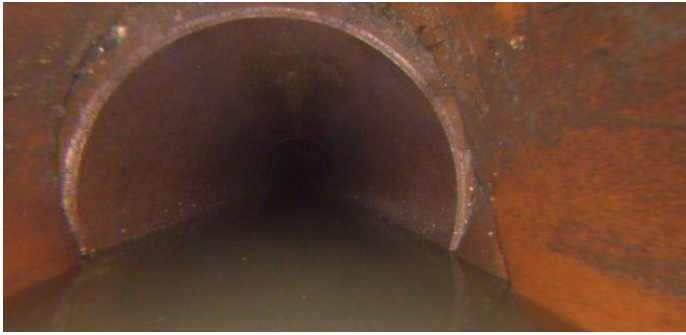
Code: **JOM**
Description: **Joint Offset Medium**

Distance (ft): **.5**
Structural Grade: **1**
O&M Grade: **0**
Clock Start/From:
Clock To:
1st Value:
2nd Value:
Value Percent:
Continuous Index:
Within 8" of Joint: **NO**
Remarks:

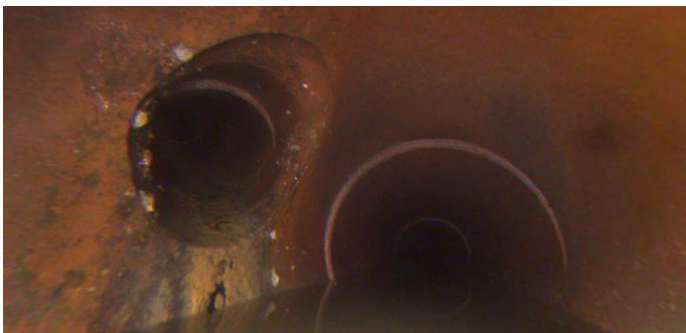
Code: **TF**
Description: **Tap Factory**

Distance (ft): **30.5**
Structural Grade: **0**
O&M Grade: **0**
Clock Start/From: **10**
Clock To:
1st Value: **4.000**
2nd Value:
Value Percent:
Continuous Index:
Within 8" of Joint:
Remarks:

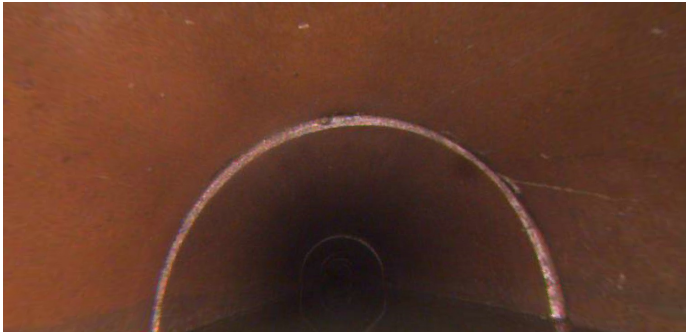
Code: **CL**
Description: **Crack Longitudinal**

Distance (ft): **61.1**
Structural Grade: **2**
O&M Grade: **0**
Clock Start/From: **2**
Clock To:
1st Value:
2nd Value:
Value Percent:
Continuous Index:
Within 8" of Joint: **YES**
Remarks:

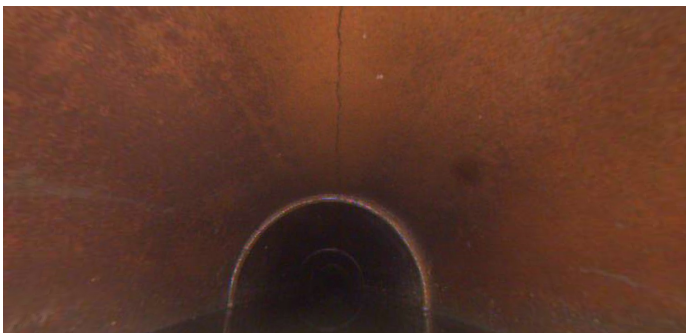
Code: **FL**
Description: **Fracture Longitudinal**

Distance (ft): **72.3**
Structural Grade: **3**
O&M Grade: **0**
Clock Start/From: **12**
Clock To:
1st Value:
2nd Value:
Value Percent:
Continuous Index:
Within 8" of Joint: **YES**
Remarks:

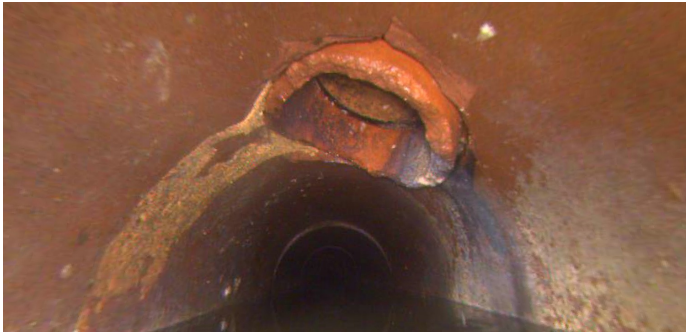
Code: **TBI**
Description: **Tap Break-in Intruding**

Distance (ft): **83.4**
Structural Grade: **0**
O&M Grade: **2**
Clock Start/From: **1**
Clock To:
1st Value: **4.000**
2nd Value: **1.000**
Value Percent:
Continuous Index:
Within 8" of Joint:
Remarks:

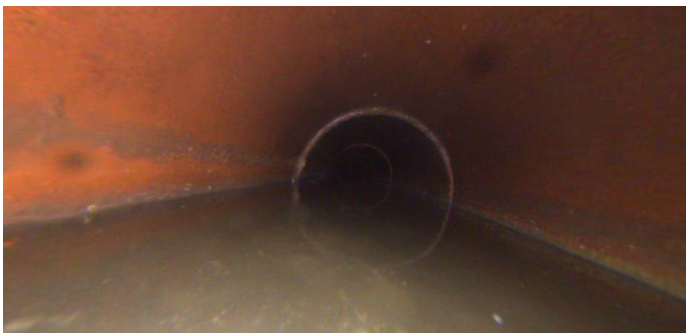
Code: **MSA**
Description: **Abandoned Survey**

Distance (ft): **96.1**
Structural Grade: **0**
O&M Grade: **0**
Clock Start/From:
Clock To:
1st Value:
2nd Value:
Value Percent:
Continuous Index:
Within 8" of Joint: **NO**
Remarks: **DEBRIS UNDER WATER**
