## Profile/Photo Observation Report

Date:	<b>04/03/2018</b>	Weather:		Coding:	<b>PACP 6.0</b>
Pipe Length (ft):	<b>158.9</b>	Owner:	<b>NA</b>	Pre Clean:	<b>Not Known</b>
P.O.#:		Surveyor:	<b>Jen Costello</b>	PSR:	<b>P-903-028-029</b>
Customer:		Clean Date:	<b>01/01/1900</b>	Shape:	<b>C</b>

Street:	<b>E RAND ST</b>	Flow Control:	<b>Not Controlled</b>
City:	<b>Hobart, IN</b>	Year Renewed:	
Location:	<b>Other</b>	Tape/Media #:	
Purpose:	<b>Not Known</b>	Dia/Height:	<b>12"</b>
Use:	<b>Sanitary</b>	Material:	<b>VCP</b>
Drain Area:	<b>NA</b>	Lining:	
Category:	<b>NA</b>		
Comment:

Location Details:		Direction of Survey:	<b>Upstream</b>
US MH:	<b>M-903-028</b>	DS MH:	<b>M-903-029</b>
		Total Length Surveyed (ft):	<b>149.7</b>

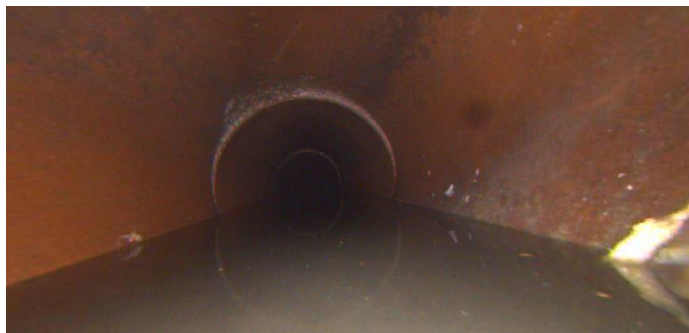
Code: **AMH**  
Description: **Manhole**

Distance (ft): **.0**  
Structural Grade: **0**  
O&M Grade: **0**  
Clock Start/From:  
Clock To:  
1st Value:  
2nd Value:  
Value Percent:  
Continuous Index:  
Within 8" of Joint: **NO**  
Remarks: **M-903-029**

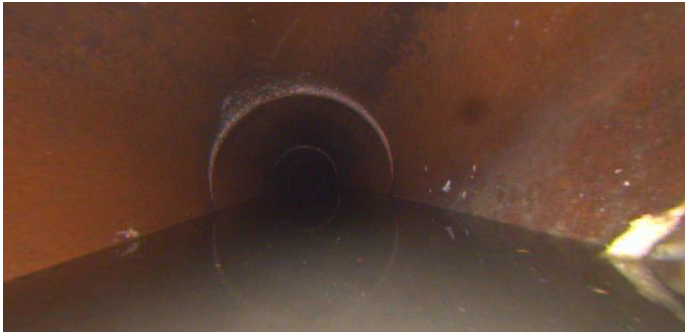
Code:	<b>MWL</b>
Description:	<b>Water Level</b>

Distance (ft):	<b>.0</b>
Structural Grade:	<b>0</b>
O&M Grade:	<b>0</b>
Clock Start/From:	
Clock To:	
1st Value:	
2nd Value:	
Value Percent:	<b>40.000</b>
Continuous Index:	
Within 8" of Joint:	<b>NO</b>
Remarks:

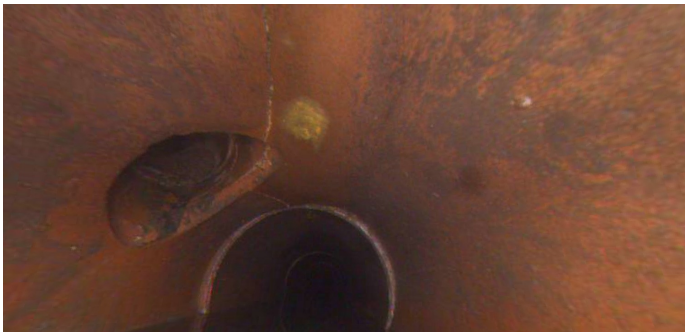
Code:	<b>FL</b>
Description:	<b>Fracture Longitudinal</b>

Distance (ft):	<b>9.6</b>
Structural Grade:	<b>3</b>
O&M Grade:	<b>0</b>
Clock Start/From:	<b>12</b>
Clock To:	
1st Value:	
2nd Value:	
Value Percent:	
Continuous Index:	
Within 8" of Joint:	<b>YES</b>
Remarks:

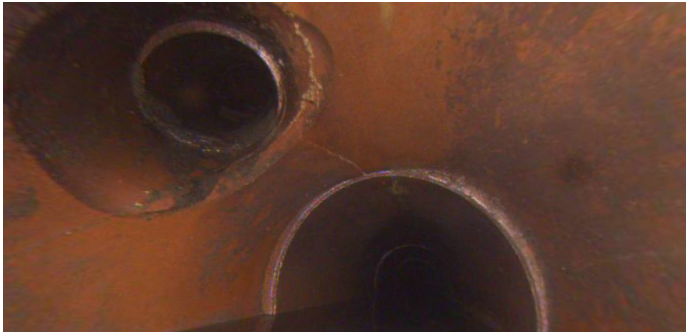
Code: **TFD**  
Description: **Tap Factory Defective**

Distance (ft): **10.2**  
Structural Grade: **0**  
O&M Grade: **2**  
Clock Start/From: **11**  
Clock To:  
1st Value: **4.000**  
2nd Value:  
Value Percent:  
Continuous Index:  
Within 8" of Joint:  
Remarks: **FL**

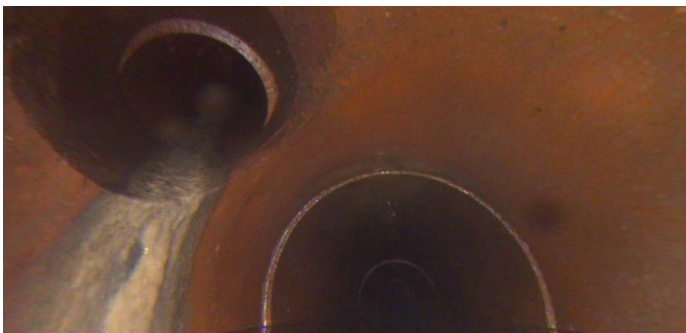
Code: **TFA**  
Description: **Tap Factory Active**

Distance (ft): **70.5**  
Structural Grade: **0**  
O&M Grade: **0**  
Clock Start/From: **10**  
Clock To:  
1st Value: **4.000**  
2nd Value:  
Value Percent:  
Continuous Index:  
Within 8" of Joint:  
Remarks:

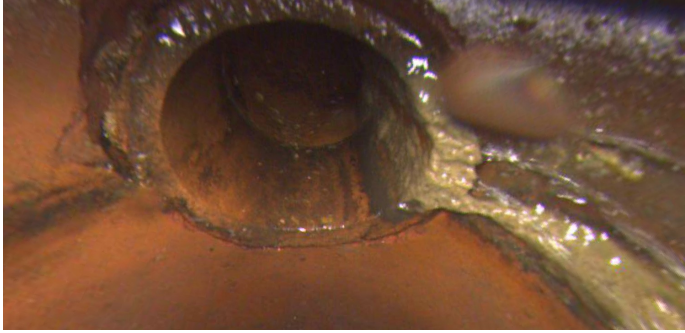
Code: **TBI**  
Description: **Tap Break-in Intruding**

Distance (ft): **78.3**  
Structural Grade: **0**  
O&M Grade: **2**  
Clock Start/From: **12**  
Clock To:  
1st Value: **4.000**  
2nd Value: **1.000**  
Value Percent:  
Continuous Index:  
Within 8" of Joint:  
Remarks: **ACTIVE**

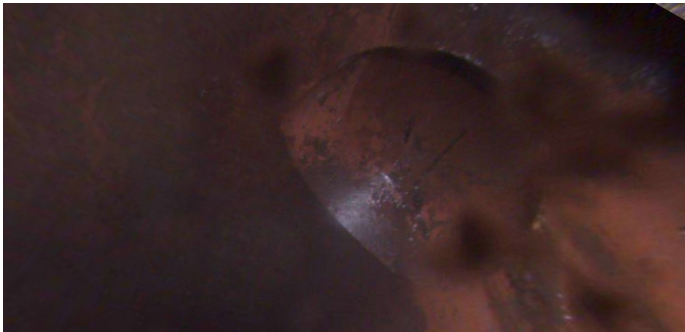
Code: **TF**  
Description: **Tap Factory**

Distance (ft): **125.6**  
Structural Grade: **0**  
O&M Grade: **0**  
Clock Start/From: **10**  
Clock To:  
1st Value: **4.000**  
2nd Value:  
Value Percent:  
Continuous Index:  
Within 8" of Joint:  
Remarks:

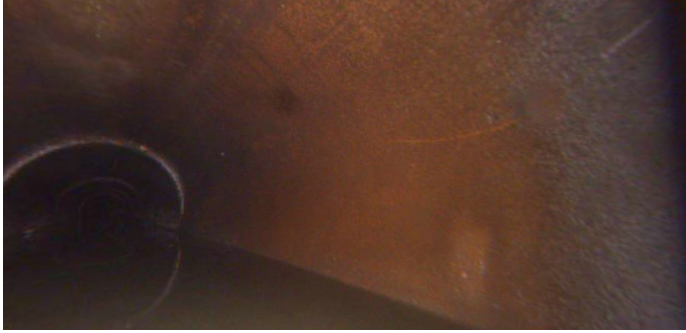
Code: **CL**  
Description: **Crack Longitudinal**

Distance (ft): **129.4**  
Structural Grade: **2**  
O&M Grade: **0**  
Clock Start/From: **3**  
Clock To:  
1st Value:  
2nd Value:  
Value Percent:  
Continuous Index:  
Within 8" of Joint:  
Remarks:

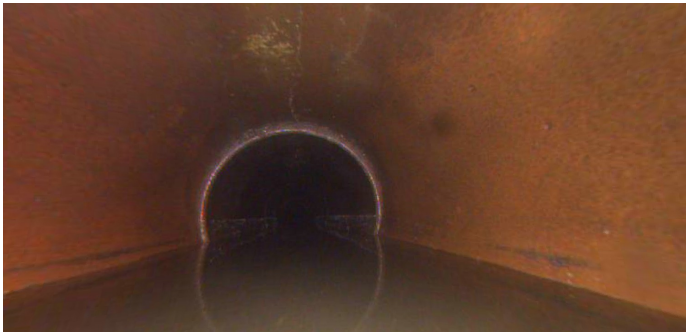
Code: **FL**  
Description: **Fracture Longitudinal**

Distance (ft): **139.5**  
Structural Grade: **3**  
O&M Grade: **0**  
Clock Start/From: **12**  
Clock To:  
1st Value:  
2nd Value:  
Value Percent:  
Continuous Index:  
Within 8" of Joint: **YES**  
Remarks:

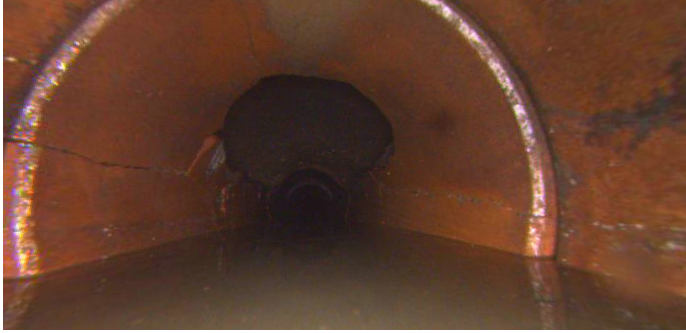
Code: **FH2**  
Description: **Fracture Longitudinal Hinge, 2**

Distance (ft): **146.7**  
Structural Grade: **4**  
O&M Grade: **0**  
Clock Start/From: **9**  
Clock To: **3**  
1st Value:  
2nd Value:  
Value Percent:  
Continuous Index:  
Within 8" of Joint: **YES**  
Remarks:

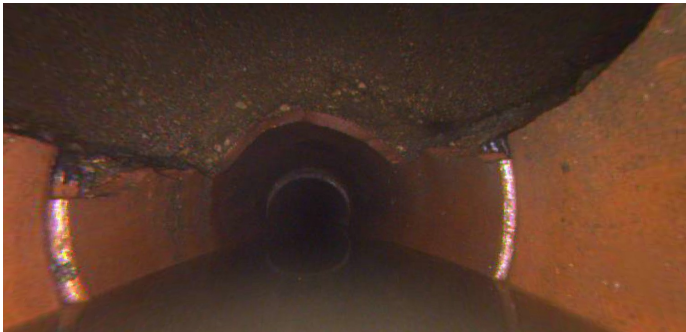
Code: **AMH**  
Description: **Manhole**

Distance (ft): **149.7**  
Structural Grade: **0**  
O&M Grade: **0**  
Clock Start/From:  
Clock To:  
1st Value:  
2nd Value:  
Value Percent:  
Continuous Index:  
Within 8" of Joint: **NO**  
Remarks: **M-903-028**
