Profile/Photo Observation Report

Date:	03/12/2024	Weather:		Coding:	PACP 7.0
Pipe Length (ft):	139.2	Owner:	City of Hobart	Pre Clean:	Heavy Cleaning
P.O.#:		Surveyor:	S. Bucklin	PSR:	M-903-029-M-803-013
Customer:	City of Hobart	Clean Date:	06/01/2023	Shape:	C

Location Details:		Direction of Survey:	Downstream
US MH:	M-903-029	DS MH:	M-803-013
		Total Length Surveyed (ft):	138.9

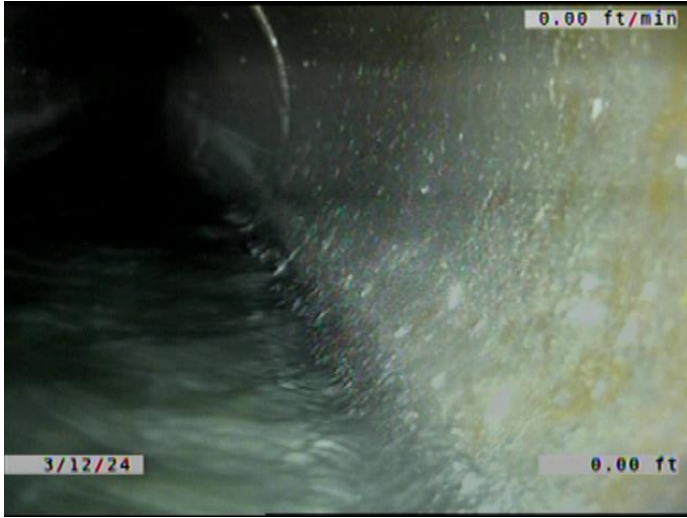
Code: **MWL**
Description: **Miscellaneous Water Level**

Distance (ft): **.0**
Structural Grade: **0**
O&M Grade: **0**
Clock Start/From:
Clock To:
1st Value:
2nd Value:
Value Percent: **15.000**
Continuous Index:
Within 8" of Joint: **NO**
Remarks:

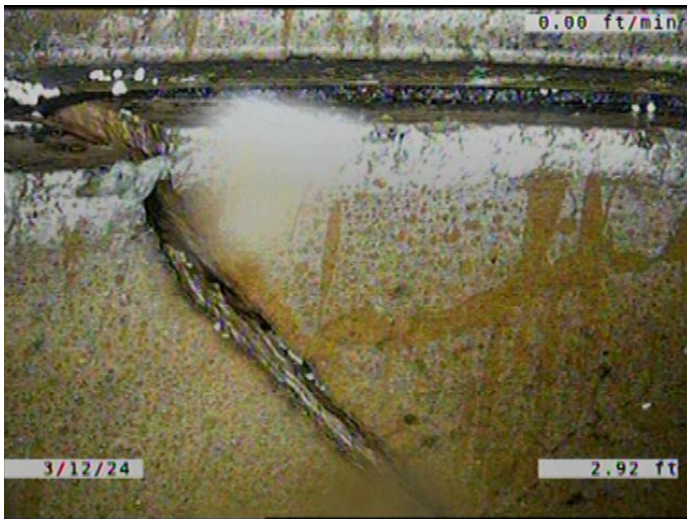
Code: **B**
Description: **Broken**

Distance (ft): **2.9**
Structural Grade: **4**
O&M Grade: **0**
Clock Start/From: **10**
Clock To: **3**
1st Value:
2nd Value:
Value Percent:
Continuous Index:
Within 8" of Joint: **YES**
Remarks:

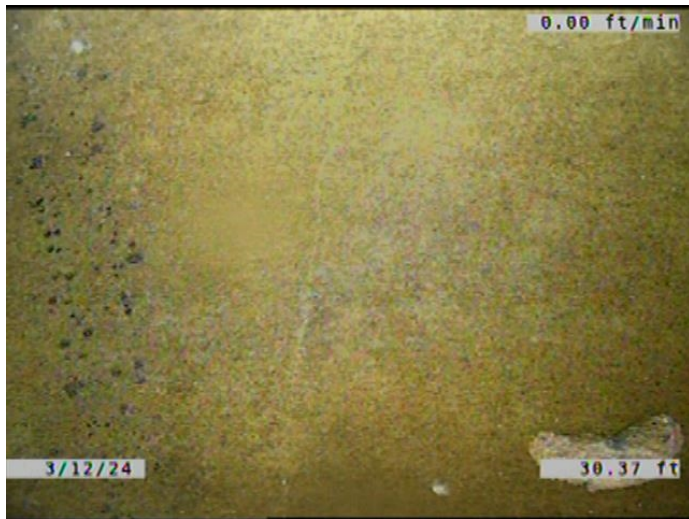
Code: **CL**
 Description: **Crack Longitudinal**

Distance (ft): **30.4**
 Structural Grade: **2**
 O&M Grade: **0**
 Clock Start/From: **10**
 Clock To:
 1st Value:
 2nd Value:
 Value Percent:
 Continuous Index:
 Within 8" of Joint: **YES**
 Remarks:

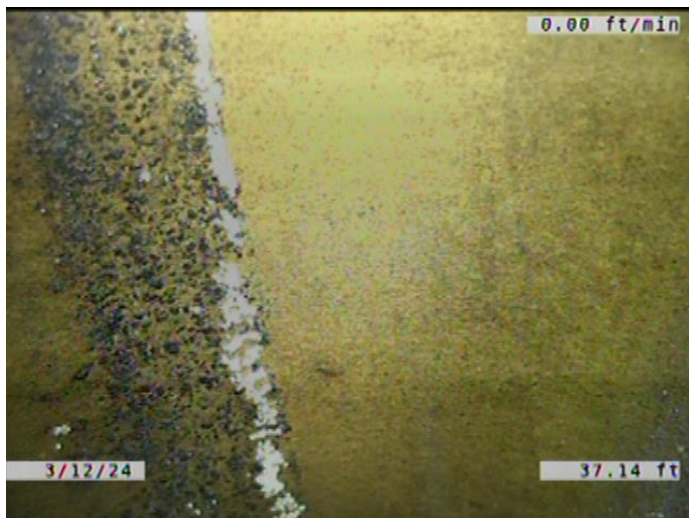
Code: **DAGS**
 Description: **Deposits Attached Grease**

Distance (ft): **37.1**
 Structural Grade: **0**
 O&M Grade: **2**
 Clock Start/From: **11**
 Clock To: **1**
 1st Value:
 2nd Value:
 Value Percent: **5.000**
 Continuous Index: **S01**
 Within 8" of Joint: **YES**
 Remarks:

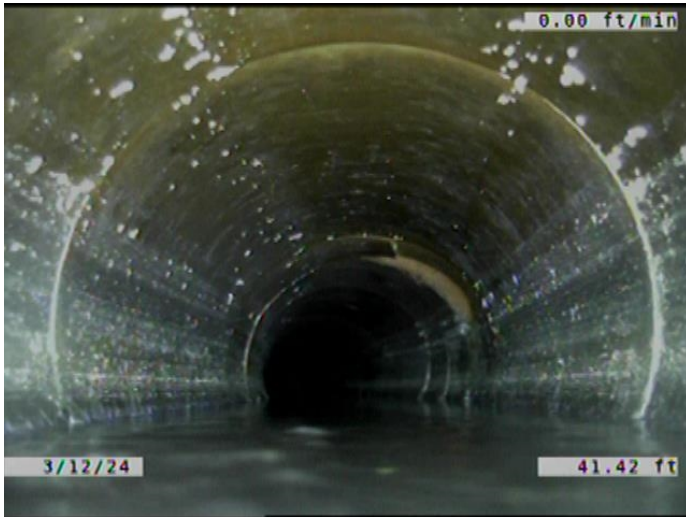
Code: **MWLS**
Description: **Miscellaneous Water Level Sag**

Distance (ft): **41.4**
Structural Grade: **2**
O&M Grade: **0**
Clock Start/From:
Clock To:
1st Value:
2nd Value:
Value Percent: **20.000**
Continuous Index:
Within 8" of Joint: **NO**
Remarks:

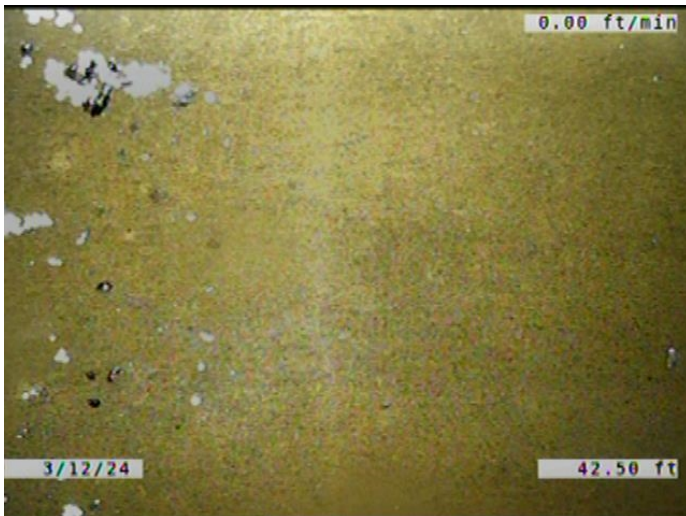
Code: **CL**
Description: **Crack Longitudinal**

Distance (ft): **42.5**
Structural Grade: **2**
O&M Grade: **0**
Clock Start/From: **12**
Clock To:
1st Value:
2nd Value:
Value Percent:
Continuous Index:
Within 8" of Joint: **YES**
Remarks:

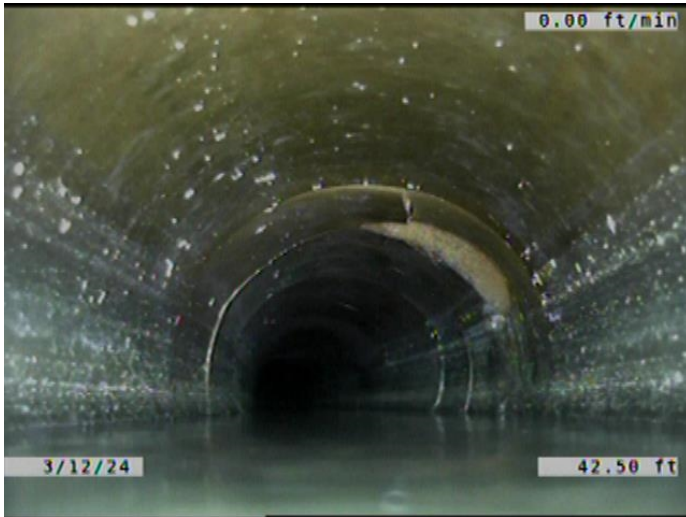
Code: **DAGS**
Description: **Deposits Attached Grease**

Distance (ft): **42.5**
Structural Grade: **0**
O&M Grade: **2**
Clock Start/From: **11**
Clock To: **1**
1st Value:
2nd Value:
Value Percent: **5.000**
Continuous Index: **F01**
Within 8" of Joint: **YES**
Remarks:

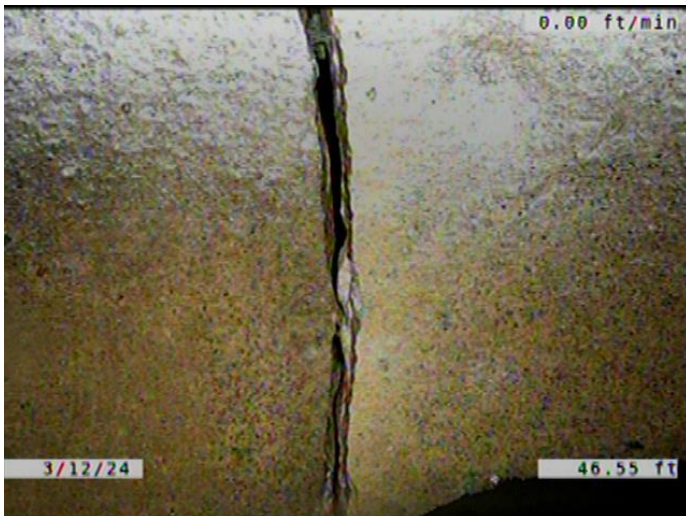
Code: **B**
Description: **Broken**

Distance (ft): **46.6**
Structural Grade: **4**
O&M Grade: **0**
Clock Start/From: **7**
Clock To: **5**
1st Value:
2nd Value:
Value Percent:
Continuous Index:
Within 8" of Joint: **YES**
Remarks:

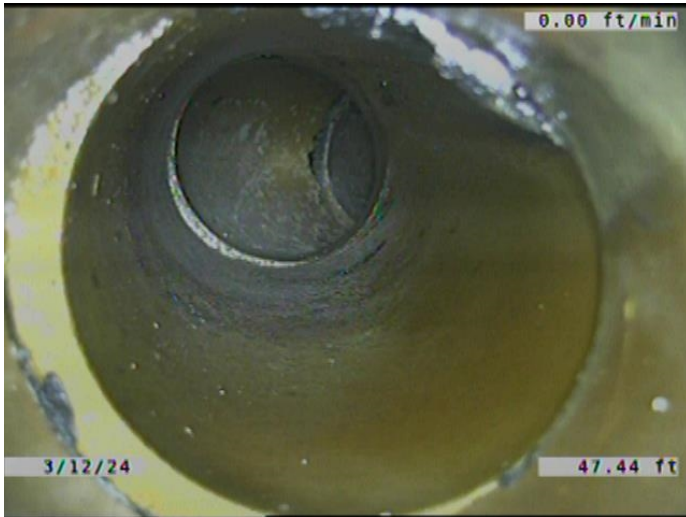
Code: **TFD**
Description: **Tap Factory Defective**

Distance (ft): **47.4**
Structural Grade: **0**
O&M Grade: **3**
Clock Start/From: **1**
Clock To:
1st Value: **6.000**
2nd Value:
Value Percent:
Continuous Index:
Within 8" of Joint: **YES**
Remarks: **TAP BROKEN. SERVICE OFFSET.**

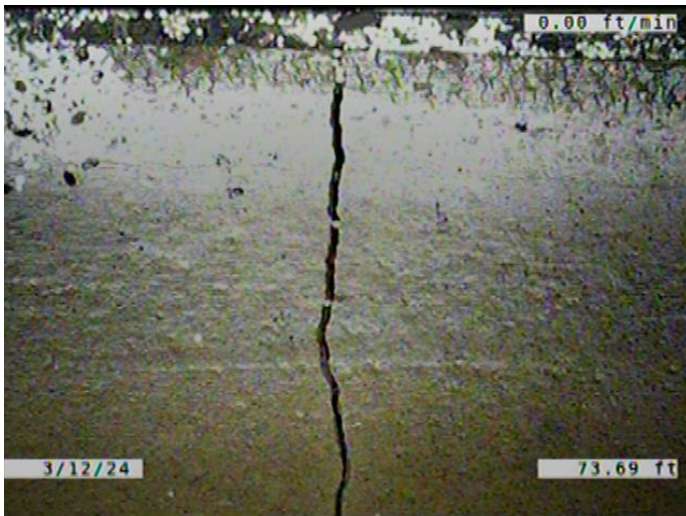
Code: **FS**
Description: **Fracture Spiral**

Distance (ft): **73.7**
Structural Grade: **3**
O&M Grade: **0**
Clock Start/From: **11**
Clock To: **1**
1st Value:
2nd Value:
Value Percent:
Continuous Index:
Within 8" of Joint: **YES**
Remarks:

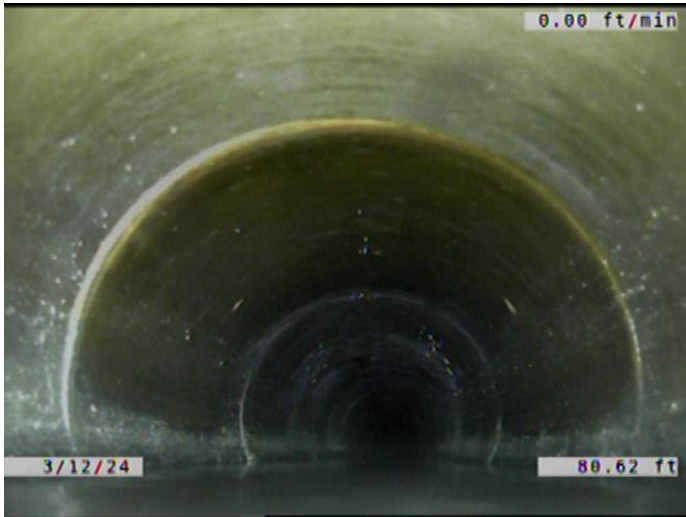
Code: **MWLS**
 Description: **Miscellaneous Water Level Sag**

Distance (ft): **80.6**
 Structural Grade: **2**
 O&M Grade: **0**
 Clock Start/From:
 Clock To:
 1st Value:
 2nd Value:
 Value Percent: **30.000**
 Continuous Index:
 Within 8" of Joint: **NO**
 Remarks:

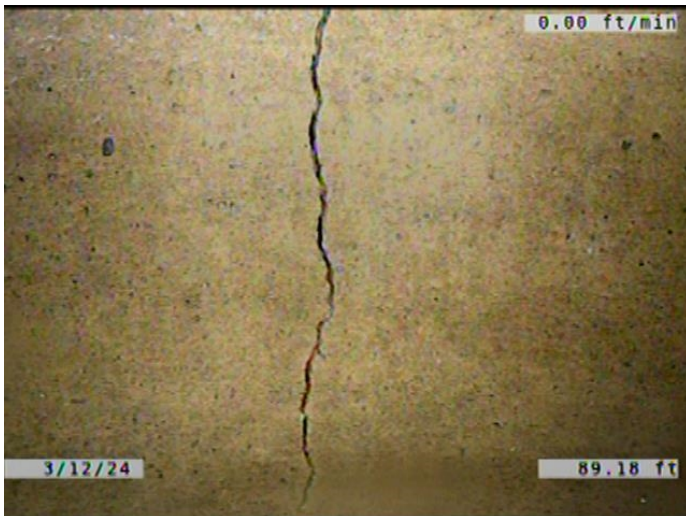
Code: **FS**
 Description: **Fracture Spiral**

Distance (ft): **89.2**
 Structural Grade: **3**
 O&M Grade: **0**
 Clock Start/From: **11**
 Clock To: **1**
 1st Value:
 2nd Value:
 Value Percent:
 Continuous Index:
 Within 8" of Joint: **YES**
 Remarks:

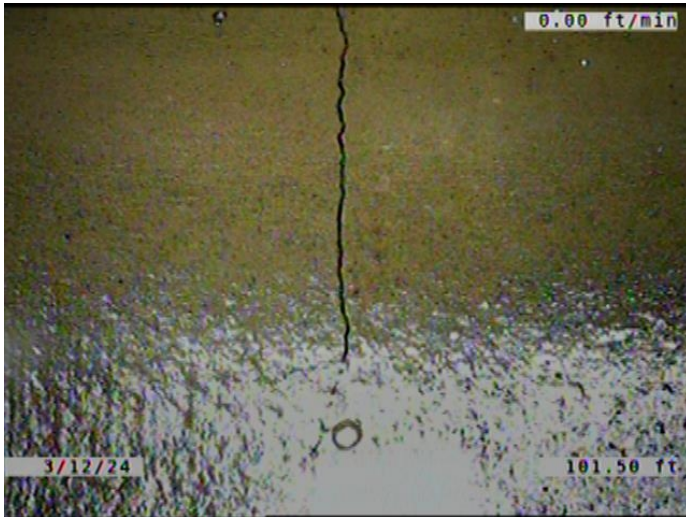
Code: **FS**
 Description: **Fracture Spiral**

Distance (ft): **101.5**
 Structural Grade: **3**
 O&M Grade: **0**
 Clock Start/From: **11**
 Clock To: **12**
 1st Value:
 2nd Value:
 Value Percent:
 Continuous Index:
 Within 8" of Joint: **YES**
 Remarks:

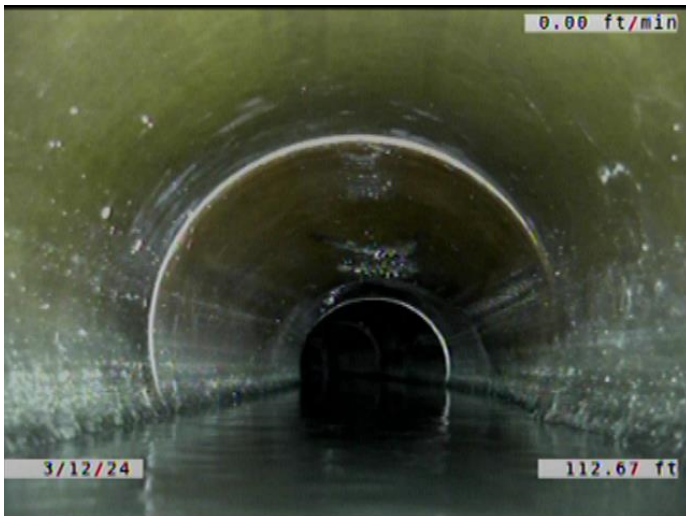
Code: **MWLS**
 Description: **Miscellaneous Water Level Sag**

Distance (ft): **112.7**
 Structural Grade: **2**
 O&M Grade: **0**
 Clock Start/From:
 Clock To:
 1st Value:
 2nd Value:
 Value Percent: **30.000**
 Continuous Index: **S02**
 Within 8" of Joint: **NO**
 Remarks:

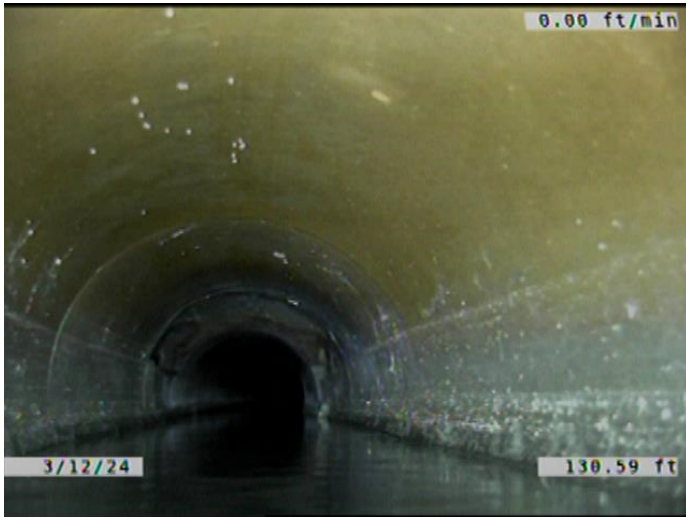
Code: **MWLS**
Description: **Miscellaneous Water Level Sag**

Distance (ft): **130.6**
Structural Grade: **2**
O&M Grade: **0**
Clock Start/From:
Clock To:
1st Value:
2nd Value:
Value Percent: **30.000**
Continuous Index: **F02**
Within 8" of Joint: **NO**
Remarks:

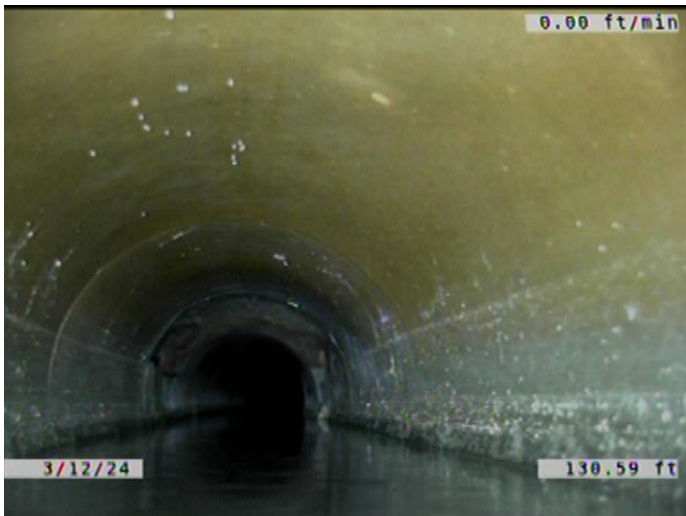
Code: **LL**
Description: **Line Left**

Distance (ft): **130.6**
Structural Grade: **0**
O&M Grade: **1**
Clock Start/From:
Clock To:
1st Value:
2nd Value:
Value Percent: **5.000**
Continuous Index:
Within 8" of Joint: **NO**
Remarks:

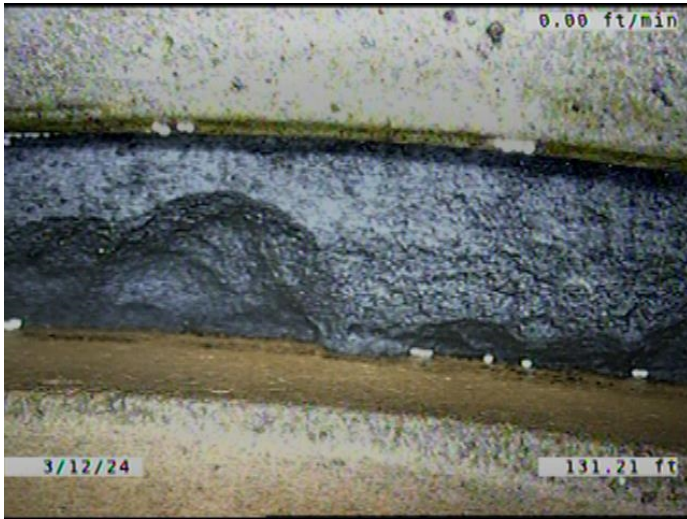
Code: **JAM**
Description: **Joint Angular Medium**

Distance (ft): **131.2**
Structural Grade: **3**
O&M Grade: **0**
Clock Start/From:
Clock To:
1st Value:
2nd Value:
Value Percent:
Continuous Index:
Within 8" of Joint: **NO**
Remarks:

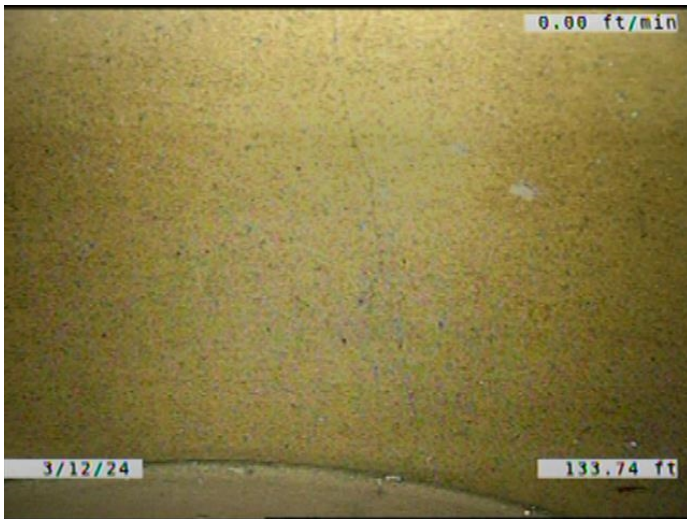
Code: **CM**
Description: **Crack Multiple**

Distance (ft): **133.7**
Structural Grade: **3**
O&M Grade: **0**
Clock Start/From: **11**
Clock To: **1**
1st Value:
2nd Value:
Value Percent:
Continuous Index:
Within 8" of Joint: **YES**
Remarks:
