Profile/Photo Observation Report

Street:	Rand St.	Flow Control:	Not Controlled
City:	Hobart, IN	Year Renewed:	
Location:	Other	Tape/Media #:	
Purpose:	Not Known	Dia/Height:	12"
Use:	Sanitary	Material:	VCP
Drain Area:	NA	Lining:	
Category:	NA		
Comment:

Location Details:		Direction of Survey:	Downstream
US MH:	M-903-029	DS MH:	M-803-013
		Total Length Surveyed (ft):	40.1

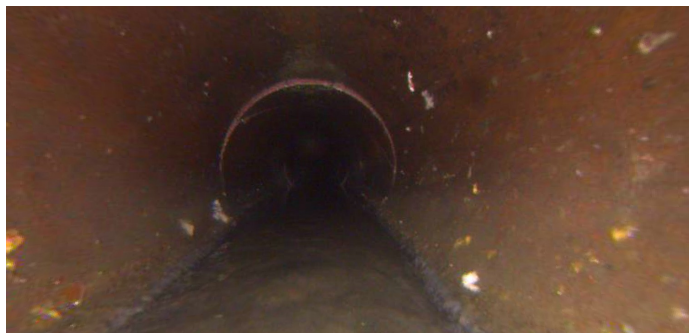
Code: **AMH**
Description: **Manhole**

Distance (ft): **.0**
Structural Grade: **0**
O&M Grade: **0**
Clock Start/From:
Clock To:
1st Value:
2nd Value:
Value Percent:
Continuous Index:
Within 8" of Joint: **NO**
Remarks: **M-903-029**

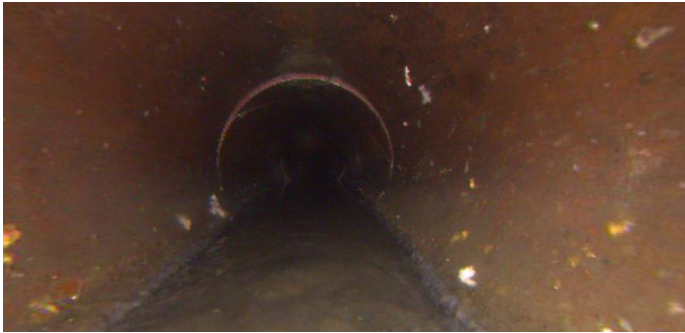
Code:	MWL
Description:	Water Level

Distance (ft):	.0
Structural Grade:	0
O&M Grade:	0
Clock Start/From:	
Clock To:	
1st Value:	
2nd Value:	
Value Percent:	10.000
Continuous Index:	
Within 8" of Joint:	NO
Remarks:

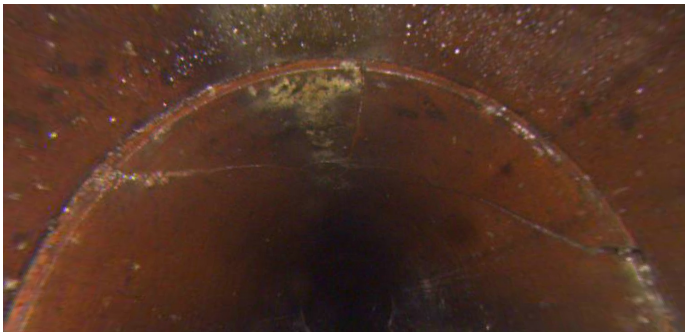
Code:	FM
Description:	Fracture Multiple

Distance (ft):	1.6
Structural Grade:	4
O&M Grade:	0
Clock Start/From:	10
Clock To:	3
1st Value:	
2nd Value:	
Value Percent:	
Continuous Index:	
Within 8" of Joint:	YES
Remarks:

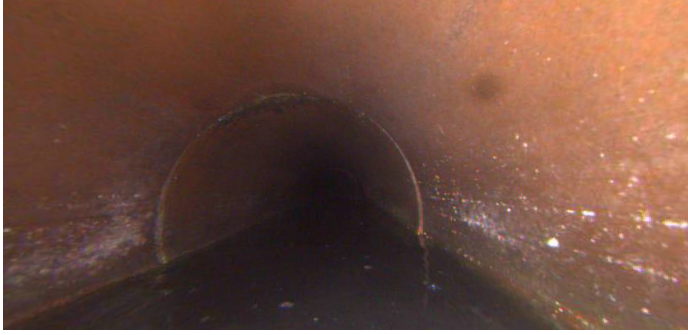
Code:	MSA
Description:	Abandoned Survey
Distance (ft):	40.1
Structural Grade:	0
O&M Grade:	0
Clock Start/From:	
Clock To:	
1st Value:	
2nd Value:	
Value Percent:	
Continuous Index:	
Within 8" of Joint:	NO
Remarks:	debris under water
