## Profile/Photo Observation Report

Street:	<b>E RAND ST &amp; N HOBART RD</b>	Flow Control:	<b>Not Controlled</b>
City:	<b>Hobart, IN</b>	Year Renewed:	
Location:	<b>Other</b>	Tape/Media #:	
Purpose:	<b>Not Known</b>	Dia/Height:	<b>12"</b>
Use:	<b>Sanitary</b>	Material:	<b>VCP</b>
Drain Area:	<b>NA</b>	Lining:	
Category:	<b>NA</b>		
Comment:

Location Details:		Direction of Survey:	<b>Upstream</b>
US MH:	<b>M-903-029</b>	DS MH:	<b>M-803-013</b>
		Total Length Surveyed (ft):	<b>8.8</b>

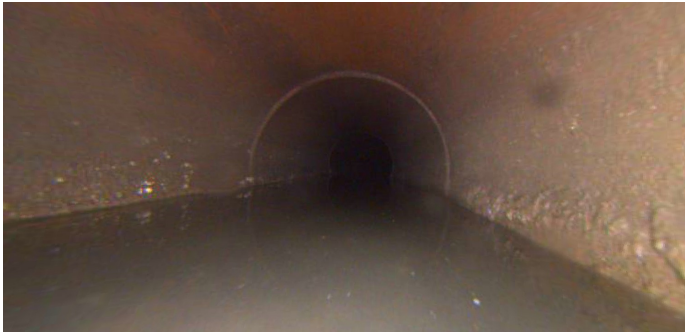
Code:	<b>MWL</b>
Description:	<b>Water Level</b>

Distance (ft):	<b>.0</b>
Structural Grade:	<b>0</b>
O&M Grade:	<b>0</b>
Clock Start/From:	
Clock To:	
1st Value:	
2nd Value:	
Value Percent:	<b>40.000</b>
Continuous Index:	
Within 8" of Joint:	<b>NO</b>
Remarks:

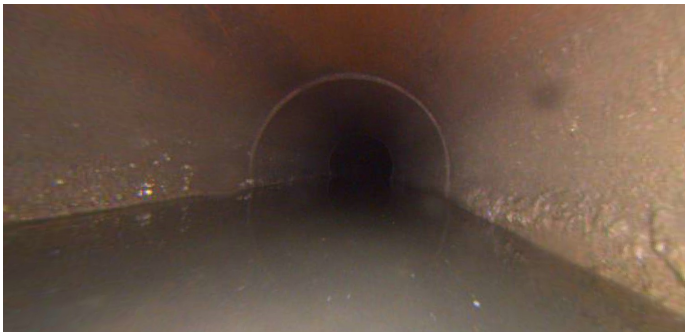
Code:	<b>DAGS</b>
Description:	<b>Deposits Attached Grease</b>

Distance (ft):	<b>.0</b>
Structural Grade:	<b>0</b>
O&M Grade:	<b>2</b>
Clock Start/From:	<b>8</b>
Clock To:	<b>4</b>
1st Value:	
2nd Value:	
Value Percent:	<b>5.000</b>
Continuous Index:	<b>S01</b>
Within 8" of Joint:	<b>NO</b>
Remarks:

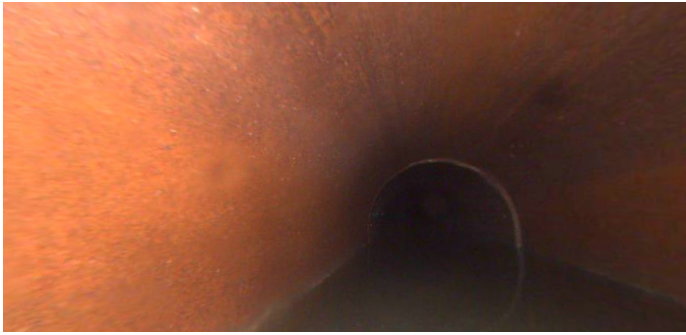
Code: **DAGS**  
Description: **Deposits Attached Grease**

Distance (ft): **6.3**  
Structural Grade: **0**  
O&M Grade: **2**  
Clock Start/From: **8**  
Clock To: **4**  
1st Value:  
2nd Value:  
Value Percent: **5.000**  
Continuous Index: **F01**  
Within 8" of Joint: **NO**  
Remarks:

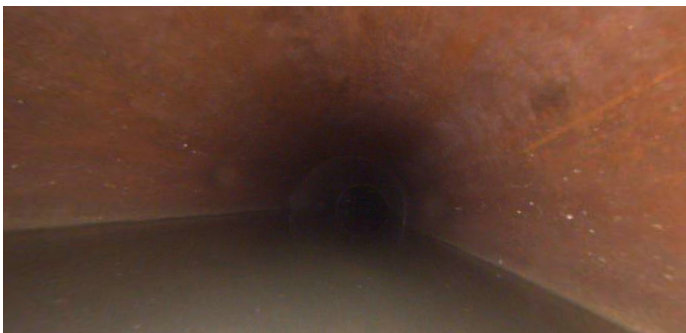
Code: **MSA**  
Description: **Abandoned Survey**

Distance (ft): **8.8**  
Structural Grade: **0**  
O&M Grade: **0**  
Clock Start/From:  
Clock To:  
1st Value:  
2nd Value:  
Value Percent:  
Continuous Index:  
Within 8" of Joint: **NO**  
Remarks: **HIGH WATER**
