Profile/Photo Observation Report

Street:	Rand St.	Flow Control:	Not Controlled
City:	Hobart, IN	Year Renewed:	
Location:	Light Highway	Tape/Media #:	
Purpose:	Routine Assessment	Dia/Height:	12"
Use:	Sanitary	Material:	VCP
Drain Area:	NA	Lining:	
Category:	NA		
Comment:

Location Details:		Direction of Survey:	Upstream
US MH:	M-903-029	DS MH:	M-803-013
		Total Length Surveyed (ft):	17.6

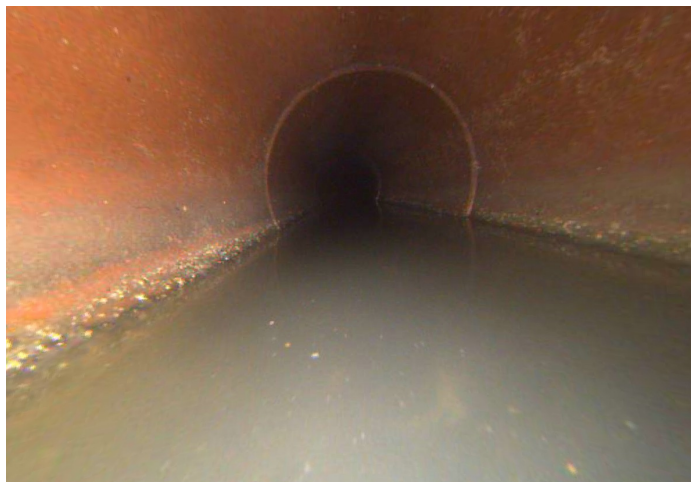
Code: **AMH**
 Description: **Manhole**

Distance (ft): **.0**
 Structural Grade: **0**
 O&M Grade: **0**
 Clock Start/From:
 Clock To:
 1st Value:
 2nd Value:
 Value Percent:
 Continuous Index:
 Within 8" of Joint: **NO**
 Remarks: **M-803-013**

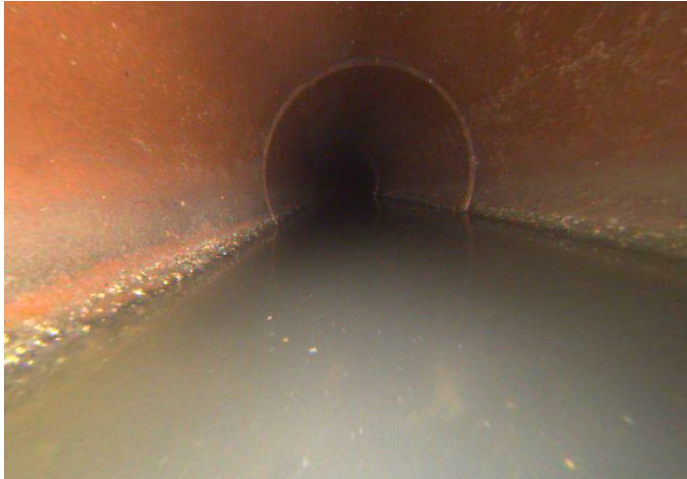
Code: **MWL**
Description: **Water Level**

Distance (ft): **.0**
Structural Grade: **0**
O&M Grade: **0**
Clock Start/From:
Clock To:
1st Value:
2nd Value:
Value Percent: **25.000**
Continuous Index:
Within 8" of Joint: **NO**
Remarks:

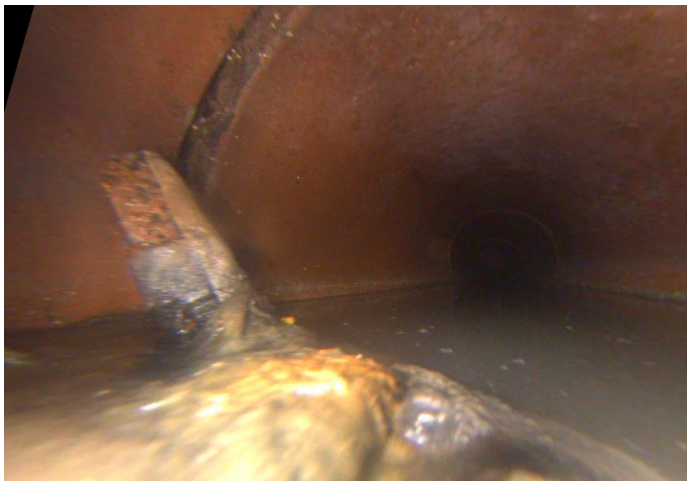
Code: **OBM**
Description: **Obstacle Pipe Material**

Distance (ft): **16.7**
Structural Grade: **0**
O&M Grade: **3**
Clock Start/From: **6**
Clock To: **8**
1st Value:
2nd Value:
Value Percent: **20.000**
Continuous Index:
Within 8" of Joint: **NO**
Remarks:

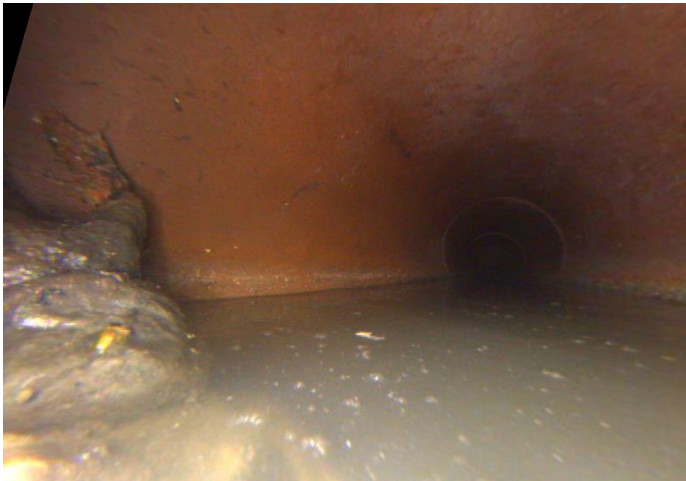
Code:	MSA
Description:	Abandoned Survey
Distance (ft):	17.6
Structural Grade:	0
O&M Grade:	0
Clock Start/From:	
Clock To:	
1st Value:	
2nd Value:	
Value Percent:	
Continuous Index:	
Within 8" of Joint:	NO
Remarks:	OBM
