Profile/Photo Observation Report

Date:	10/02/2018	Weather:		Coding:	PACP 6.0
Pipe Length (ft):	139.2	Owner:	NA	Pre Clean:	Not Known
P.O.#:		Surveyor:	Michael Carlino	PSR:	P-903-029-013
Customer:		Clean Date:	01/01/1900	Shape:	C

Street:	E RAND ST & N HOBART RD	Flow Control:	Not Controlled
City:	Hobart, IN	Year Renewed:	
Location:	Light Highway	Tape/Media #:	
Purpose:	Routine Assessment	Dia/Height:	12"
Use:	Sanitary	Material:	VCP
Drain Area:	NA	Lining:	
Category:	NA		
Comment:

Location Details:		Direction of Survey:	Downstream
US MH:	M-903-029	DS MH:	M-803-013
		Total Length Surveyed (ft):	41.3

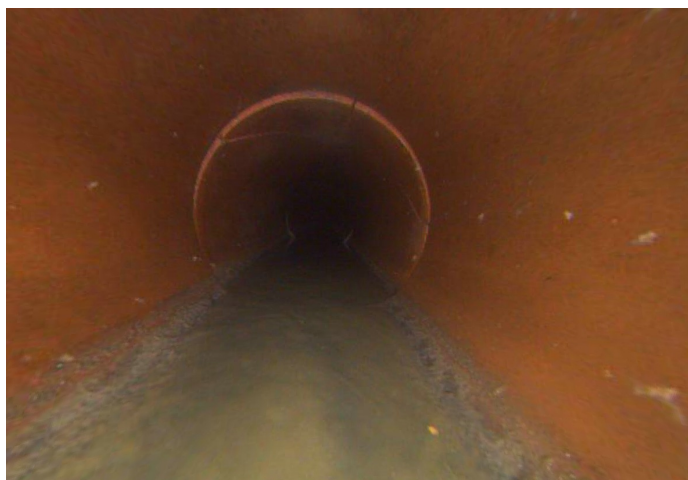
Code: **AMH**
Description: **Manhole**

Distance (ft): **.0**
Structural Grade: **0**
O&M Grade: **0**
Clock Start/From:
Clock To:
1st Value:
2nd Value:
Value Percent:
Continuous Index:
Within 8" of Joint: **NO**
Remarks: **M-903-029**

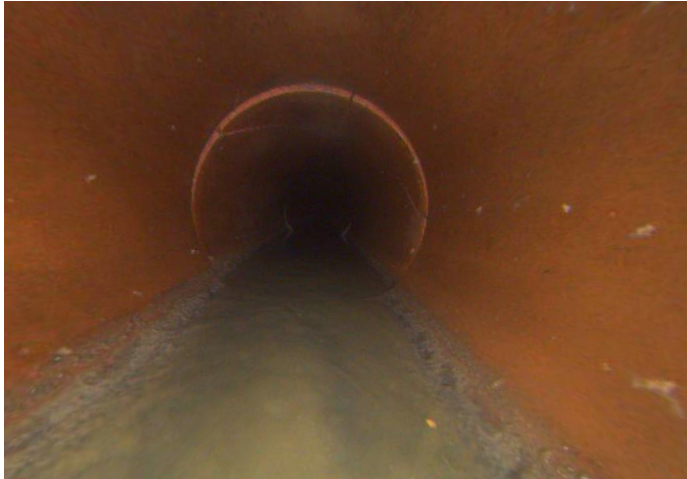
Code: **MWL**
Description: **Water Level**

Distance (ft): **.0**
Structural Grade: **0**
O&M Grade: **0**
Clock Start/From:
Clock To:
1st Value:
2nd Value:
Value Percent: **15.000**
Continuous Index:
Within 8" of Joint: **NO**
Remarks:

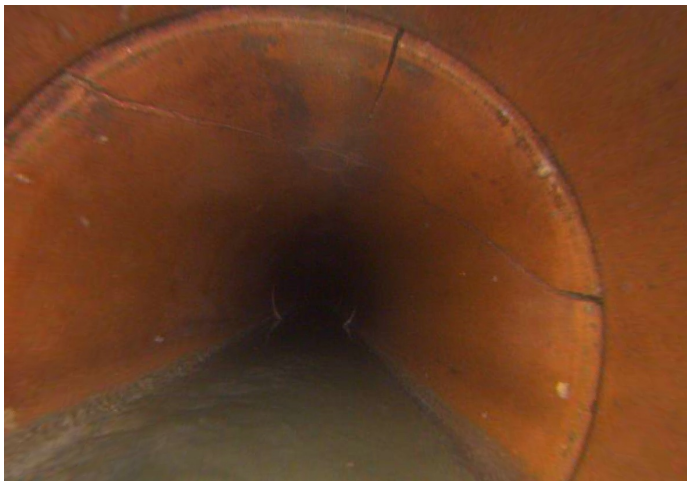
Code: **FM**
Description: **Fracture Multiple**

Distance (ft): **1.9**
Structural Grade: **4**
O&M Grade: **0**
Clock Start/From: **11**
Clock To: **3**
1st Value:
2nd Value:
Value Percent:
Continuous Index:
Within 8" of Joint: **YES**
Remarks:

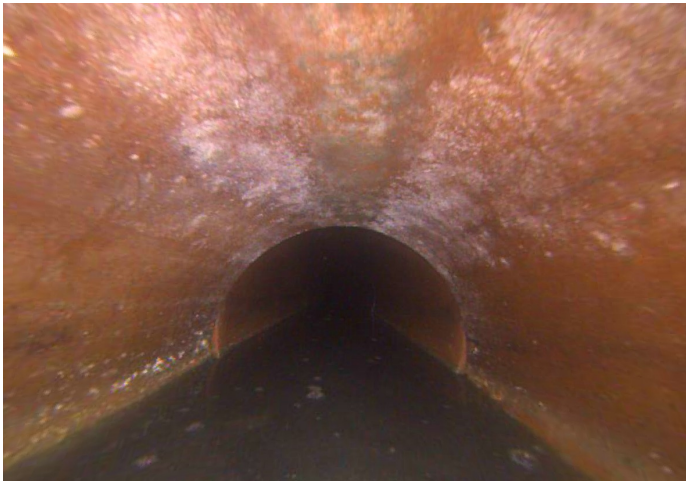
Code:	MWL
Description:	Water Level
Distance (ft):	35.2
Structural Grade:	0
O&M Grade:	0
Clock Start/From:	
Clock To:	
1st Value:	
2nd Value:	
Value Percent:	30.000
Continuous Index:	
Within 8" of Joint:	NO
Remarks:

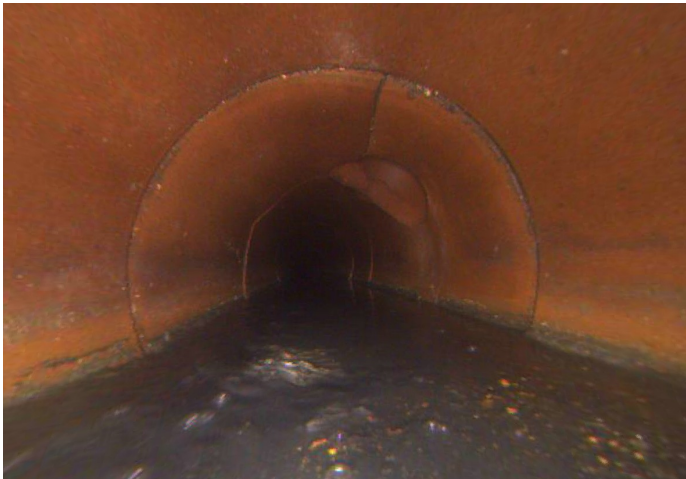
Code:	MSA
Description:	Abandoned Survey
Distance (ft):	41.3
Structural Grade:	0
O&M Grade:	0
Clock Start/From:	
Clock To:	
1st Value:	
2nd Value:	
Value Percent:	
Continuous Index:	
Within 8" of Joint:	NO
Remarks:	Possible Debris
