Profile/Photo Observation Report

Date:	10/02/2018	Weather:		Coding:	PACP 6.0
Pipe Length (ft):	139.2	Owner:	NA	Pre Clean:	Not Known
P.O.#:		Surveyor:	Michael Carlino	PSR:	P-903-029-013
Customer:		Clean Date:	01/01/1900	Shape:	C

Street:	Rand St.	Flow Control:	Not Controlled
City:	Hobart, IN	Year Renewed:	
Location:	Light Highway	Tape/Media #:	
Purpose:	Routine Assessment	Dia/Height:	12"
Use:	Sanitary	Material:	VCP
Drain Area:	NA	Lining:	
Category:	NA		
Comment:

Location Details:		Direction of Survey:	Downstream
US MH:	M-903-029	DS MH:	M-803-013
		Total Length Surveyed (ft):	41.3

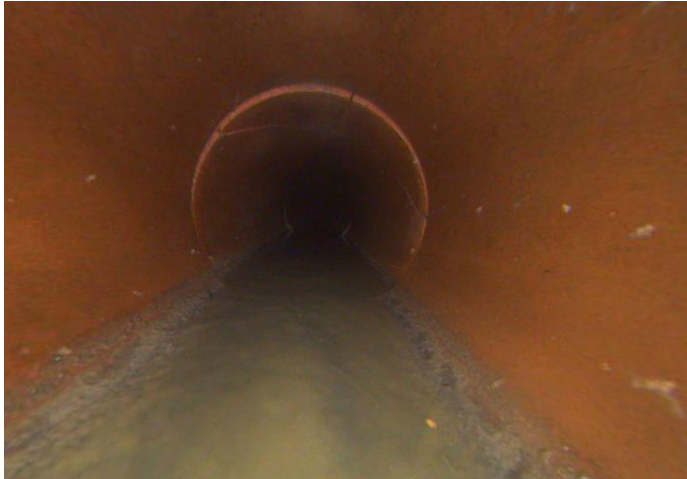
Code: **MWL**
Description: **Water Level**

Distance (ft): **.0**
Structural Grade: **0**
O&M Grade: **0**
Clock Start/From:
Clock To:
1st Value:
2nd Value:
Value Percent: **15.000**
Continuous Index:
Within 8" of Joint: **NO**
Remarks:

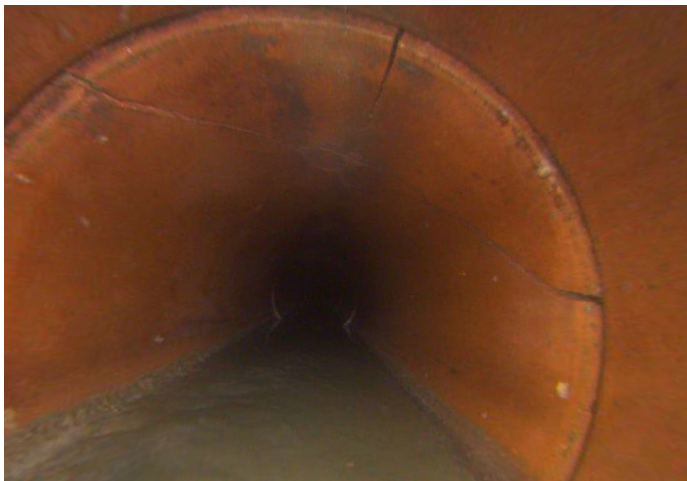
Code: **FM**
Description: **Fracture Multiple**

Distance (ft): **1.9**
Structural Grade: **4**
O&M Grade: **0**
Clock Start/From: **11**
Clock To: **3**
1st Value:
2nd Value:
Value Percent:
Continuous Index:
Within 8" of Joint: **YES**
Remarks:

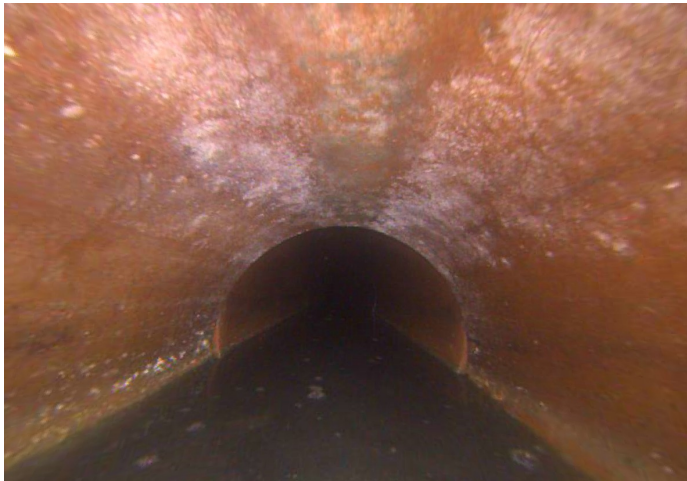
Code: **MWL**
Description: **Water Level**

Distance (ft): **35.2**
Structural Grade: **0**
O&M Grade: **0**
Clock Start/From:
Clock To:
1st Value:
2nd Value:
Value Percent: **30.000**
Continuous Index:
Within 8" of Joint: **NO**
Remarks:

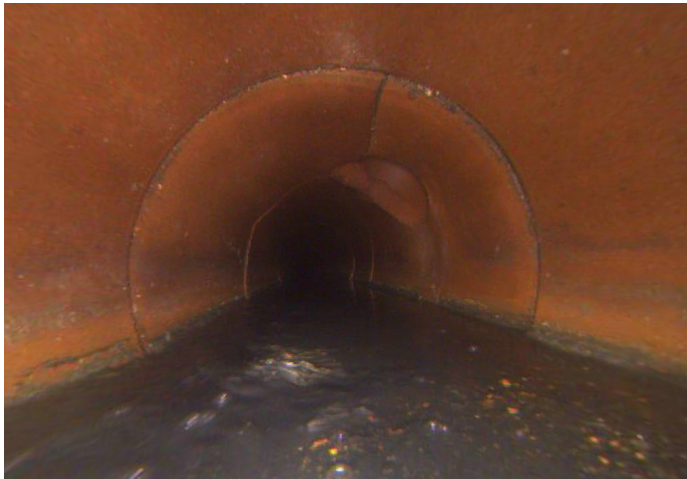
Code: **MSA**
Description: **Abandoned Survey**

Distance (ft): **41.3**
Structural Grade: **0**
O&M Grade: **0**
Clock Start/From:
Clock To:
1st Value:
2nd Value:
Value Percent:
Continuous Index:
Within 8" of Joint: **NO**
Remarks: **Possible Debris**
