Profile/Photo Observation Report

Street:	E RAND ST	Flow Control:	Not Controlled
City:	Hobart, IN	Year Renewed:	
Location:	Light Highway	Tape/Media #:	
Purpose:	Routine Assessment	Dia/Height:	12"
Use:	Sanitary	Material:	VCP
Drain Area:	NA	Lining:	
Category:	NA		
Comment:

Location Details:		Direction of Survey:	Downstream
US MH:	M-903-029	DS MH:	M-903-030
		Total Length Surveyed (ft):	217.5

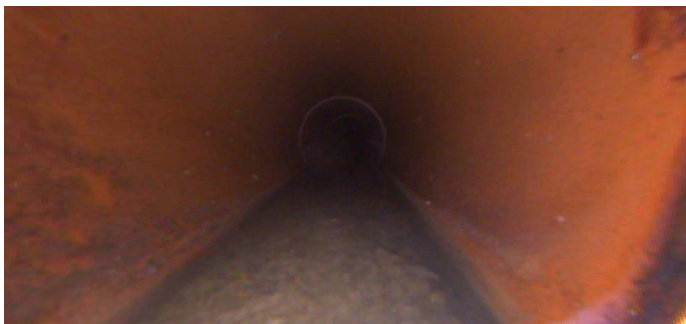
Code: **AMH**
Description: **Manhole**

Distance (ft): **.0**
Structural Grade: **0**
O&M Grade: **0**
Clock Start/From:
Clock To:
1st Value:
2nd Value:
Value Percent:
Continuous Index:
Within 8" of Joint: **NO**
Remarks: **M-903-029**

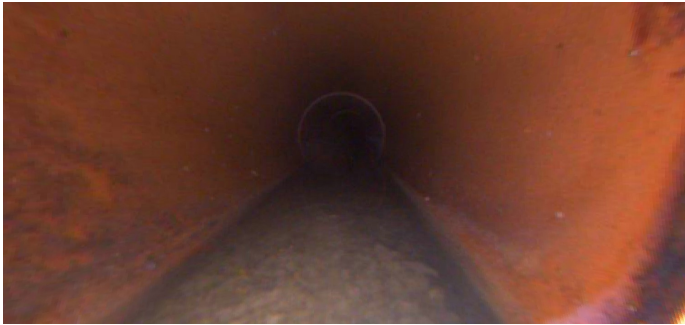
Code:	MWL
Description:	Water Level

Distance (ft):	.0
Structural Grade:	0
O&M Grade:	0
Clock Start/From:	
Clock To:	
1st Value:	
2nd Value:	
Value Percent:	10.000
Continuous Index:	
Within 8" of Joint:	NO
Remarks:

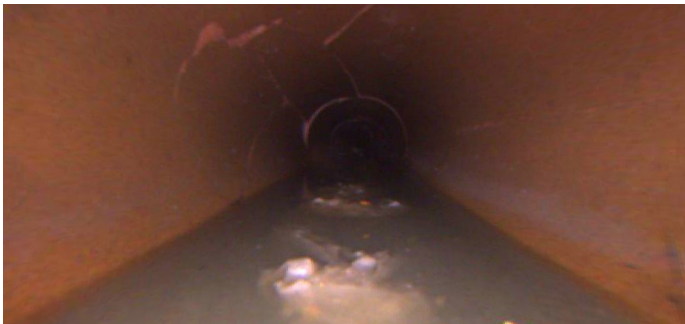
Code:	CM
Description:	Crack Multiple

Distance (ft):	28.2
Structural Grade:	3
O&M Grade:	0
Clock Start/From:	8
Clock To:	3
1st Value:	
2nd Value:	
Value Percent:	
Continuous Index:	
Within 8" of Joint:	YES
Remarks:

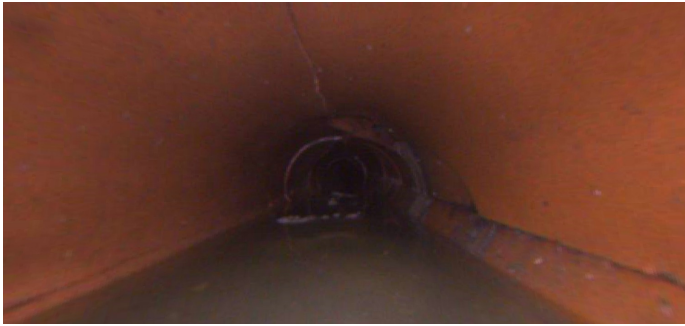
Code: **FM**
Description: **Fracture Multiple**

Distance (ft): **31.4**
Structural Grade: **4**
O&M Grade: **0**
Clock Start/From: **12**
Clock To: **4**
1st Value:
2nd Value:
Value Percent:
Continuous Index:
Within 8" of Joint: **YES**
Remarks:

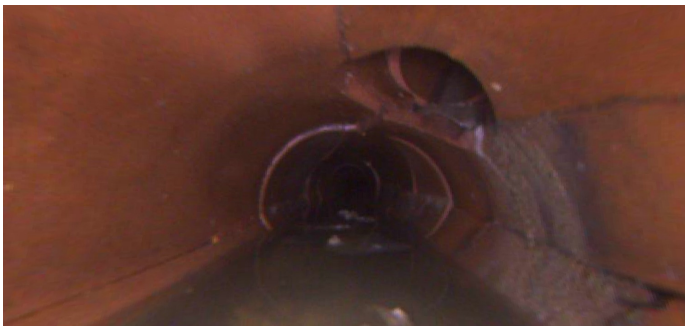
Code: **TFD**
Description: **Tap Factory Defective**

Distance (ft): **32.5**
Structural Grade: **0**
O&M Grade: **2**
Clock Start/From: **1**
Clock To:
1st Value: **4.000**
2nd Value:
Value Percent:
Continuous Index:
Within 8" of Joint:
Remarks: **FRACTURES AROUND TAP**

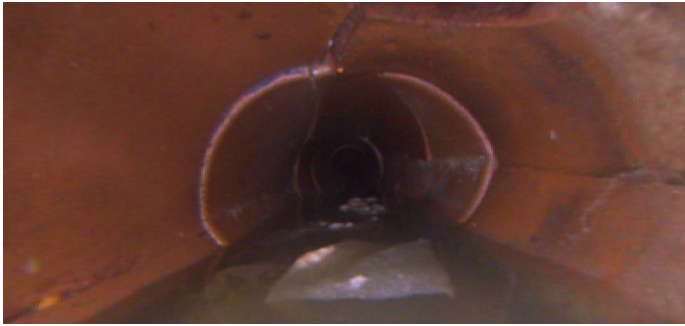
Code: **B**
Description: **Broken**

Distance (ft): **33.1**
Structural Grade: **5**
O&M Grade: **0**
Clock Start/From: **7**
Clock To: **5**
1st Value:
2nd Value:
Value Percent:
Continuous Index:
Within 8" of Joint: **YES**
Remarks:

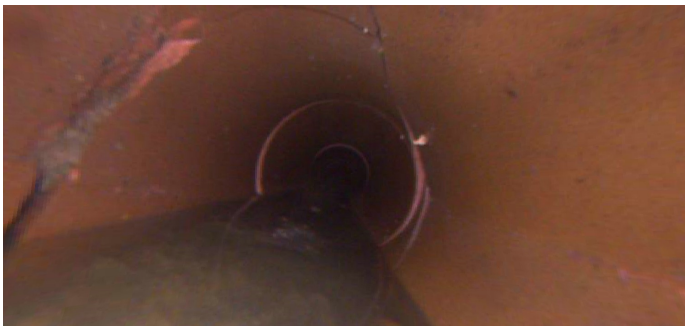
Code: **B**
Description: **Broken**

Distance (ft): **35.5**
Structural Grade: **5**
O&M Grade: **0**
Clock Start/From: **7**
Clock To: **5**
1st Value:
2nd Value:
Value Percent:
Continuous Index:
Within 8" of Joint: **YES**
Remarks:

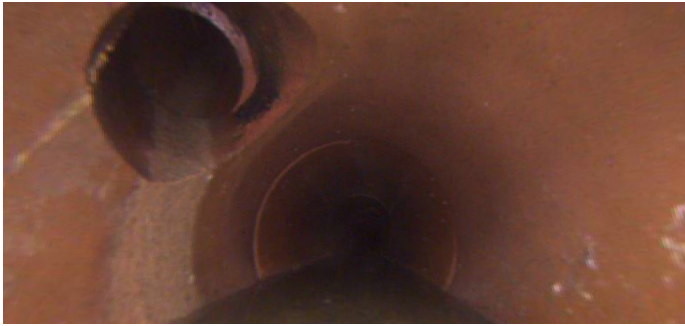
Code: **TF**
Description: **Tap Factory**

Distance (ft): **86.3**
Structural Grade: **0**
O&M Grade: **0**
Clock Start/From: **10**
Clock To:
1st Value: **4.000**
2nd Value:
Value Percent:
Continuous Index:
Within 8" of Joint:
Remarks:

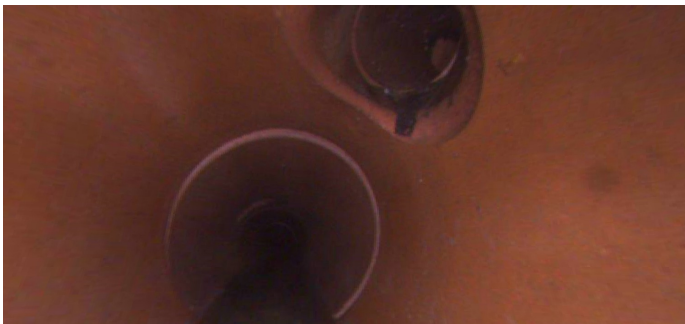
Code: **TF**
Description: **Tap Factory**

Distance (ft): **92.4**
Structural Grade: **0**
O&M Grade: **0**
Clock Start/From: **2**
Clock To:
1st Value: **4.000**
2nd Value:
Value Percent:
Continuous Index:
Within 8" of Joint:
Remarks:

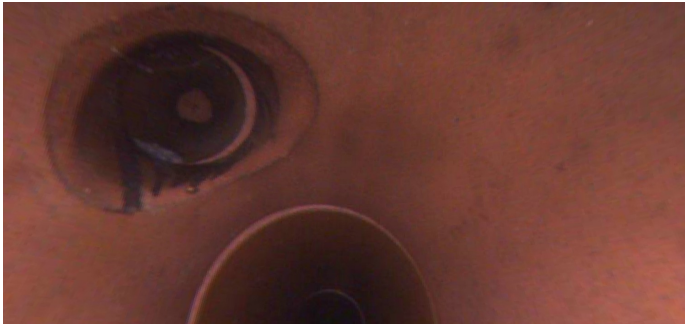
Code: **TF**
Description: **Tap Factory**

Distance (ft): **95.4**
Structural Grade: **0**
O&M Grade: **0**
Clock Start/From: **11**
Clock To:
1st Value: **4.000**
2nd Value:
Value Percent:
Continuous Index:
Within 8" of Joint:
Remarks:

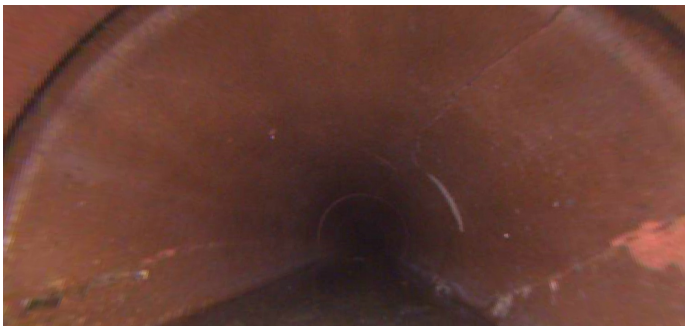
Code: **FM**
Description: **Fracture Multiple**

Distance (ft): **144.7**
Structural Grade: **4**
O&M Grade: **0**
Clock Start/From: **8**
Clock To: **5**
1st Value:
2nd Value:
Value Percent:
Continuous Index:
Within 8" of Joint: **YES**
Remarks:

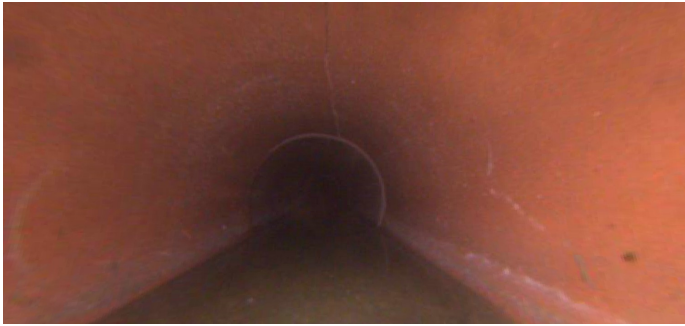
Code: **CL**
Description: **Crack Longitudinal**

Distance (ft): **149.0**
Structural Grade: **2**
O&M Grade: **0**
Clock Start/From: **1**
Clock To:
1st Value:
2nd Value:
Value Percent:
Continuous Index:
Within 8" of Joint: **YES**
Remarks:

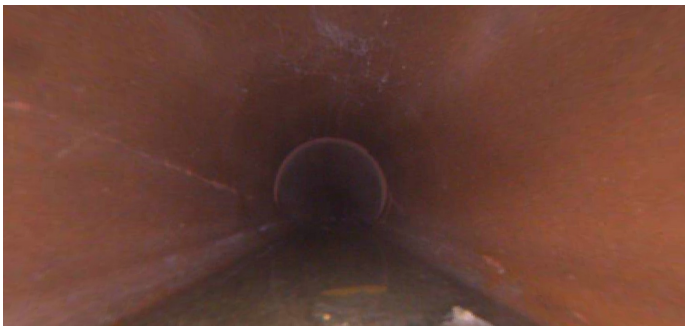
Code: **CL**
Description: **Crack Longitudinal**

Distance (ft): **154.4**
Structural Grade: **2**
O&M Grade: **0**
Clock Start/From: **9**
Clock To:
1st Value:
2nd Value:
Value Percent:
Continuous Index:
Within 8" of Joint: **YES**
Remarks:

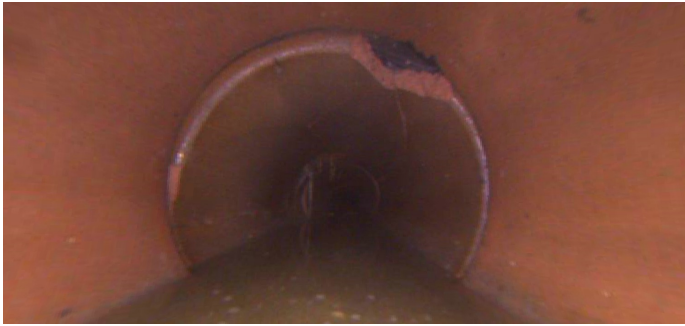
Code: **HSV**
Description: **Hole Soil Visible**

Distance (ft): **165.3**
Structural Grade: **5**
O&M Grade: **0**
Clock Start/From: **1**
Clock To:
1st Value:
2nd Value:
Value Percent:
Continuous Index:
Within 8" of Joint: **YES**
Remarks:

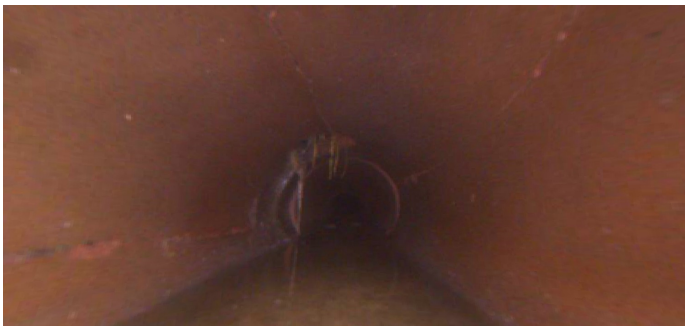
Code: **CM**
Description: **Crack Multiple**

Distance (ft): **166.4**
Structural Grade: **3**
O&M Grade: **0**
Clock Start/From: **8**
Clock To: **1**
1st Value:
2nd Value:
Value Percent:
Continuous Index:
Within 8" of Joint:
Remarks:

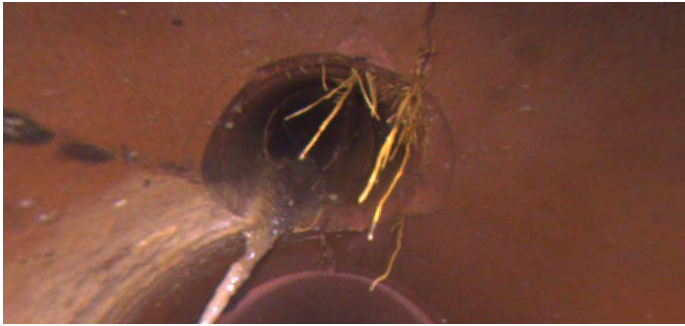
Code: **TFD**
Description: **Tap Factory Defective**

Distance (ft): **168.0**
Structural Grade: **0**
O&M Grade: **2**
Clock Start/From: **11**
Clock To:
1st Value: **4.000**
2nd Value:
Value Percent:
Continuous Index:
Within 8" of Joint:
Remarks: **RF COMING FROM FRACTURES
AROUND TAP**

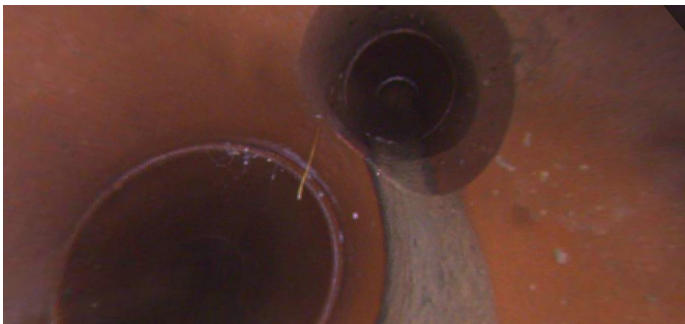
Code: **TF**
Description: **Tap Factory**

Distance (ft): **176.9**
Structural Grade: **0**
O&M Grade: **0**
Clock Start/From: **1**
Clock To:
1st Value: **4.000**
2nd Value:
Value Percent:
Continuous Index:
Within 8" of Joint:
Remarks:

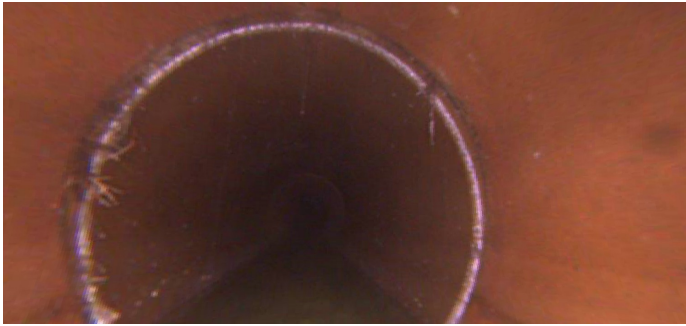
Code: **RFJ**
Description: **Roots Fine Joint**

Distance (ft): **186.5**
Structural Grade: **0**
O&M Grade: **1**
Clock Start/From: **7**
Clock To: **2**
1st Value:
2nd Value:
Value Percent:
Continuous Index:
Within 8" of Joint: **YES**
Remarks:

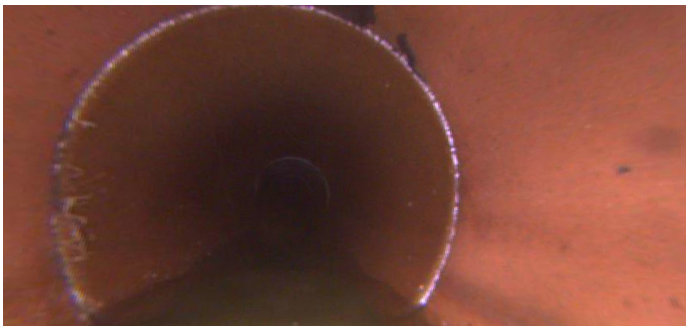
Code: **RFJ**
Description: **Roots Fine Joint**

Distance (ft): **192.4**
Structural Grade: **0**
O&M Grade: **1**
Clock Start/From: **8**
Clock To: **9**
1st Value:
2nd Value:
Value Percent:
Continuous Index:
Within 8" of Joint: **YES**
Remarks:

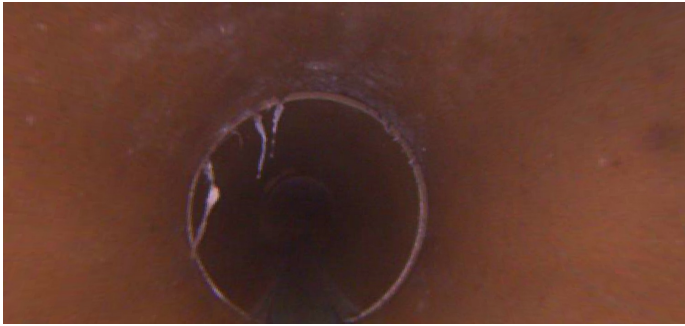
Code: **RFJ**
Description: **Roots Fine Joint**

Distance (ft): **201.0**
Structural Grade: **0**
O&M Grade: **1**
Clock Start/From: **8**
Clock To: **10**
1st Value:
2nd Value:
Value Percent:
Continuous Index:
Within 8" of Joint: **YES**
Remarks:

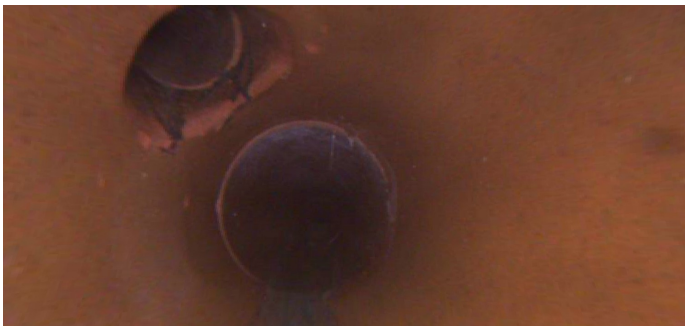
Code: **TF**
Description: **Tap Factory**

Distance (ft): **203.6**
Structural Grade: **0**
O&M Grade: **0**
Clock Start/From: **10**
Clock To:
1st Value: **4.000**
2nd Value:
Value Percent:
Continuous Index:
Within 8" of Joint:
Remarks:

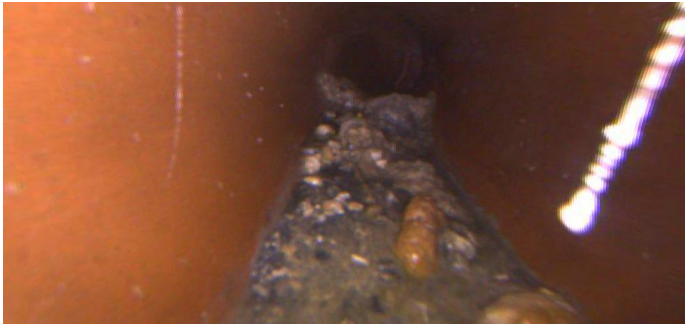
Code: **DSZ**
Description: **Deposits Settled Other**

Distance (ft): **211.1**
Structural Grade: **0**
O&M Grade: **2**
Clock Start/From: **6**
Clock To:
1st Value:
2nd Value:
Value Percent: **10.000**
Continuous Index:
Within 8" of Joint: **YES**
Remarks: **TOILET WASTE**

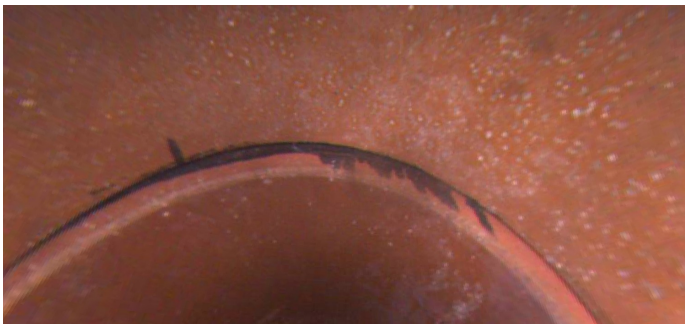
Code: **AMH**
Description: **Manhole**

Distance (ft): **217.5**
Structural Grade: **0**
O&M Grade: **0**
Clock Start/From:
Clock To:
1st Value:
2nd Value:
Value Percent:
Continuous Index:
Within 8" of Joint: **NO**
Remarks: **M-903-030**
