## Profile/Photo Observation Report

Street:	<b>Rand St.</b>	Flow Control:	<b>Not Controlled</b>
City:	<b>Hobart, IN</b>	Year Renewed:	
Location:	<b>Light Highway</b>	Tape/Media #:	
Purpose:	<b>Routine Assessment</b>	Dia/Height:	<b>12"</b>
Use:	<b>Sanitary</b>	Material:	<b>VCP</b>
Drain Area:	<b>NA</b>	Lining:	
Category:	<b>NA</b>		
Comment:

Location Details:		Direction of Survey:	<b>Downstream</b>
US MH:	<b>M-903-029</b>	DS MH:	<b>M-903-030</b>
		Total Length Surveyed (ft):	<b>217.5</b>

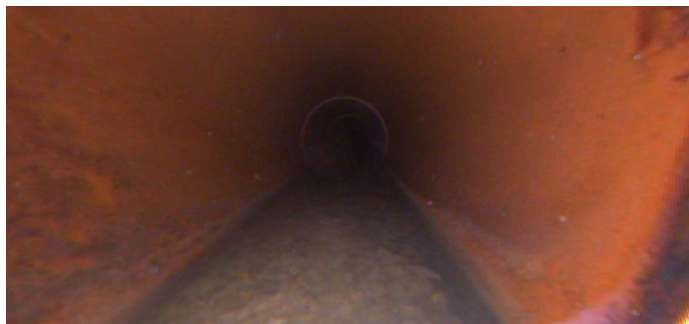
Code: **AMH**  
Description: **Manhole**

Distance (ft): **.0**  
Structural Grade: **0**  
O&M Grade: **0**  
Clock Start/From:  
Clock To:  
1st Value:  
2nd Value:  
Value Percent:  
Continuous Index:  
Within 8" of Joint: **NO**  
Remarks: **M-903-029**

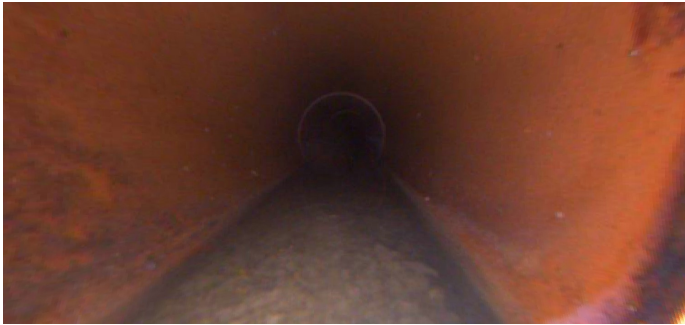
Code:	<b>MWL</b>
Description:	<b>Water Level</b>

Distance (ft):	<b>.0</b>
Structural Grade:	<b>0</b>
O&M Grade:	<b>0</b>
Clock Start/From:	
Clock To:	
1st Value:	
2nd Value:	
Value Percent:	<b>10.000</b>
Continuous Index:	
Within 8" of Joint:	<b>NO</b>
Remarks:

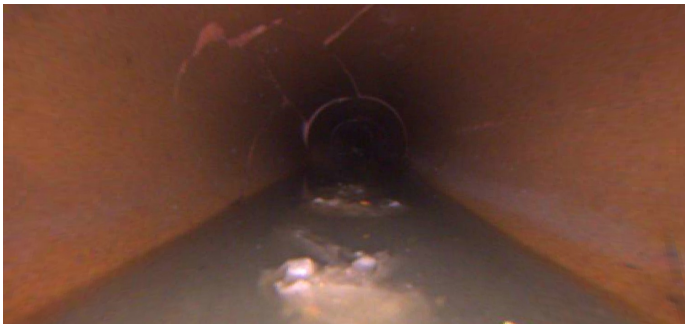
Code:	<b>CM</b>
Description:	<b>Crack Multiple</b>

Distance (ft):	<b>28.2</b>
Structural Grade:	<b>3</b>
O&M Grade:	<b>0</b>
Clock Start/From:	<b>8</b>
Clock To:	<b>3</b>
1st Value:	
2nd Value:	
Value Percent:	
Continuous Index:	
Within 8" of Joint:	<b>YES</b>
Remarks:

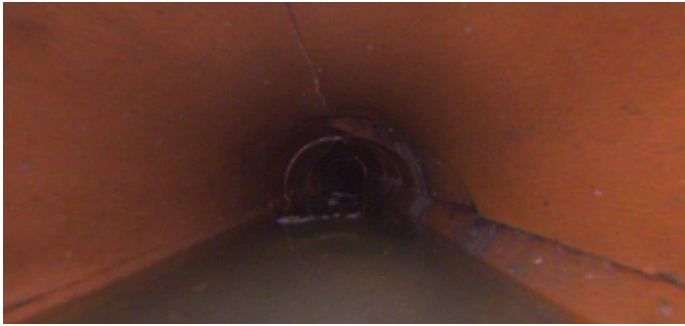
Code: **FM**  
Description: **Fracture Multiple**

Distance (ft): **31.4**  
Structural Grade: **4**  
O&M Grade: **0**  
Clock Start/From: **12**  
Clock To: **4**  
1st Value:  
2nd Value:  
Value Percent:  
Continuous Index:  
Within 8" of Joint: **YES**  
Remarks:

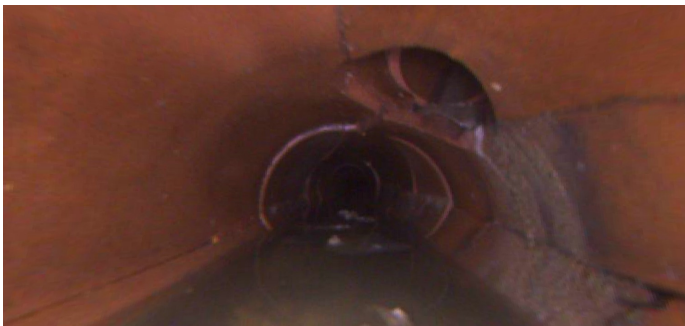
Code: **TFD**  
Description: **Tap Factory Defective**

Distance (ft): **32.5**  
Structural Grade: **0**  
O&M Grade: **2**  
Clock Start/From: **1**  
Clock To:  
1st Value: **4.000**  
2nd Value:  
Value Percent:  
Continuous Index:  
Within 8" of Joint:  
Remarks: **FRACTURES AROUND TAP**

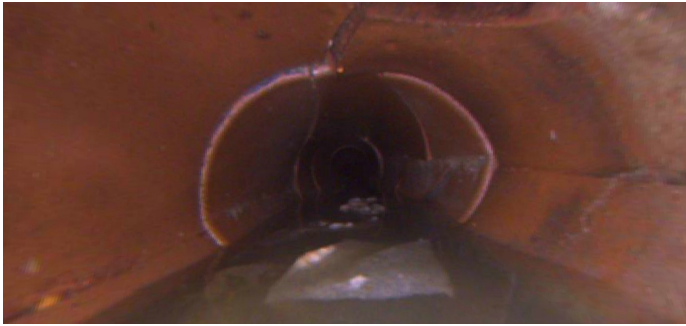
Code: **B**  
Description: **Broken**

Distance (ft): **33.1**  
Structural Grade: **5**  
O&M Grade: **0**  
Clock Start/From: **7**  
Clock To: **5**  
1st Value:  
2nd Value:  
Value Percent:  
Continuous Index:  
Within 8" of Joint: **YES**  
Remarks:

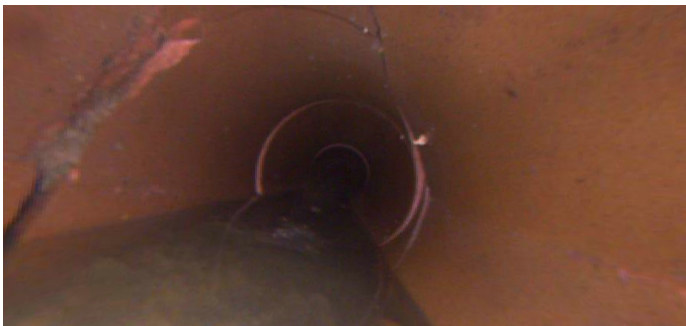
Code: **B**  
Description: **Broken**

Distance (ft): **35.5**  
Structural Grade: **5**  
O&M Grade: **0**  
Clock Start/From: **7**  
Clock To: **5**  
1st Value:  
2nd Value:  
Value Percent:  
Continuous Index:  
Within 8" of Joint: **YES**  
Remarks:

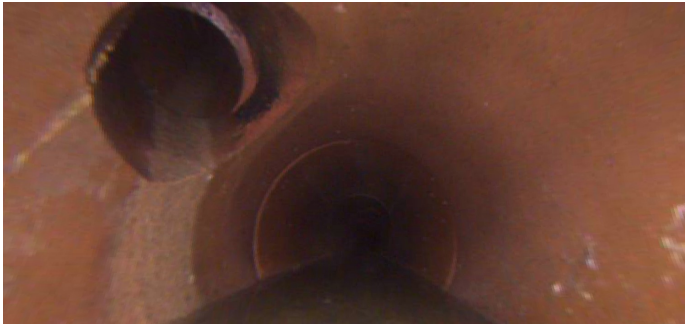
Code: **TF**  
Description: **Tap Factory**

Distance (ft): **86.3**  
Structural Grade: **0**  
O&M Grade: **0**  
Clock Start/From: **10**  
Clock To:  
1st Value: **4.000**  
2nd Value:  
Value Percent:  
Continuous Index:  
Within 8" of Joint:  
Remarks:

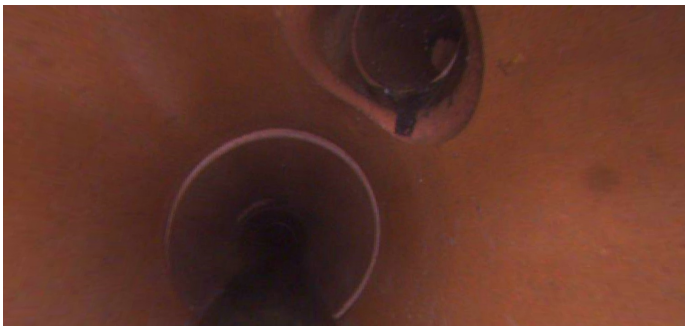
Code: **TF**  
Description: **Tap Factory**

Distance (ft): **92.4**  
Structural Grade: **0**  
O&M Grade: **0**  
Clock Start/From: **2**  
Clock To:  
1st Value: **4.000**  
2nd Value:  
Value Percent:  
Continuous Index:  
Within 8" of Joint:  
Remarks:

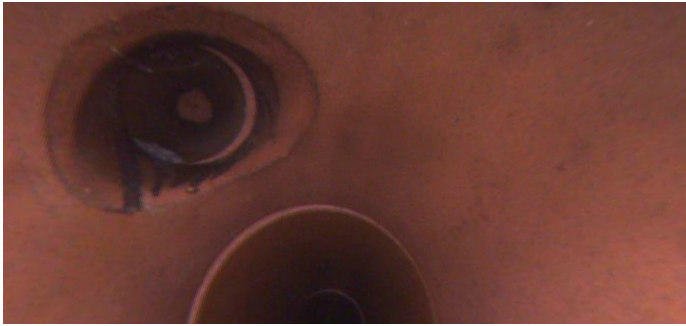
Code: **TF**  
Description: **Tap Factory**

Distance (ft): **95.4**  
Structural Grade: **0**  
O&M Grade: **0**  
Clock Start/From: **11**  
Clock To:  
1st Value: **4.000**  
2nd Value:  
Value Percent:  
Continuous Index:  
Within 8" of Joint:  
Remarks:

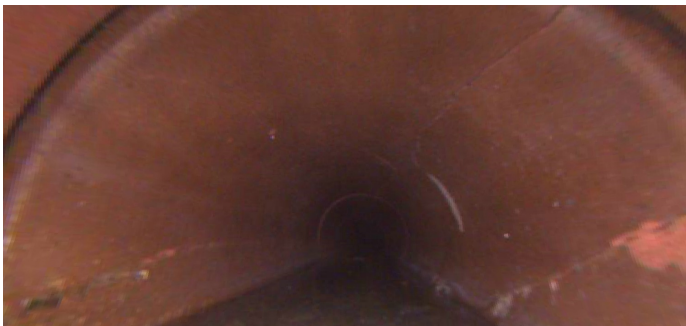
Code: **FM**  
Description: **Fracture Multiple**

Distance (ft): **144.7**  
Structural Grade: **4**  
O&M Grade: **0**  
Clock Start/From: **8**  
Clock To: **5**  
1st Value:  
2nd Value:  
Value Percent:  
Continuous Index:  
Within 8" of Joint: **YES**  
Remarks:

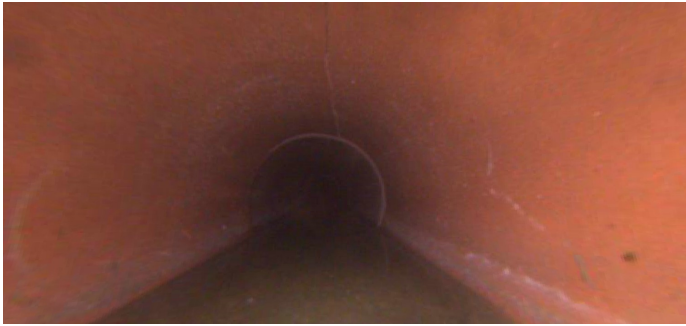
Code: **CL**  
Description: **Crack Longitudinal**

Distance (ft): **149.0**  
Structural Grade: **2**  
O&M Grade: **0**  
Clock Start/From: **1**  
Clock To:  
1st Value:  
2nd Value:  
Value Percent:  
Continuous Index:  
Within 8" of Joint: **YES**  
Remarks:

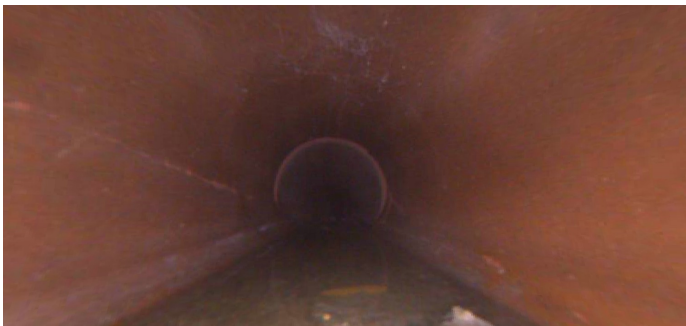
Code: **CL**  
Description: **Crack Longitudinal**

Distance (ft): **154.4**  
Structural Grade: **2**  
O&M Grade: **0**  
Clock Start/From: **9**  
Clock To:  
1st Value:  
2nd Value:  
Value Percent:  
Continuous Index:  
Within 8" of Joint: **YES**  
Remarks:

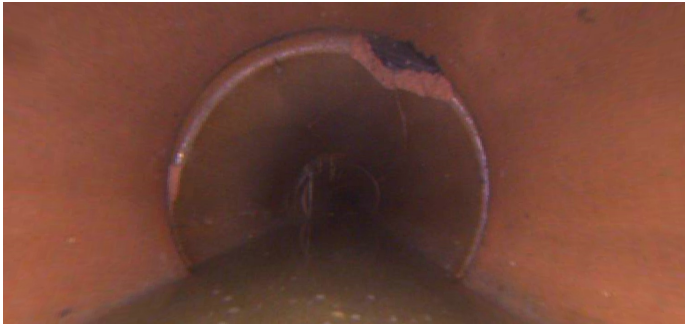
Code: **HSV**  
Description: **Hole Soil Visible**

Distance (ft): **165.3**  
Structural Grade: **5**  
O&M Grade: **0**  
Clock Start/From: **1**  
Clock To:  
1st Value:  
2nd Value:  
Value Percent:  
Continuous Index:  
Within 8" of Joint: **YES**  
Remarks:

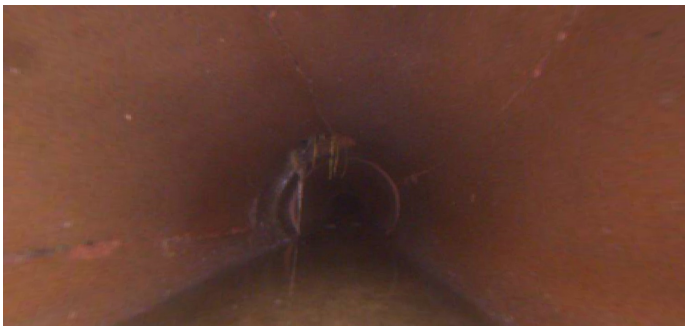
Code: **CM**  
Description: **Crack Multiple**

Distance (ft): **166.4**  
Structural Grade: **3**  
O&M Grade: **0**  
Clock Start/From: **8**  
Clock To: **1**  
1st Value:  
2nd Value:  
Value Percent:  
Continuous Index:  
Within 8" of Joint:  
Remarks:

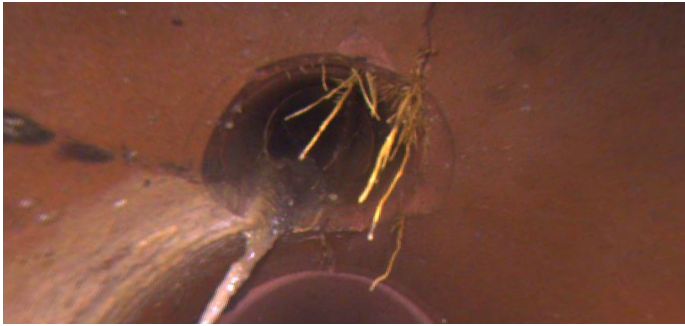
Code: **TFD**  
Description: **Tap Factory Defective**

Distance (ft): **168.0**  
Structural Grade: **0**  
O&M Grade: **2**  
Clock Start/From: **11**  
Clock To:  
1st Value: **4.000**  
2nd Value:  
Value Percent:  
Continuous Index:  
Within 8" of Joint:  
Remarks: **RF COMING FROM FRACTURES  
AROUND TAP**

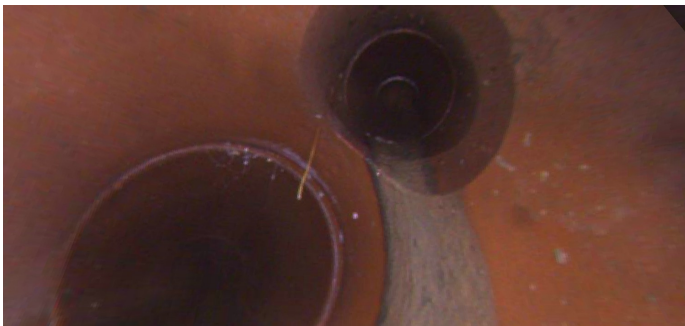
Code: **TF**  
Description: **Tap Factory**

Distance (ft): **176.9**  
Structural Grade: **0**  
O&M Grade: **0**  
Clock Start/From: **1**  
Clock To:  
1st Value: **4.000**  
2nd Value:  
Value Percent:  
Continuous Index:  
Within 8" of Joint:  
Remarks:

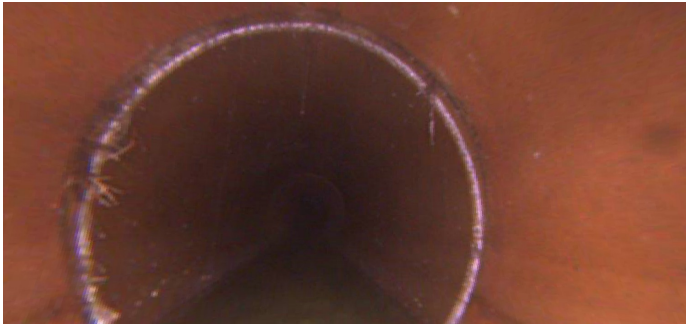
Code: **RFJ**  
Description: **Roots Fine Joint**

Distance (ft): **186.5**  
Structural Grade: **0**  
O&M Grade: **1**  
Clock Start/From: **7**  
Clock To: **2**  
1st Value:  
2nd Value:  
Value Percent:  
Continuous Index:  
Within 8" of Joint: **YES**  
Remarks:

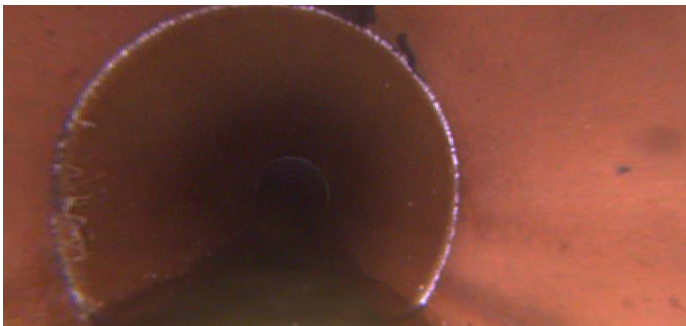
Code: **RFJ**  
Description: **Roots Fine Joint**

Distance (ft): **192.4**  
Structural Grade: **0**  
O&M Grade: **1**  
Clock Start/From: **8**  
Clock To: **9**  
1st Value:  
2nd Value:  
Value Percent:  
Continuous Index:  
Within 8" of Joint: **YES**  
Remarks:

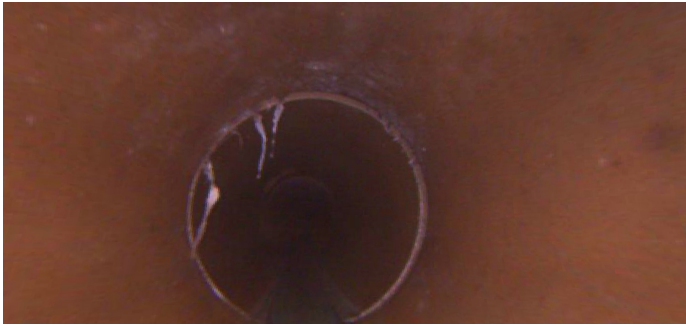
Code: **RFJ**  
Description: **Roots Fine Joint**

Distance (ft): **201.0**  
Structural Grade: **0**  
O&M Grade: **1**  
Clock Start/From: **8**  
Clock To: **10**  
1st Value:  
2nd Value:  
Value Percent:  
Continuous Index:  
Within 8" of Joint: **YES**  
Remarks:

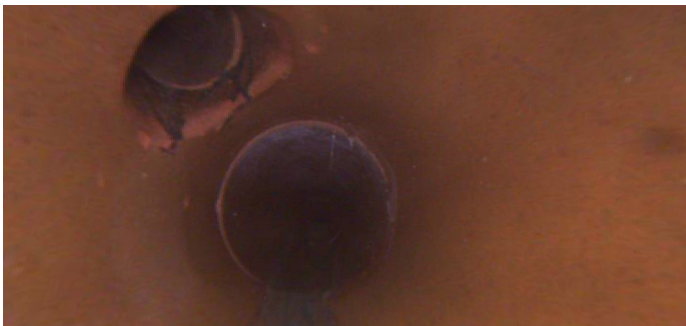
Code: **TF**  
Description: **Tap Factory**

Distance (ft): **203.6**  
Structural Grade: **0**  
O&M Grade: **0**  
Clock Start/From: **10**  
Clock To:  
1st Value: **4.000**  
2nd Value:  
Value Percent:  
Continuous Index:  
Within 8" of Joint:  
Remarks:

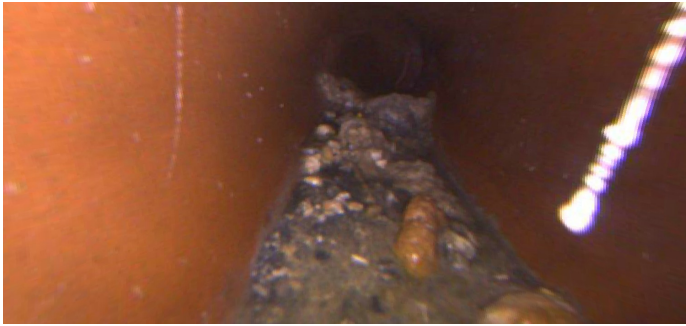
Code: **DSZ**  
Description: **Deposits Settled Other**

Distance (ft): **211.1**  
Structural Grade: **0**  
O&M Grade: **2**  
Clock Start/From: **6**  
Clock To:  
1st Value:  
2nd Value:  
Value Percent: **10.000**  
Continuous Index:  
Within 8" of Joint: **YES**  
Remarks: **TOILET WASTE**

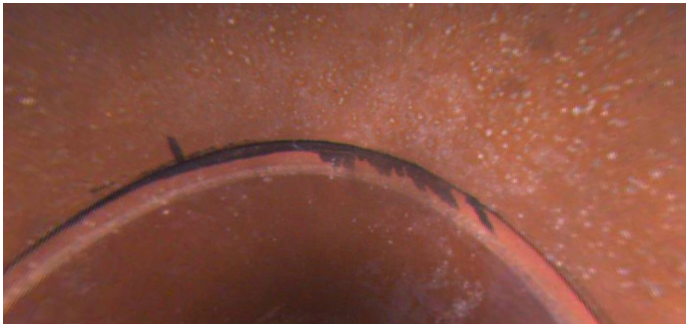
Code: **AMH**  
Description: **Manhole**

Distance (ft): **217.5**  
Structural Grade: **0**  
O&M Grade: **0**  
Clock Start/From:  
Clock To:  
1st Value:  
2nd Value:  
Value Percent:  
Continuous Index:  
Within 8" of Joint: **NO**  
Remarks: **M-903-030**
