Profile/Photo Observation Report

Date:	04/04/2018	Weather:		Coding:	PACP 6.0
Pipe Length (ft):	210.9	Owner:	NA	Pre Clean:	Not Known
P.O.#:		Surveyor:	Jen Costello	PSR:	P-903-033-032
Customer:		Clean Date:	01/01/1900	Shape:	C

Street:	N HOBART RD & E 38TH PL	Flow Control:	Not Controlled
City:	Hobart, IN	Year Renewed:	
Location:	Other	Tape/Media #:	
Purpose:	Not Known	Dia/Height:	12"
Use:	Sanitary	Material:	VCP
Drain Area:	NA	Lining:	
Category:	NA		
Comment:			
Location Details:		Direction of Survey:	Downstream
US MH:	M-903-032	DS MH:	M-903-033
		Total Length Surveyed (ft):	193.4

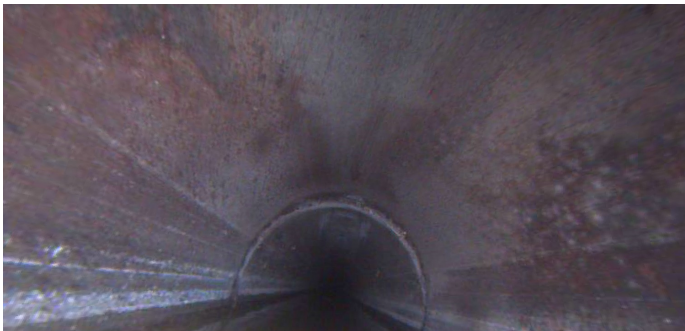
Code: **AMH**
Description: **Manhole**

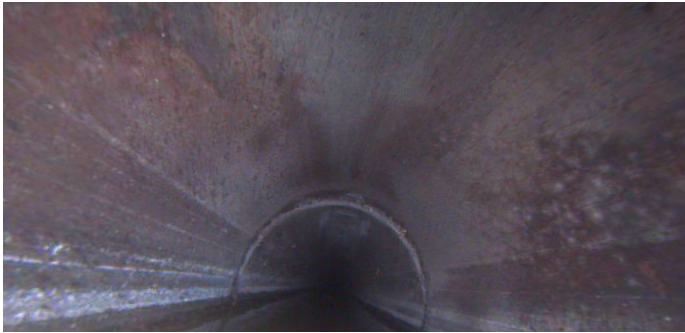
Code:	MWL
Description:	Water Level

Distance (ft):	.0
Structural Grade:	0
O&M Grade:	0
Clock Start/From:	
Clock To:	
1st Value:	
2nd Value:	
Value Percent:	20.000
Continuous Index:	
Within 8" of Joint:	NO
Remarks:

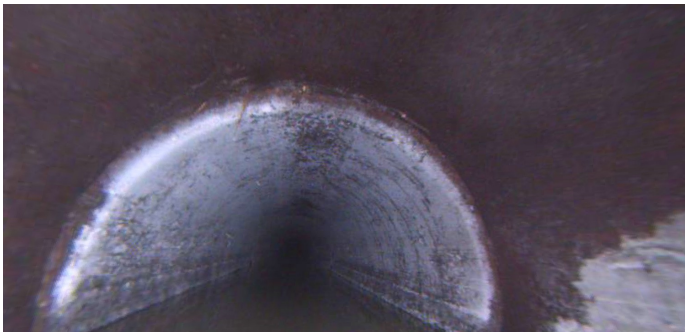
Code:	RFJ
Description:	Roots Fine Joint

Distance (ft):	20.4
Structural Grade:	0
O&M Grade:	1
Clock Start/From:	12
Clock To:	
1st Value:	
2nd Value:	
Value Percent:	
Continuous Index:	
Within 8" of Joint:	YES
Remarks:

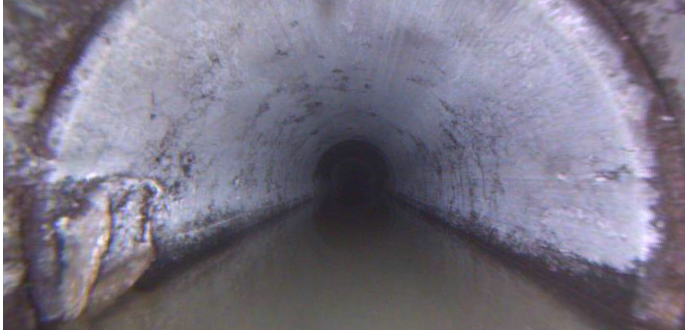
Code: **DAE**
Description: **Deposits Attached Encrustation**

Distance (ft): **63.0**
Structural Grade: **0**
O&M Grade: **2**
Clock Start/From: **8**
Clock To: **9**
1st Value:
2nd Value:
Value Percent: **5.000**
Continuous Index:
Within 8" of Joint: **YES**
Remarks:

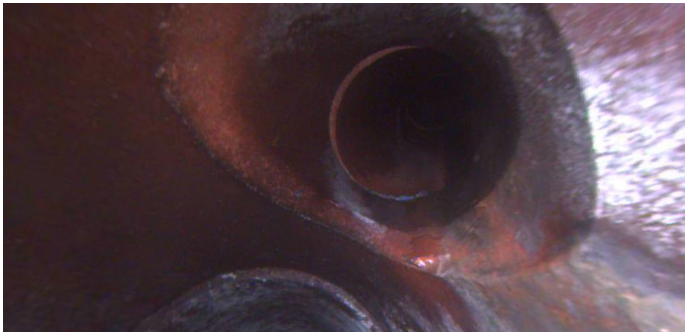
Code: **TF**
Description: **Tap Factory**

Distance (ft): **92.7**
Structural Grade: **0**
O&M Grade: **0**
Clock Start/From: **2**
Clock To:
1st Value: **4.000**
2nd Value:
Value Percent:
Continuous Index:
Within 8" of Joint:
Remarks:

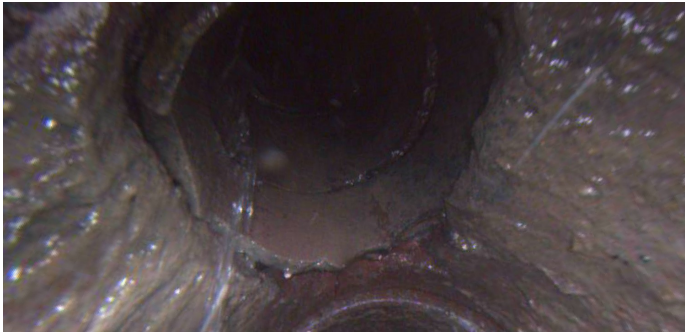
Code: **TBA**
Description: **Tap Break-in Active**

Distance (ft): **147.1**
Structural Grade: **0**
O&M Grade: **0**
Clock Start/From: **11**
Clock To:
1st Value: **4.000**
2nd Value:
Value Percent:
Continuous Index:
Within 8" of Joint:
Remarks:

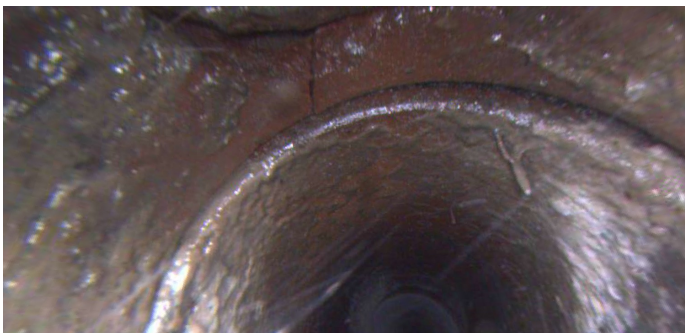
Code: **FL**
Description: **Fracture Longitudinal**

Distance (ft): **147.6**
Structural Grade: **3**
O&M Grade: **0**
Clock Start/From: **11**
Clock To:
1st Value:
2nd Value:
Value Percent:
Continuous Index:
Within 8" of Joint: **YES**
Remarks:

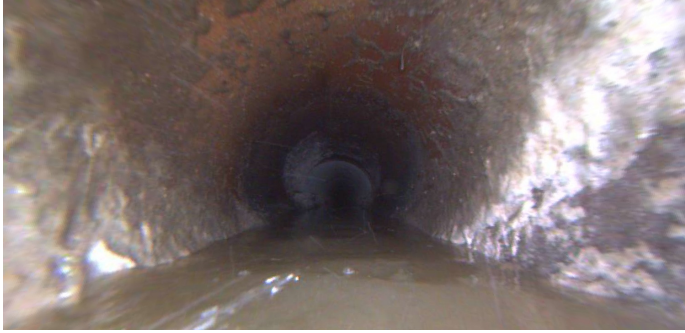
Code: **DAGS**
Description: **Deposits Attached Grease**

Distance (ft): **148.1**
Structural Grade: **0**
O&M Grade: **2**
Clock Start/From: **8**
Clock To: **4**
1st Value:
2nd Value:
Value Percent: **5.000**
Continuous Index:
Within 8" of Joint: **NO**
Remarks:

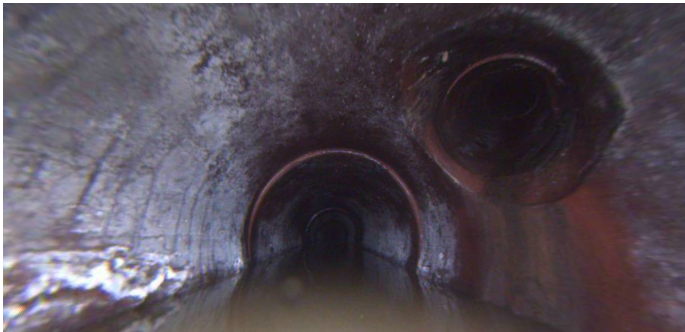
Code: **TF**
Description: **Tap Factory**

Distance (ft): **164.9**
Structural Grade: **0**
O&M Grade: **0**
Clock Start/From: **2**
Clock To:
1st Value: **4.000**
2nd Value:
Value Percent:
Continuous Index:
Within 8" of Joint:
Remarks:

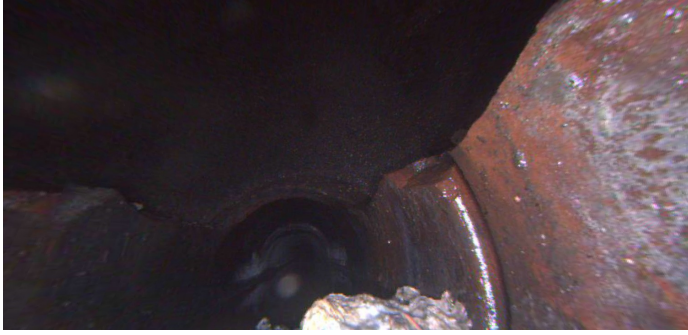
Code:	AMH
Description:	Manhole
Distance (ft):	193.4
Structural Grade:	0
O&M Grade:	0
Clock Start/From:	
Clock To:	
1st Value:	
2nd Value:	
Value Percent:	
Continuous Index:	
Within 8" of Joint:	NO
Remarks:	M-903-033
