Profile/Photo Observation Report

Street:	N Hobart St.	Flow Control:	Not Controlled
City:	Hobart, IN	Year Renewed:	
Location:	Other	Tape/Media #:	
Purpose:	Not Known	Dia/Height:	12"
Use:	Sanitary	Material:	VCP
Drain Area:	NA	Lining:	
Category:	NA		
Comment:

Location Details:		Direction of Survey:	Downstream
US MH:	M-903-032	DS MH:	M-903-033
		Total Length Surveyed (ft):	193.4

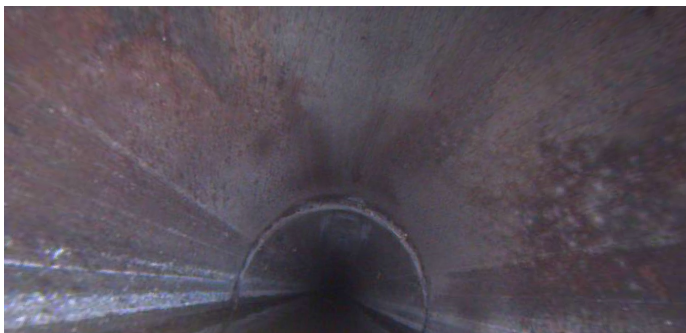
Code: **AMH**
Description: **Manhole**

Distance (ft): **.0**
Structural Grade: **0**
O&M Grade: **0**
Clock Start/From:
Clock To:
1st Value:
2nd Value:
Value Percent:
Continuous Index:
Within 8" of Joint: **NO**
Remarks: **M-903-032**

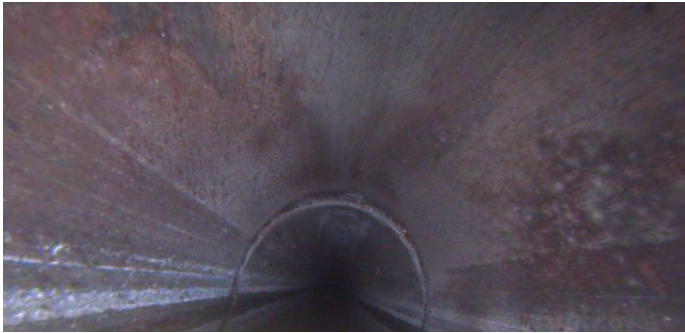
Code: **MWL**
Description: **Water Level**

Distance (ft): **.0**
Structural Grade: **0**
O&M Grade: **0**
Clock Start/From:
Clock To:
1st Value:
2nd Value:
Value Percent: **20.000**
Continuous Index:
Within 8" of Joint: **NO**
Remarks:

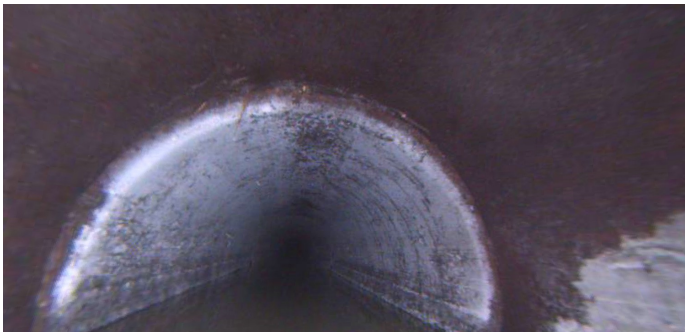
Code: **RFJ**
Description: **Roots Fine Joint**

Distance (ft): **20.4**
Structural Grade: **0**
O&M Grade: **1**
Clock Start/From: **12**
Clock To:
1st Value:
2nd Value:
Value Percent:
Continuous Index:
Within 8" of Joint: **YES**
Remarks:

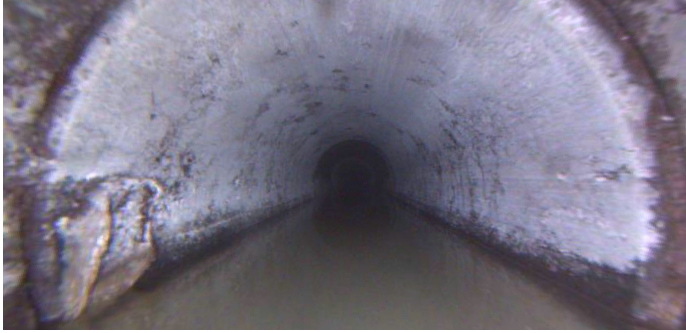
Code: **DAE**
Description: **Deposits Attached Encrustation**

Distance (ft): **63.0**
Structural Grade: **0**
O&M Grade: **2**
Clock Start/From: **8**
Clock To: **9**
1st Value:
2nd Value:
Value Percent: **5.000**
Continuous Index:
Within 8" of Joint: **YES**
Remarks:

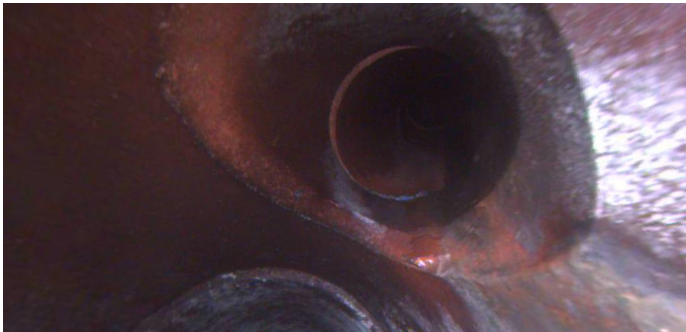
Code: **TF**
Description: **Tap Factory**

Distance (ft): **92.7**
Structural Grade: **0**
O&M Grade: **0**
Clock Start/From: **2**
Clock To:
1st Value: **4.000**
2nd Value:
Value Percent:
Continuous Index:
Within 8" of Joint:
Remarks:

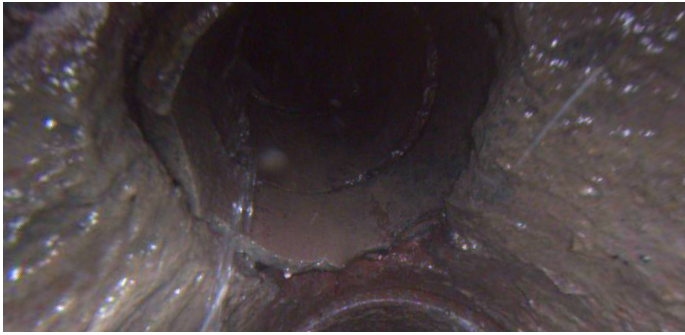
Code: **TBA**
Description: **Tap Break-in Active**

Distance (ft): **147.1**
Structural Grade: **0**
O&M Grade: **0**
Clock Start/From: **11**
Clock To:
1st Value: **4.000**
2nd Value:
Value Percent:
Continuous Index:
Within 8" of Joint:
Remarks:

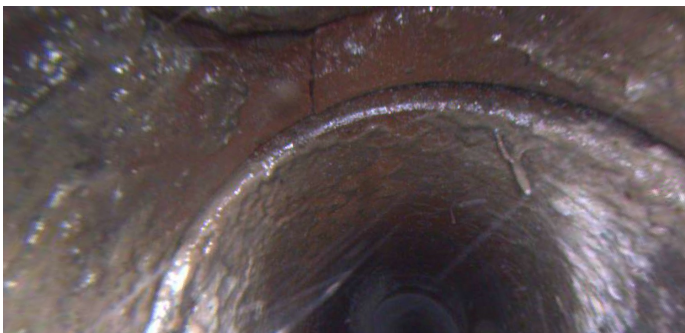
Code: **FL**
Description: **Fracture Longitudinal**

Distance (ft): **147.6**
Structural Grade: **3**
O&M Grade: **0**
Clock Start/From: **11**
Clock To:
1st Value:
2nd Value:
Value Percent:
Continuous Index:
Within 8" of Joint: **YES**
Remarks:

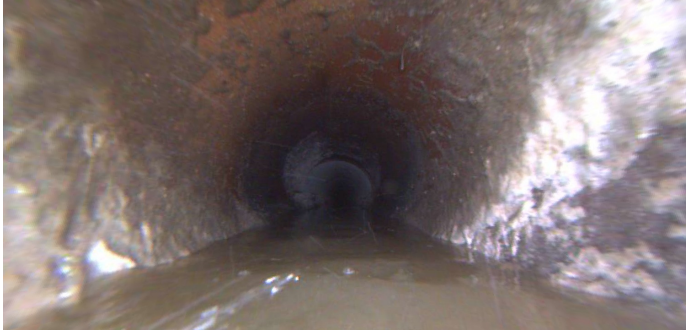
Code: **DAGS**
Description: **Deposits Attached Grease**

Distance (ft): **148.1**
Structural Grade: **0**
O&M Grade: **2**
Clock Start/From: **8**
Clock To: **4**
1st Value:
2nd Value:
Value Percent: **5.000**
Continuous Index:
Within 8" of Joint: **NO**
Remarks:

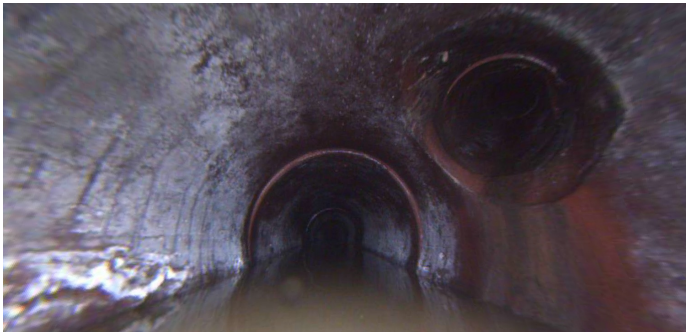
Code: **TF**
Description: **Tap Factory**

Distance (ft): **164.9**
Structural Grade: **0**
O&M Grade: **0**
Clock Start/From: **2**
Clock To:
1st Value: **4.000**
2nd Value:
Value Percent:
Continuous Index:
Within 8" of Joint:
Remarks:

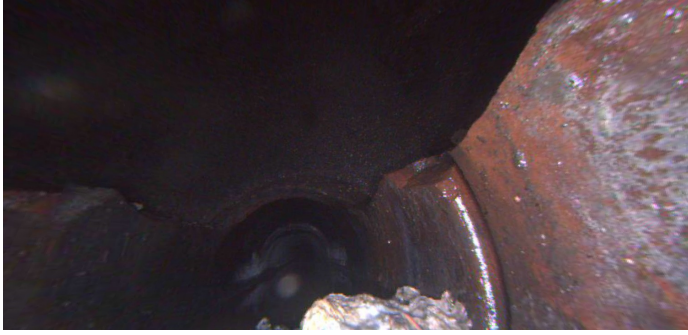
Code:	AMH
Description:	Manhole
Distance (ft):	193.4
Structural Grade:	0
O&M Grade:	0
Clock Start/From:	
Clock To:	
1st Value:	
2nd Value:	
Value Percent:	
Continuous Index:	
Within 8" of Joint:	NO
Remarks:	M-903-033
