Profile/Photo Observation Report

Date:	03/22/2018	Weather:		Coding:	PACP 6.0
Pipe Length (ft):	216.2	Owner:	NA	Pre Clean:	Not Known
P.O.#:		Surveyor:	Selasie Honu	PSR:	P-903-035-034
Customer:		Clean Date:	01/01/1900	Shape:	C

Street:	N HOBART RD	Flow Control:	Not Controlled
City:	Hobart, IN	Year Renewed:	
Location:	Other	Tape/Media #:	
Purpose:	Not Known	Dia/Height:	10"
Use:	Sanitary	Material:	VCP
Drain Area:	NA	Lining:	
Category:	NA		
Comment:

Location Details:		Direction of Survey:	Downstream
US MH:	M-903-034	DS MH:	M-903-035
		Total Length Surveyed (ft):	45.3

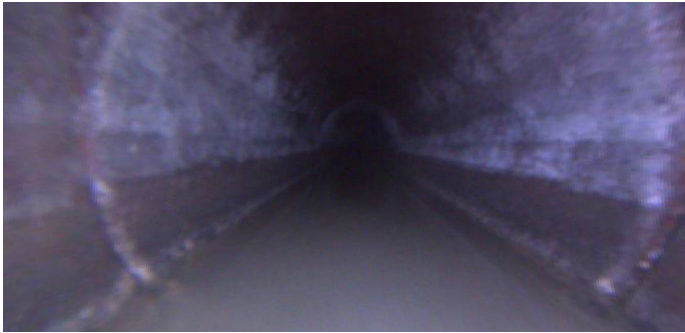
Code:	MWL
Description:	Water Level

Distance (ft):	.0
Structural Grade:	0
O&M Grade:	0
Clock Start/From:	
Clock To:	
1st Value:	
2nd Value:	
Value Percent:	5.000
Continuous Index:	
Within 8" of Joint:	NO
Remarks:

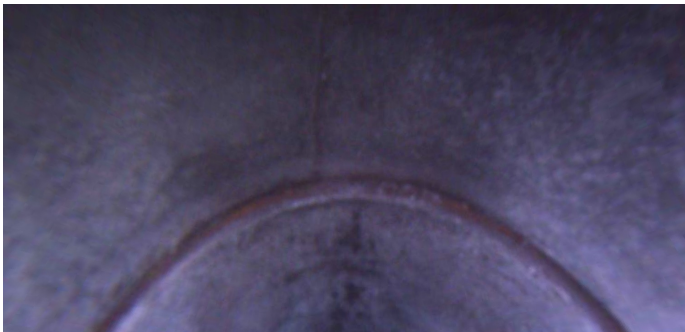
Code:	FM
Description:	Fracture Multiple

Distance (ft):	13.0
Structural Grade:	4
O&M Grade:	0
Clock Start/From:	10
Clock To:	12
1st Value:	
2nd Value:	
Value Percent:	
Continuous Index:	
Within 8" of Joint:	
Remarks:

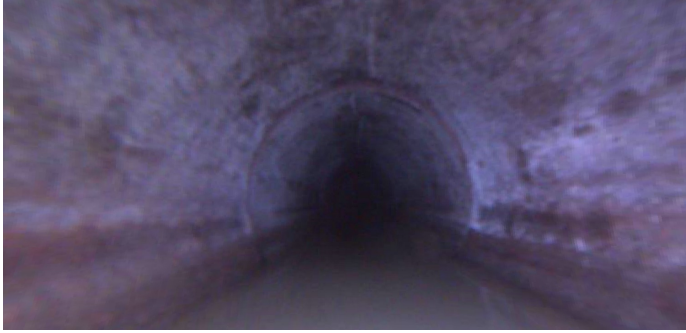
Code: **FL**
Description: **Fracture Longitudinal**

Distance (ft): **24.0**
Structural Grade: **3**
O&M Grade: **0**
Clock Start/From: **12**
Clock To:
1st Value:
2nd Value:
Value Percent:
Continuous Index:
Within 8" of Joint: **YES**
Remarks:

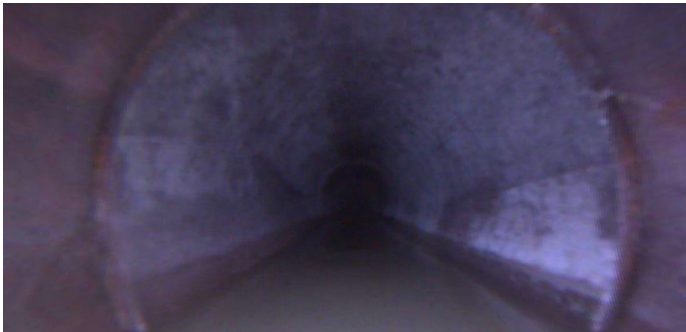
Code: **FL**
Description: **Fracture Longitudinal**

Distance (ft): **30.6**
Structural Grade: **3**
O&M Grade: **0**
Clock Start/From: **3**
Clock To:
1st Value:
2nd Value:
Value Percent:
Continuous Index:
Within 8" of Joint: **YES**
Remarks:

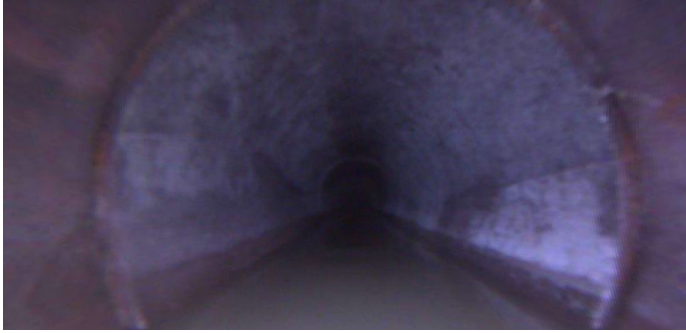
Code: **FL**
Description: **Fracture Longitudinal**

Distance (ft): **30.6**
Structural Grade: **3**
O&M Grade: **0**
Clock Start/From: **3**
Clock To:
1st Value:
2nd Value:
Value Percent:
Continuous Index:
Within 8" of Joint: **YES**
Remarks:

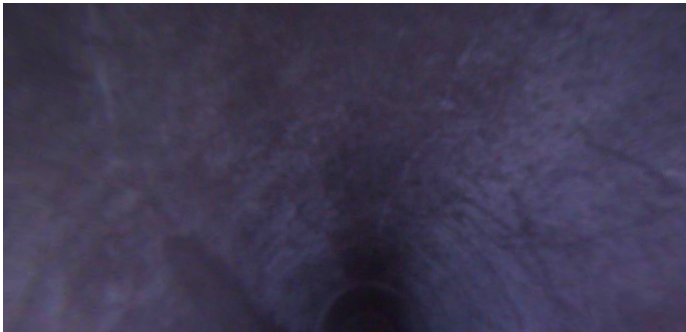
Code: **FL**
Description: **Fracture Longitudinal**

Distance (ft): **31.2**
Structural Grade: **3**
O&M Grade: **0**
Clock Start/From: **12**
Clock To:
1st Value:
2nd Value:
Value Percent:
Continuous Index:
Within 8" of Joint:
Remarks:

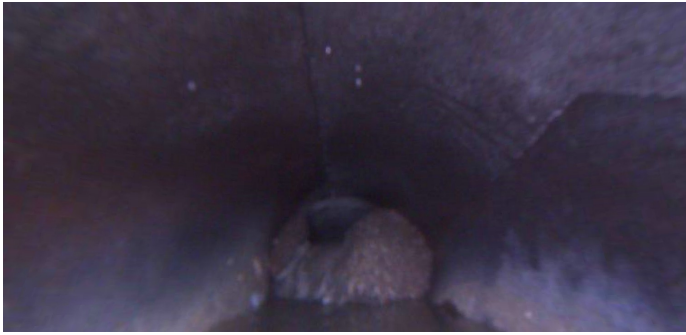
Code: **FM**
Description: **Fracture Multiple**

Distance (ft): **43.3**
Structural Grade: **4**
O&M Grade: **0**
Clock Start/From: **8**
Clock To: **4**
1st Value:
2nd Value:
Value Percent:
Continuous Index:
Within 8" of Joint:
Remarks:

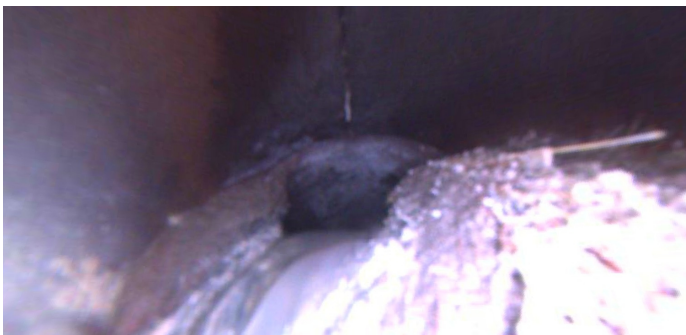
Code: **RBJ**
Description: **Roots Ball Joint**

Distance (ft): **44.8**
Structural Grade: **0**
O&M Grade: **4**
Clock Start/From: **12**
Clock To: **12**
1st Value:
2nd Value:
Value Percent: **90.000**
Continuous Index:
Within 8" of Joint: **YES**
Remarks:

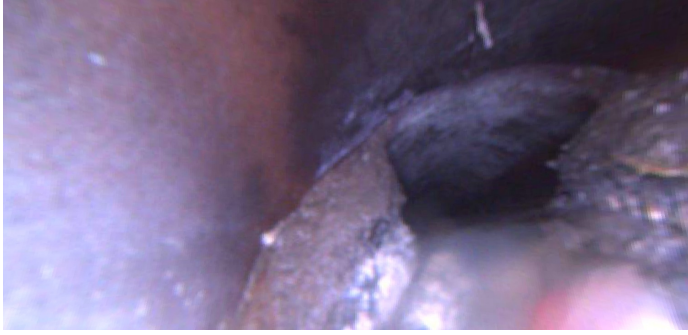
Code:	MSA
Description:	Abandoned Survey
Distance (ft):	45.3
Structural Grade:	0
O&M Grade:	0
Clock Start/From:	
Clock To:	
1st Value:	
2nd Value:	
Value Percent:	
Continuous Index:	
Within 8" of Joint:	NO
Remarks:	root ball infiltration
