Profile/Photo Observation Report

Date:	03/22/2018	Weather:		Coding:	PACP 6.0
Pipe Length (ft):	216.2	Owner:	NA	Pre Clean:	Not Known
P.O.#:		Surveyor:	Selasie Honu	PSR:	P-903-035-034
Customer:		Clean Date:	01/01/1900	Shape:	C

Street:	n hobart rd	Flow Control:	Not Controlled
City:	Hobart, IN	Year Renewed:	
Location:	Other	Tape/Media #:	
Purpose:	Not Known	Dia/Height:	10"
Use:	Sanitary	Material:	VCP
Drain Area:	NA	Lining:	
Category:	NA		
Comment:

Location Details:		Direction of Survey:	Downstream
US MH:	M-903-034	DS MH:	M-903-035
		Total Length Surveyed (ft):	45.3

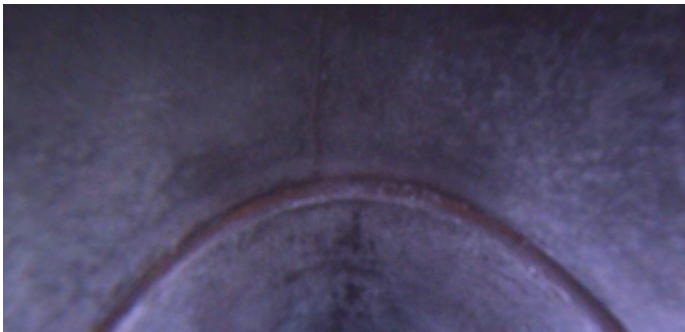
Code:	FM
Description:	Fracture Multiple

Distance (ft):	13.0
Structural Grade:	4
O&M Grade:	0
Clock Start/From:	10
Clock To:	12
1st Value:	
2nd Value:	
Value Percent:	
Continuous Index:	
Within 8" of Joint:	
Remarks:

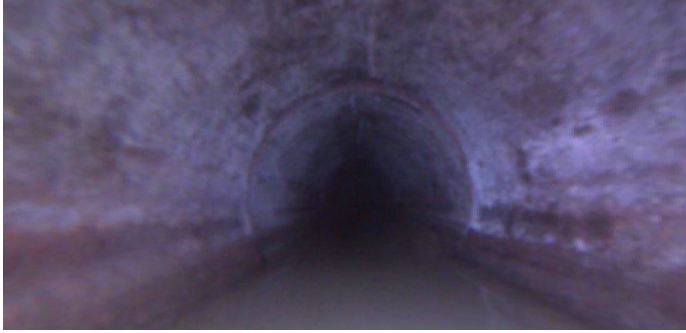
Code: **FL**
Description: **Fracture Longitudinal**

Distance (ft): **24.0**
Structural Grade: **3**
O&M Grade: **0**
Clock Start/From: **12**
Clock To:
1st Value:
2nd Value:
Value Percent:
Continuous Index:
Within 8" of Joint: **YES**
Remarks:

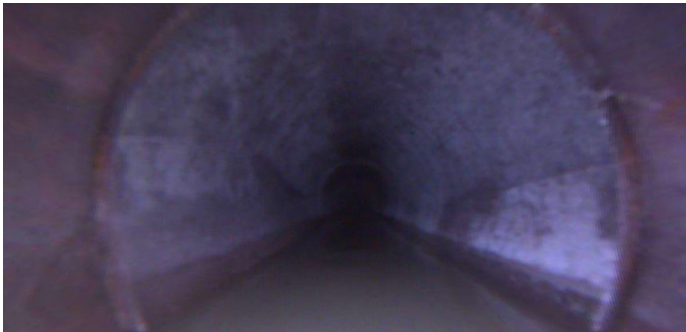
Code: **FL**
Description: **Fracture Longitudinal**

Distance (ft): **30.6**
Structural Grade: **3**
O&M Grade: **0**
Clock Start/From: **3**
Clock To:
1st Value:
2nd Value:
Value Percent:
Continuous Index:
Within 8" of Joint: **YES**
Remarks:

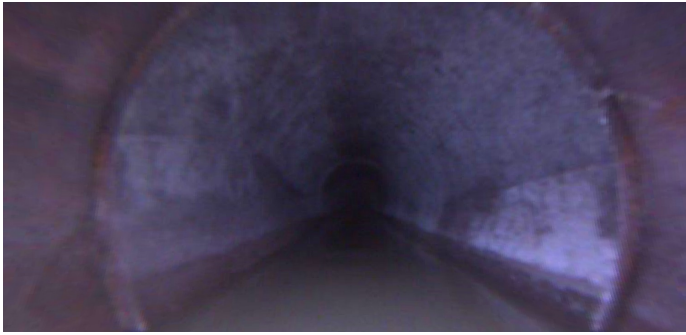
Code: **FL**
Description: **Fracture Longitudinal**

Distance (ft): **30.6**
Structural Grade: **3**
O&M Grade: **0**
Clock Start/From: **3**
Clock To:
1st Value:
2nd Value:
Value Percent:
Continuous Index:
Within 8" of Joint: **YES**
Remarks:

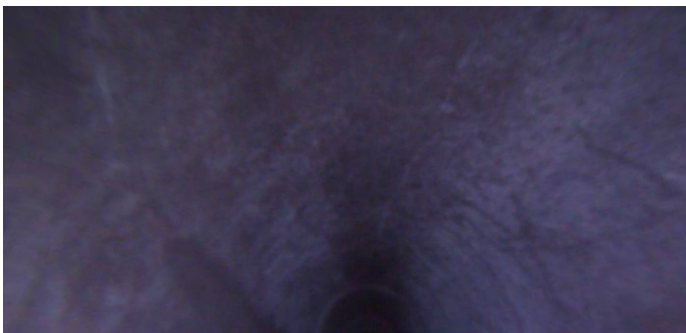
Code: **FL**
Description: **Fracture Longitudinal**

Distance (ft): **31.2**
Structural Grade: **3**
O&M Grade: **0**
Clock Start/From: **12**
Clock To:
1st Value:
2nd Value:
Value Percent:
Continuous Index:
Within 8" of Joint:
Remarks:

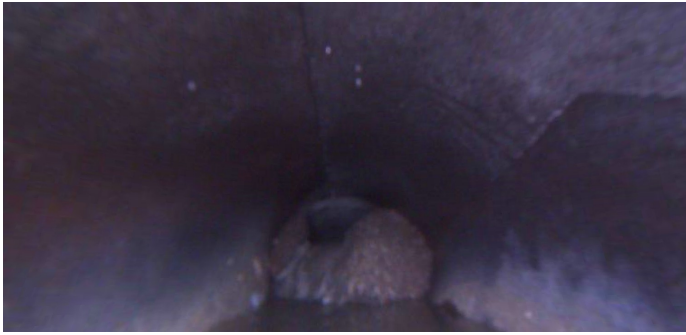
Code: **FM**
Description: **Fracture Multiple**

Distance (ft): **43.3**
Structural Grade: **4**
O&M Grade: **0**
Clock Start/From: **8**
Clock To: **4**
1st Value:
2nd Value:
Value Percent:
Continuous Index:
Within 8" of Joint:
Remarks:

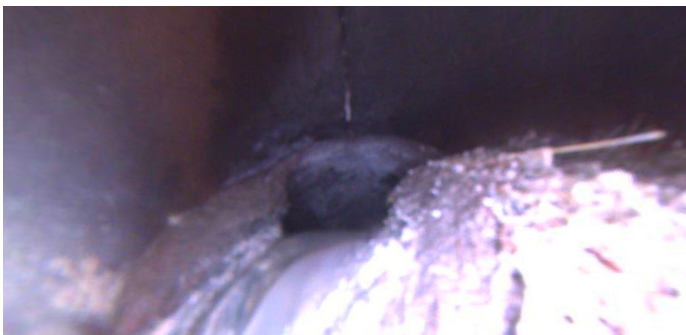
Code: **RBJ**
Description: **Roots Ball Joint**

Distance (ft): **44.8**
Structural Grade: **0**
O&M Grade: **4**
Clock Start/From: **12**
Clock To: **12**
1st Value:
2nd Value:
Value Percent: **90.000**
Continuous Index:
Within 8" of Joint: **YES**
Remarks:

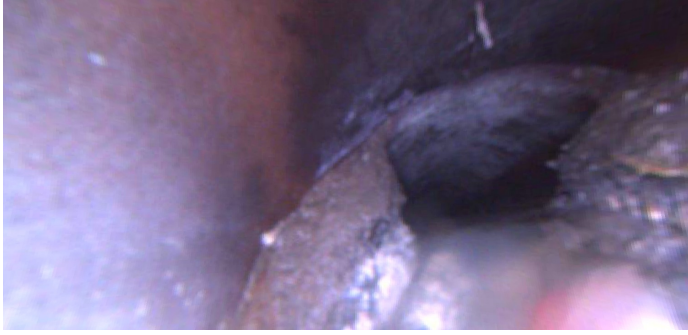
Code:	MSA
Description:	Abandoned Survey
Distance (ft):	45.3
Structural Grade:	0
O&M Grade:	0
Clock Start/From:	
Clock To:	
1st Value:	
2nd Value:	
Value Percent:	
Continuous Index:	
Within 8" of Joint:	NO
Remarks:	root ball infiltration
