Profile/Photo Observation Report

Street:	n hobart rd	Flow Control:	Not Controlled
City:	Hobart, IN	Year Renewed:	
Location:	Other	Tape/Media #:	
Purpose:	Not Known	Dia/Height:	10"
Use:	Sanitary	Material:	PVC
Drain Area:	NA	Lining:	
Category:	NA		
Comment:

Location Details:		Direction of Survey:	Downstream
US MH:	M-903-034	DS MH:	M-903-050
		Total Length Surveyed (ft):	36.2

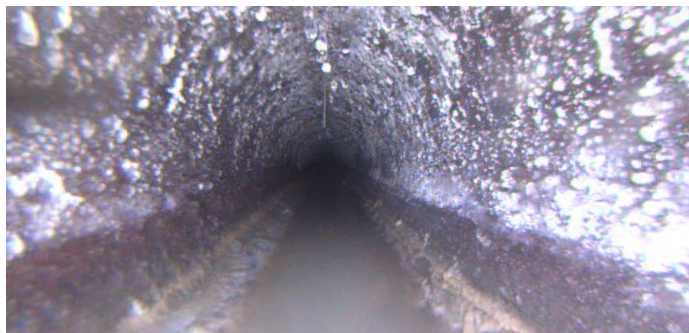
Code: **DAGS**
Description: **Deposits Attached Grease**

Distance (ft): **.0**
Structural Grade: **0**
O&M Grade: **2**
Clock Start/From: **8**
Clock To: **4**
1st Value:
2nd Value:
Value Percent: **5.000**
Continuous Index: **S01**
Within 8" of Joint: **NO**
Remarks:

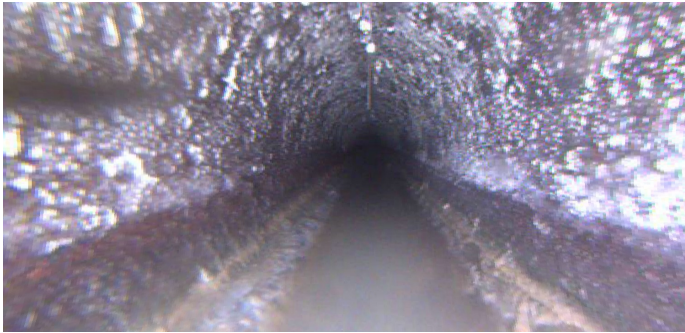
Code:	AMH
Description:	Manhole

Distance (ft):	.0
Structural Grade:	0
O&M Grade:	0
Clock Start/From:	
Clock To:	
1st Value:	
2nd Value:	
Value Percent:	
Continuous Index:	
Within 8" of Joint:	NO
Remarks:	M-903-034

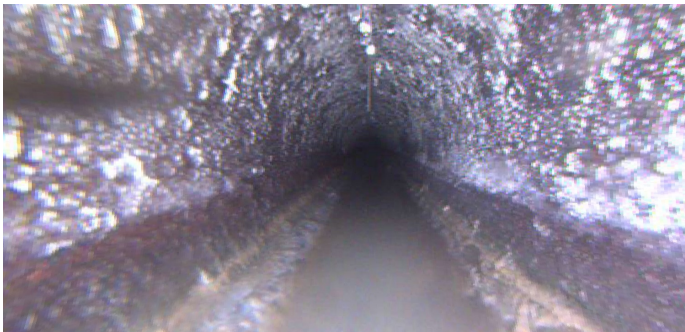
Code:	MWL
Description:	Water Level

Distance (ft):	.0
Structural Grade:	0
O&M Grade:	0
Clock Start/From:	
Clock To:	
1st Value:	
2nd Value:	
Value Percent:	5.000
Continuous Index:	
Within 8" of Joint:	NO
Remarks:

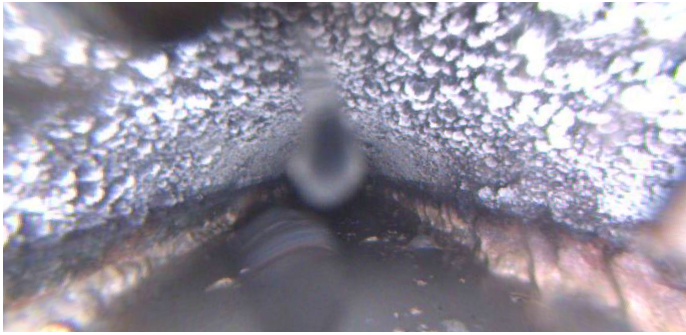
Code: **DAGS**
Description: **Deposits Attached Grease**

Distance (ft): **36.2**
Structural Grade: **0**
O&M Grade: **2**
Clock Start/From: **8**
Clock To: **4**
1st Value:
2nd Value:
Value Percent: **5.000**
Continuous Index: **F01**
Within 8" of Joint: **NO**
Remarks:

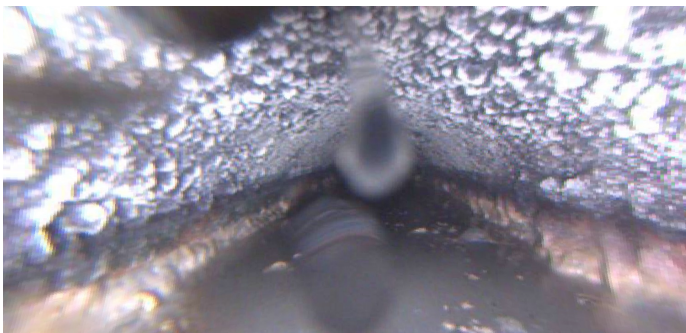
Code: **MSA**
Description: **Abandoned Survey**

Distance (ft): **36.2**
Structural Grade: **0**
O&M Grade: **0**
Clock Start/From:
Clock To:
1st Value:
2nd Value:
Value Percent:
Continuous Index:
Within 8" of Joint: **NO**
Remarks: **encrustation**
