Profile/Photo Observation Report

Date:	10/15/2021	Weather:		Coding:	PACP 6.0
Pipe Length (ft):		Owner:	Hobart, IN	Pre Clean:	Not Known
P.O.#:	811_1	Surveyor:	M. Pielacha	PSR:	P-903-036-035
Customer:	Hobart, IN	Clean Date:		Shape:	C

Location Details:		Direction of Survey:	Upstream
US MH:	M-903-35	DS MH:	M-903-36
		Total Length Surveyed (ft):	4.8

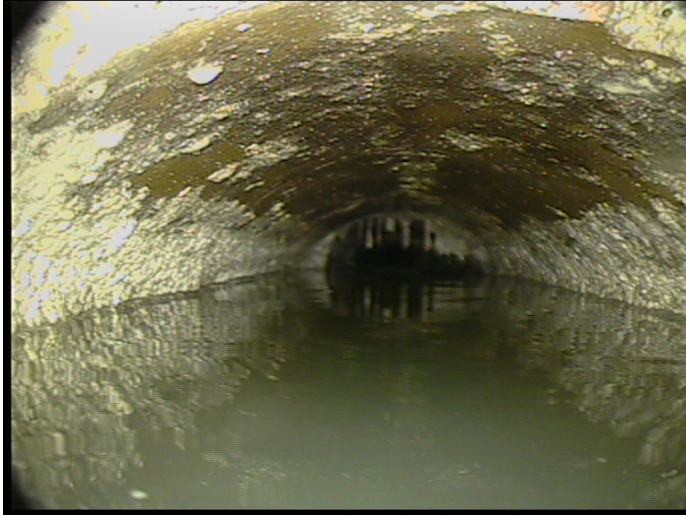
Code: **MWL**
Description: **Water Level**

Distance (ft): **.0**
Structural Grade: **0**
O&M Grade: **0**
Clock Start/From:
Clock To:
1st Value:
2nd Value:
Value Percent: **60.000**
Continuous Index:
Within 8" of Joint: **NO**
Remarks:

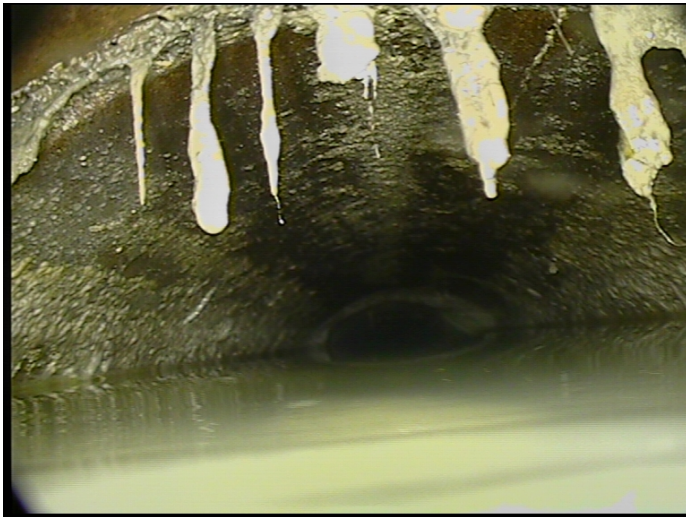
Code: **OBZ**
Description: **Obstacle Other**

Distance (ft): **4.7**
Structural Grade: **0**
O&M Grade: **2**
Clock Start/From: **4**
Clock To: **8**
1st Value:
2nd Value:
Value Percent: **10.000**
Continuous Index:
Within 8" of Joint: **NO**
Remarks: **Under water debris**

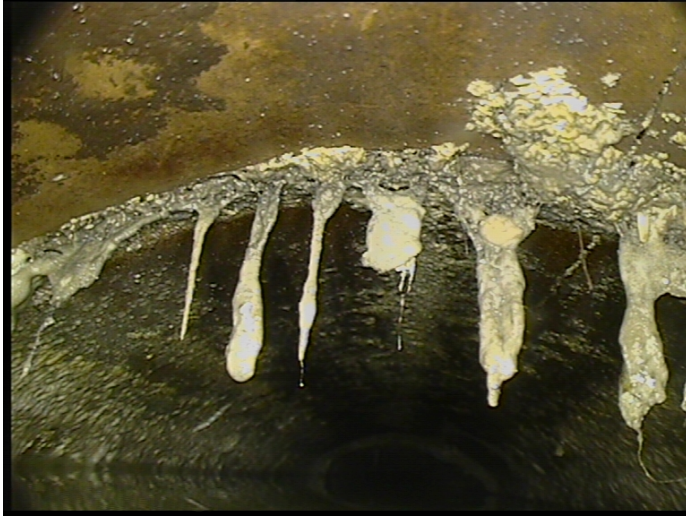
Code:	MSA
Description:	Abandoned Survey
Distance (ft):	4.7
Structural Grade:	0
O&M Grade:	0
Clock Start/From:	
Clock To:	
1st Value:	
2nd Value:	
Value Percent:	
Continuous Index:	
Within 8" of Joint:	NO
Remarks:	under water debris
