Profile/Photo Observation Report

Date:	10/15/2021	Weather:		Coding:	PACP 6.0
Pipe Length (ft):		Owner:	Hobart, IN	Pre Clean:	Not Known
P.O.#:	812_1	Surveyor:	M. Pielacha	PSR:	P-903-036-035
Customer:	Hobart, IN	Clean Date:		Shape:	C

Street:	Off Hobart Road	Flow Control:	
City:	Hobart, IN	Year Renewed:	
Location:	Parking Lot	Tape/Media #:	812
Purpose:	Routine Assessment	Dia/Height:	12"
Use:	Sanitary	Material:	VCP
Drain Area:		Lining:	
Category:	NA		
Comment:

Location Details:		Direction of Survey:	Downstream
US MH:	M-903-35	DS MH:	M-903-36
		Total Length Surveyed (ft):	7.7

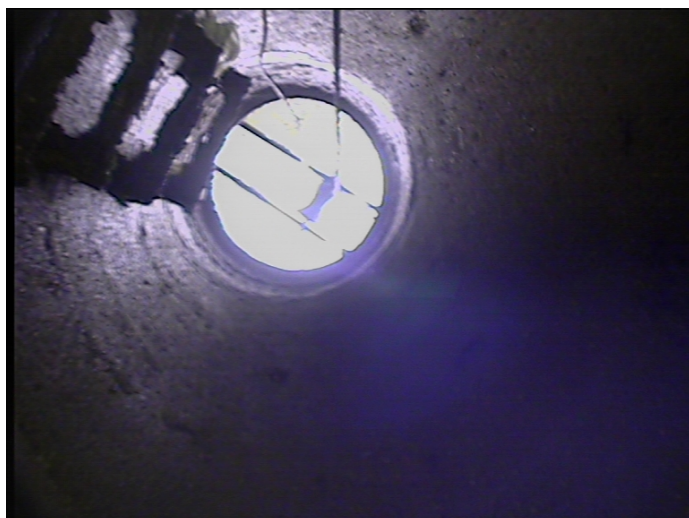
Code: **AMH**
Description: **Manhole**

Distance (ft): **.0**
Structural Grade: **0**
O&M Grade: **0**
Clock Start/From:
Clock To:
1st Value:
2nd Value:
Value Percent:
Continuous Index:
Within 8" of Joint: **NO**
Remarks: **M-903-35**

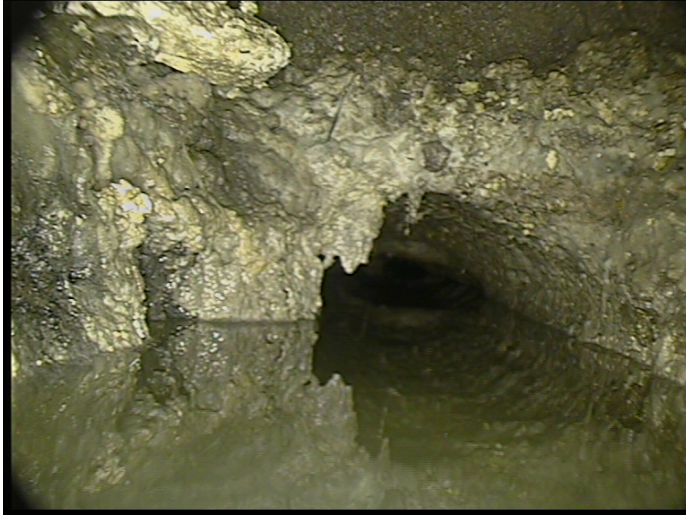
Code: **MWL**
Description: **Water Level**

Distance (ft): **.0**
Structural Grade: **0**
O&M Grade: **0**
Clock Start/From:
Clock To:
1st Value:
2nd Value:
Value Percent: **60.000**
Continuous Index:
Within 8" of Joint: **NO**
Remarks:

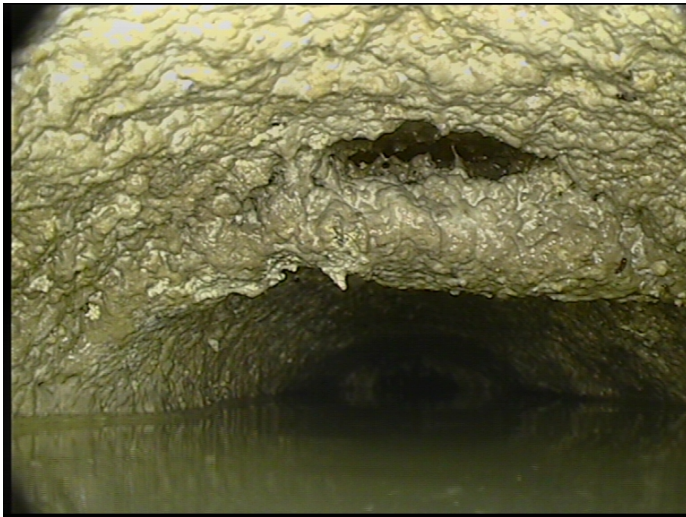
Code: **DAGS**
Description: **Deposits Attached Grease**

Distance (ft): **.0**
Structural Grade: **0**
O&M Grade: **2**
Clock Start/From: **9**
Clock To: **3**
1st Value:
2nd Value:
Value Percent: **10.000**
Continuous Index: **S01**
Within 8" of Joint: **YES**
Remarks:

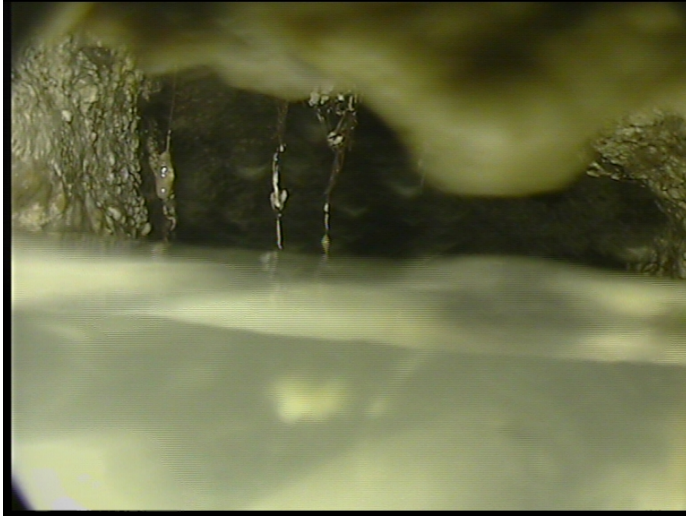
Code: **OBZ**
Description: **Obstacle Other**

Distance (ft): **7.7**
Structural Grade: **0**
O&M Grade: **2**
Clock Start/From: **4**
Clock To: **8**
1st Value:
2nd Value:
Value Percent: **5.000**
Continuous Index:
Within 8" of Joint: **NO**
Remarks: **Under water debris**

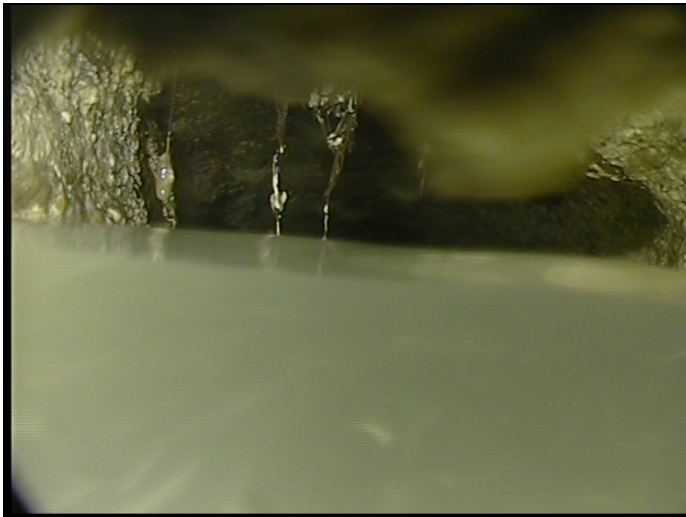
Code: **DAGS**
Description: **Deposits Attached Grease**

Distance (ft): **7.7**
Structural Grade: **0**
O&M Grade: **2**
Clock Start/From: **9**
Clock To: **3**
1st Value:
2nd Value:
Value Percent: **10.000**
Continuous Index: **F01**
Within 8" of Joint: **NO**
Remarks:

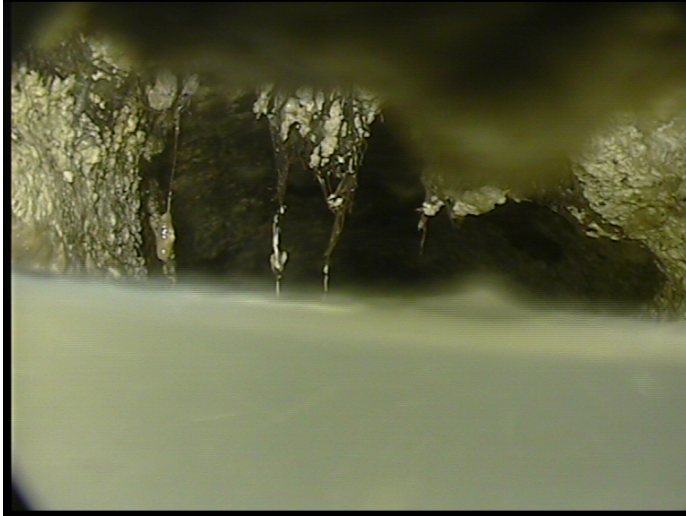
Code:	MSA
Description:	Abandoned Survey
Distance (ft):	7.7
Structural Grade:	0
O&M Grade:	0
Clock Start/From:	
Clock To:	
1st Value:	
2nd Value:	
Value Percent:	
Continuous Index:	
Within 8" of Joint:	NO
Remarks:	Grease and under water debris
