## Profile/Photo Observation Report

Date:	<b>03/21/2018</b>	Weather:		Coding:	<b>PACP 6.0</b>
Pipe Length (ft):	<b>232.4</b>	Owner:	<b>NA</b>	Pre Clean:	<b>Not Known</b>
P.O.#:		Surveyor:	<b>Selasie Honu</b>	PSR:	<b>P-903-037-036</b>
Customer:		Clean Date:	<b>01/01/1900</b>	Shape:	<b>C</b>

Street:	<b>OFF E 38TH PL</b>	Flow Control:	<b>Not Controlled</b>
City:	<b>Hobart, IN</b>	Year Renewed:	
Location:	<b>Other</b>	Tape/Media #:	
Purpose:	<b>Not Known</b>	Dia/Height:	<b>12"</b>
Use:	<b>Sanitary</b>	Material:	<b>VCP</b>
Drain Area:	<b>NA</b>	Lining:	
Category:	<b>NA</b>		
Comment:

Location Details:		Direction of Survey:	<b>Upstream</b>
US MH:	<b>M-903-036</b>	DS MH:	<b>M-903-037</b>
		Total Length Surveyed (ft):	<b>60.3</b>

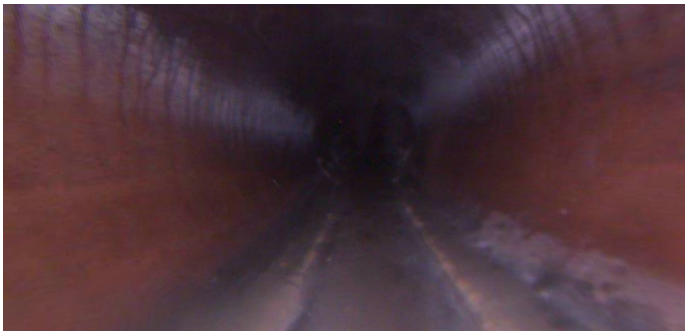
Code: **AMH**  
Description: **Manhole**

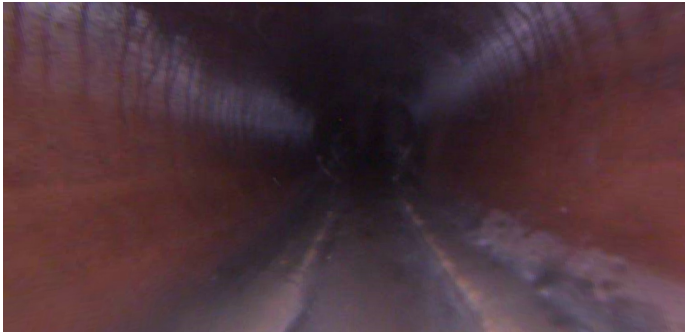
Code:	<b>MWL</b>
Description:	<b>Water Level</b>

Distance (ft):	<b>.0</b>
Structural Grade:	<b>0</b>
O&M Grade:	<b>0</b>
Clock Start/From:	
Clock To:	
1st Value:	
2nd Value:	
Value Percent:	<b>5.000</b>
Continuous Index:	
Within 8" of Joint:	<b>NO</b>
Remarks:

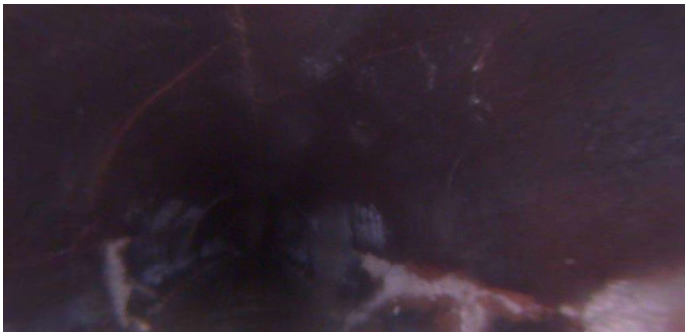
Code:	<b>FM</b>
Description:	<b>Fracture Multiple</b>

Distance (ft):	<b>3.5</b>
Structural Grade:	<b>4</b>
O&M Grade:	<b>0</b>
Clock Start/From:	<b>8</b>
Clock To:	<b>4</b>
1st Value:	
2nd Value:	
Value Percent:	
Continuous Index:	<b>S03</b>
Within 8" of Joint:	<b>YES</b>
Remarks:

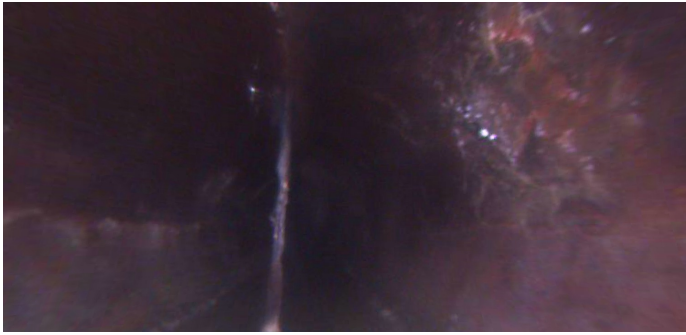
Code: **RFB**  
Description: **Roots Fine Barrel**

Distance (ft): **36.3**  
Structural Grade: **0**  
O&M Grade: **2**  
Clock Start/From: **12**  
Clock To:  
1st Value:  
2nd Value:  
Value Percent:  
Continuous Index:  
Within 8" of Joint: **NO**  
Remarks:

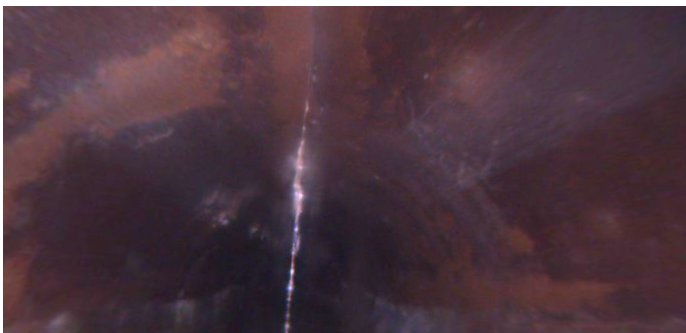
Code: **RFB**  
Description: **Roots Fine Barrel**

Distance (ft): **47.9**  
Structural Grade: **0**  
O&M Grade: **2**  
Clock Start/From: **12**  
Clock To:  
1st Value:  
2nd Value:  
Value Percent:  
Continuous Index:  
Within 8" of Joint: **NO**  
Remarks:

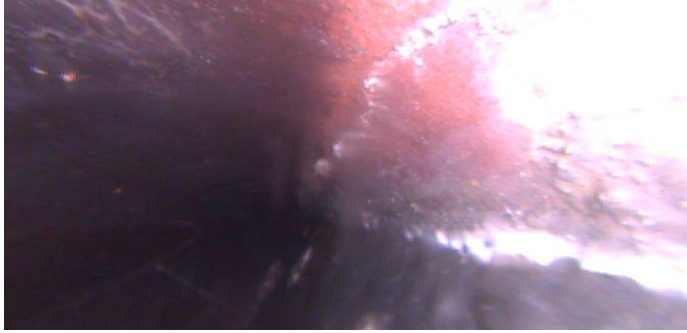
Code: **FM**  
Description: **Fracture Multiple**

Distance (ft): **60.3**  
Structural Grade: **4**  
O&M Grade: **0**  
Clock Start/From: **8**  
Clock To: **4**  
1st Value:  
2nd Value:  
Value Percent:  
Continuous Index: **F03**  
Within 8" of Joint: **YES**  
Remarks:

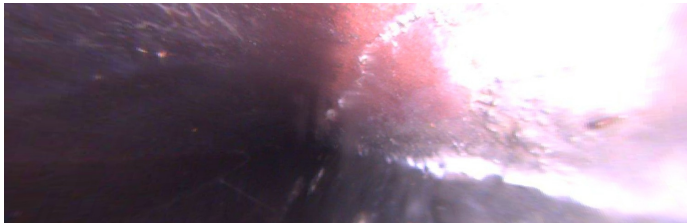
Code: **MSA**  
Description: **Abandoned Survey**

Distance (ft): **60.3**  
Structural Grade: **0**  
O&M Grade: **0**  
Clock Start/From:  
Clock To:  
1st Value:  
2nd Value:  
Value Percent:  
Continuous Index:  
Within 8" of Joint: **NO**  
Remarks: **camera stopped**
