## Profile/Photo Observation Report

Date:	<b>03/21/2018</b>	Weather:		Coding:	<b>PACP 6.0</b>
Pipe Length (ft):	<b>232.4</b>	Owner:	<b>NA</b>	Pre Clean:	<b>Not Known</b>
P.O.#:		Surveyor:	<b>Selasie Honu</b>	PSR:	<b>P-903-037-036</b>
Customer:		Clean Date:	<b>01/01/1900</b>	Shape:	<b>C</b>

Street:	<b>38th pl</b>	Flow Control:	<b>Not Controlled</b>
City:	<b>Hobart, IN</b>	Year Renewed:	
Location:	<b>Other</b>	Tape/Media #:	
Purpose:	<b>Not Known</b>	Dia/Height:	<b>12"</b>
Use:	<b>Sanitary</b>	Material:	<b>VCP</b>
Drain Area:	<b>NA</b>	Lining:	
Category:	<b>NA</b>		
Comment:

Location Details:		Direction of Survey:	<b>Upstream</b>
US MH:	<b>M-903-036</b>	DS MH:	<b>M-903-037</b>
		Total Length Surveyed (ft):	<b>60.3</b>

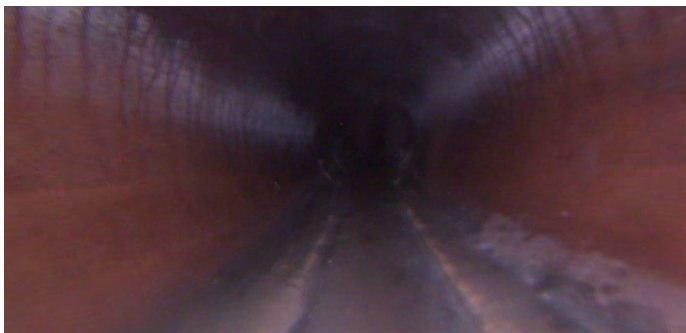
Code: **AMH**  
Description: **Manhole**

Distance (ft): **.0**  
Structural Grade: **0**  
O&M Grade: **0**  
Clock Start/From:  
Clock To:  
1st Value:  
2nd Value:  
Value Percent:  
Continuous Index:  
Within 8" of Joint: **NO**  
Remarks: **M-903-037**

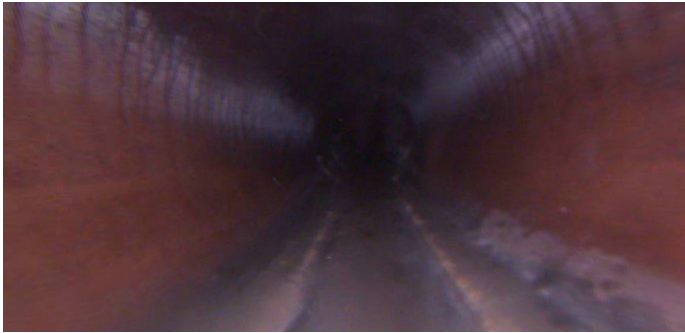
Code:	<b>MWL</b>
Description:	<b>Water Level</b>

Distance (ft):	<b>.0</b>
Structural Grade:	<b>0</b>
O&M Grade:	<b>0</b>
Clock Start/From:	
Clock To:	
1st Value:	
2nd Value:	
Value Percent:	<b>5.000</b>
Continuous Index:	
Within 8" of Joint:	<b>NO</b>
Remarks:

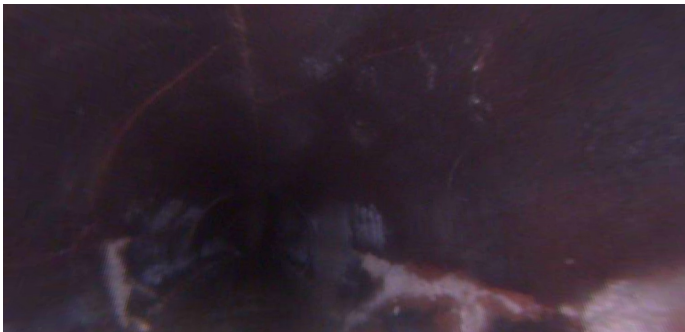
Code:	<b>FM</b>
Description:	<b>Fracture Multiple</b>

Distance (ft):	<b>3.5</b>
Structural Grade:	<b>4</b>
O&M Grade:	<b>0</b>
Clock Start/From:	<b>8</b>
Clock To:	<b>4</b>
1st Value:	
2nd Value:	
Value Percent:	
Continuous Index:	<b>S03</b>
Within 8" of Joint:	<b>YES</b>
Remarks:

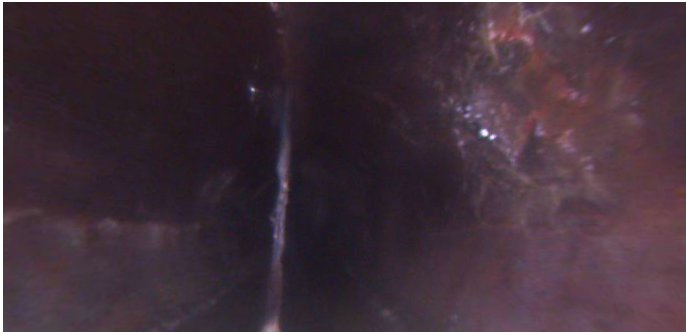
Code: **RFB**  
Description: **Roots Fine Barrel**

Distance (ft): **36.3**  
Structural Grade: **0**  
O&M Grade: **2**  
Clock Start/From: **12**  
Clock To:  
1st Value:  
2nd Value:  
Value Percent:  
Continuous Index:  
Within 8" of Joint: **NO**  
Remarks:

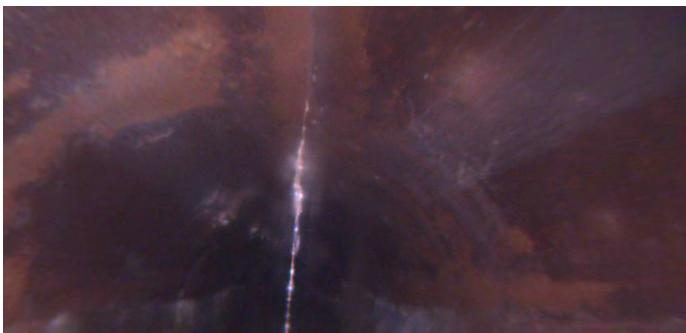
Code: **RFB**  
Description: **Roots Fine Barrel**

Distance (ft): **47.9**  
Structural Grade: **0**  
O&M Grade: **2**  
Clock Start/From: **12**  
Clock To:  
1st Value:  
2nd Value:  
Value Percent:  
Continuous Index:  
Within 8" of Joint: **NO**  
Remarks:

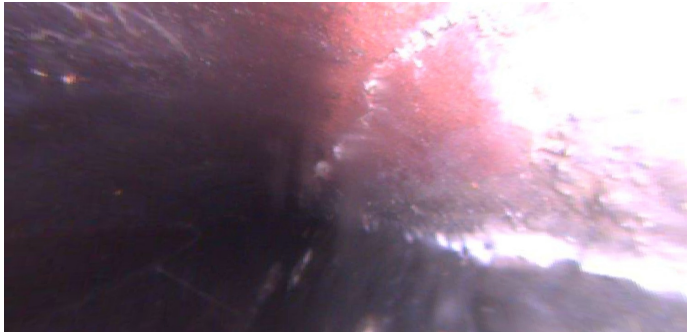
Code: **FM**  
Description: **Fracture Multiple**

Distance (ft): **60.3**  
Structural Grade: **4**  
O&M Grade: **0**  
Clock Start/From: **8**  
Clock To: **4**  
1st Value:  
2nd Value:  
Value Percent:  
Continuous Index: **F03**  
Within 8" of Joint: **YES**  
Remarks:

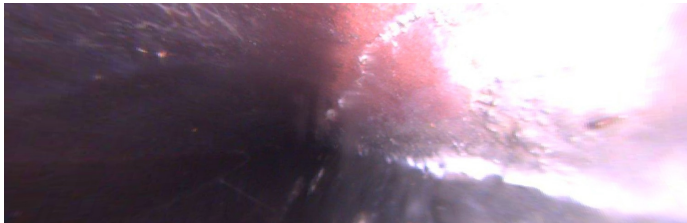
Code: **MSA**  
Description: **Abandoned Survey**

Distance (ft): **60.3**  
Structural Grade: **0**  
O&M Grade: **0**  
Clock Start/From:  
Clock To:  
1st Value:  
2nd Value:  
Value Percent:  
Continuous Index:  
Within 8" of Joint: **NO**  
Remarks: **camera stopped**
