Profile/Photo Observation Report

Street:	OFF E 38TH PL	Flow Control:	Not Controlled
City:	Hobart, IN	Year Renewed:	
Location:	Other	Tape/Media #:	
Purpose:	Not Known	Dia/Height:	10"
Use:	Sanitary	Material:	VCP
Drain Area:	NA	Lining:	
Category:	NA		
Comment:

Location Details:		Direction of Survey:	Upstream
US MH:	M-903-037	DS MH:	M-903-038
		Total Length Surveyed (ft):	131.5

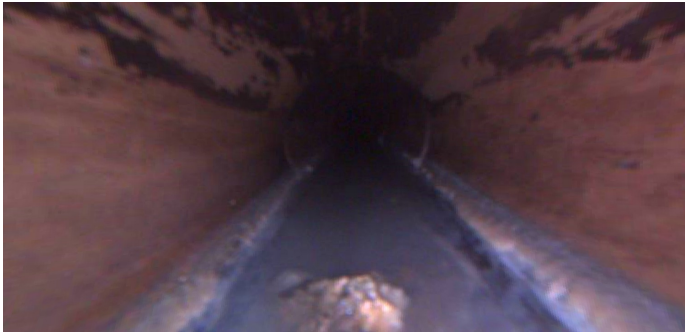
Code:	MWL
Description:	Water Level

Distance (ft):	.0
Structural Grade:	0
O&M Grade:	0
Clock Start/From:	
Clock To:	
1st Value:	
2nd Value:	
Value Percent:	5.000
Continuous Index:	
Within 8" of Joint:	NO
Remarks:

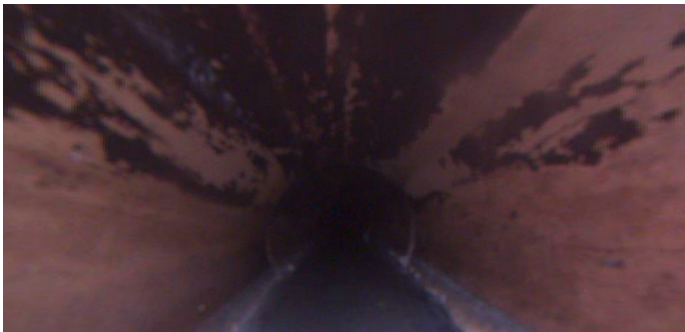
Code:	FM
Description:	Fracture Multiple

Distance (ft):	.0
Structural Grade:	4
O&M Grade:	0
Clock Start/From:	7
Clock To:	5
1st Value:	
2nd Value:	
Value Percent:	
Continuous Index:	S01
Within 8" of Joint:	
Remarks:

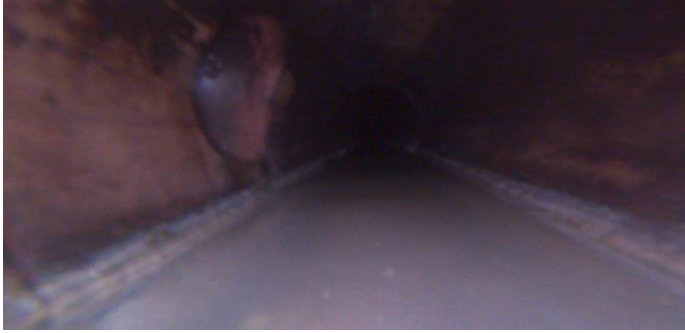
Code: **TF**
Description: **Tap Factory**

Distance (ft): **5.9**
Structural Grade: **0**
O&M Grade: **0**
Clock Start/From: **9**
Clock To:
1st Value: **4.000**
2nd Value:
Value Percent:
Continuous Index:
Within 8" of Joint:
Remarks:

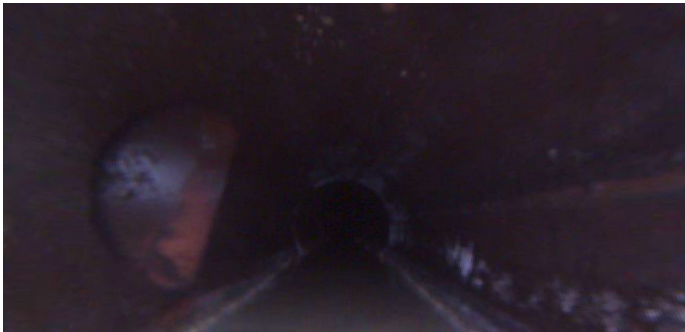
Code: **TF**
Description: **Tap Factory**

Distance (ft): **47.9**
Structural Grade: **0**
O&M Grade: **0**
Clock Start/From: **9**
Clock To:
1st Value: **4.000**
2nd Value:
Value Percent:
Continuous Index:
Within 8" of Joint:
Remarks:

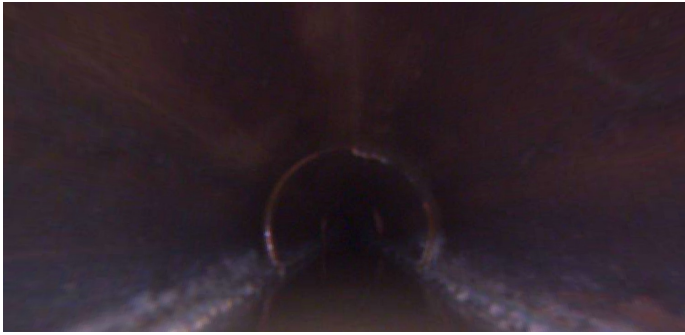
Code: **DAE**
Description: **Deposits Attached Encrustation**

Distance (ft): **87.8**
Structural Grade: **0**
O&M Grade: **2**
Clock Start/From: **7**
Clock To: **5**
1st Value:
2nd Value:
Value Percent: **5.000**
Continuous Index: **S02**
Within 8" of Joint: **YES**
Remarks:

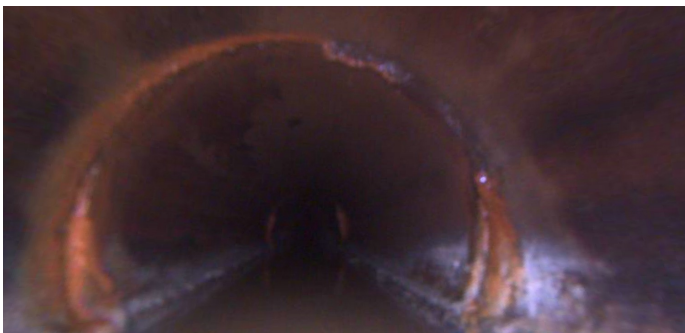
Code: **IW**
Description: **Infil Weeper**

Distance (ft): **88.8**
Structural Grade: **0**
O&M Grade: **2**
Clock Start/From: **8**
Clock To: **4**
1st Value:
2nd Value:
Value Percent:
Continuous Index:
Within 8" of Joint: **YES**
Remarks:

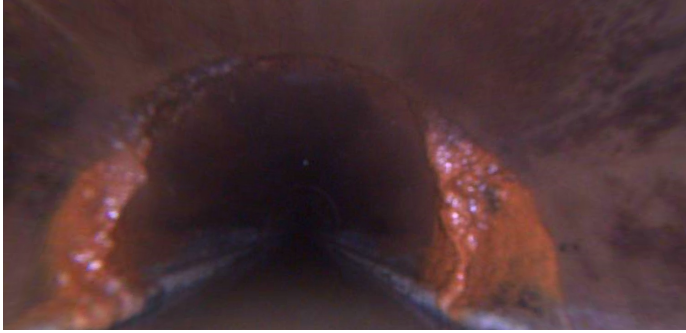
Code: **IW**
Description: **Infil Weeper**

Distance (ft): **91.7**
Structural Grade: **0**
O&M Grade: **2**
Clock Start/From: **8**
Clock To: **4**
1st Value:
2nd Value:
Value Percent:
Continuous Index:
Within 8" of Joint: **YES**
Remarks:

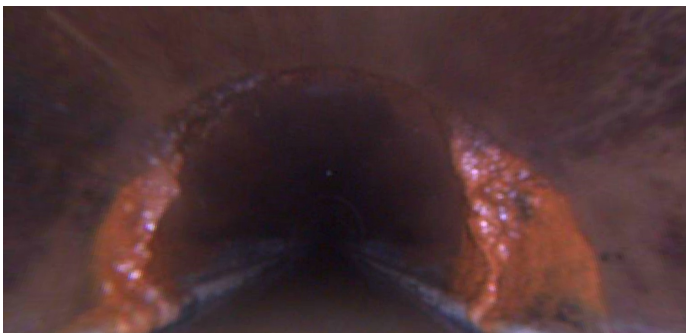
Code: **DAE**
Description: **Deposits Attached Encrustation**

Distance (ft): **91.7**
Structural Grade: **0**
O&M Grade: **2**
Clock Start/From: **7**
Clock To: **5**
1st Value:
2nd Value:
Value Percent: **5.000**
Continuous Index: **F02**
Within 8" of Joint: **YES**
Remarks:

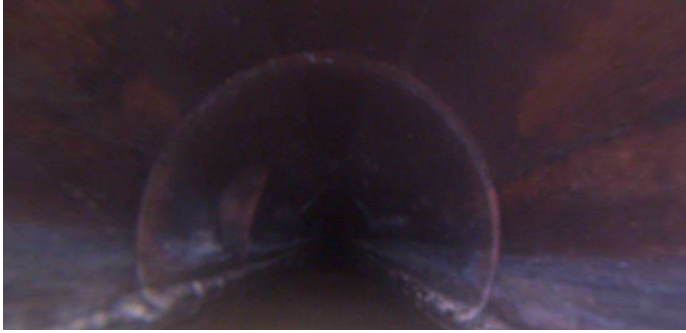
Code: **TF**
Description: **Tap Factory**

Distance (ft): **94.7**
Structural Grade: **0**
O&M Grade: **0**
Clock Start/From: **9**
Clock To:
1st Value: **4.000**
2nd Value:
Value Percent:
Continuous Index:
Within 8" of Joint:
Remarks:

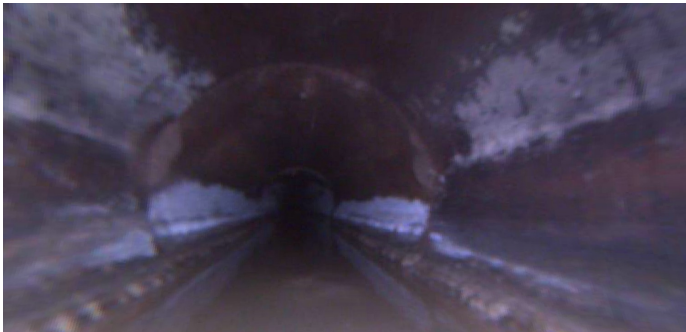
Code: **RFJ**
Description: **Roots Fine Joint**

Distance (ft): **109.2**
Structural Grade: **0**
O&M Grade: **1**
Clock Start/From: **9**
Clock To: **3**
1st Value:
2nd Value:
Value Percent:
Continuous Index:
Within 8" of Joint: **YES**
Remarks:

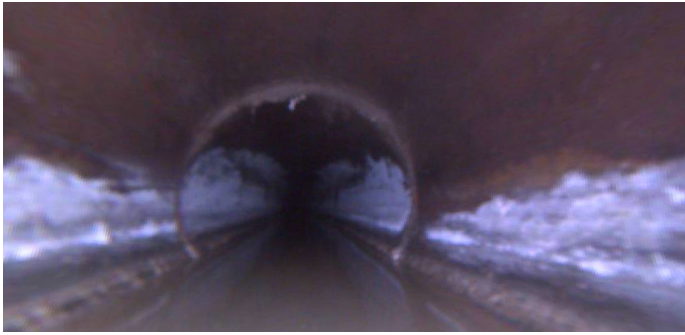
Code: **RFJ**
Description: **Roots Fine Joint**

Distance (ft): **112.1**
Structural Grade: **0**
O&M Grade: **1**
Clock Start/From: **9**
Clock To: **5**
1st Value:
2nd Value:
Value Percent:
Continuous Index:
Within 8" of Joint: **YES**
Remarks:

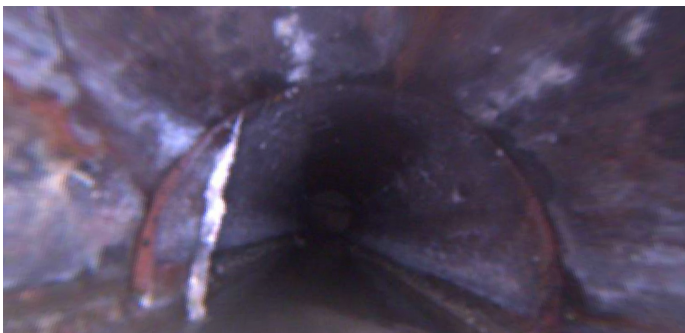
Code: **RFJ**
Description: **Roots Fine Joint**

Distance (ft): **124.5**
Structural Grade: **0**
O&M Grade: **1**
Clock Start/From: **11**
Clock To:
1st Value:
2nd Value:
Value Percent:
Continuous Index:
Within 8" of Joint: **YES**
Remarks:

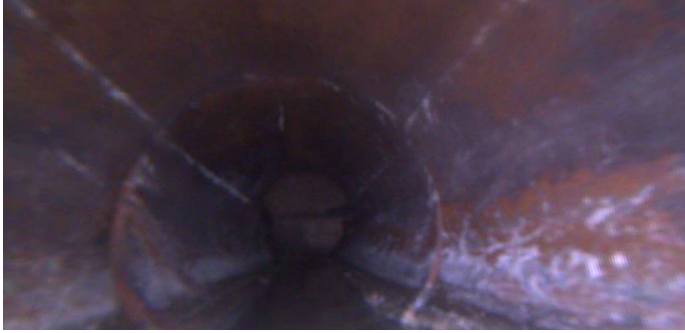
Code: **RFJ**
Description: **Roots Fine Joint**

Distance (ft): **127.3**
Structural Grade: **0**
O&M Grade: **1**
Clock Start/From: **12**
Clock To:
1st Value:
2nd Value:
Value Percent:
Continuous Index:
Within 8" of Joint: **YES**
Remarks:

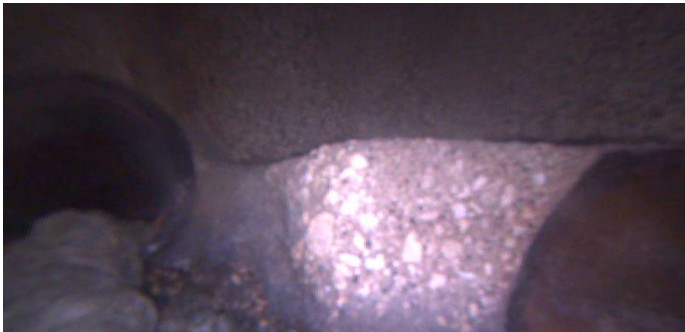
Code: **FM**
Description: **Fracture Multiple**

Distance (ft): **131.5**
Structural Grade: **4**
O&M Grade: **0**
Clock Start/From: **7**
Clock To: **5**
1st Value:
2nd Value:
Value Percent:
Continuous Index: **F01**
Within 8" of Joint:
Remarks:

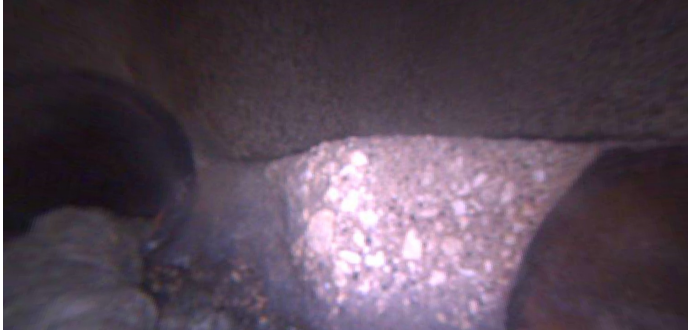
Code:	AMH
Description:	Manhole
Distance (ft):	131.5
Structural Grade:	0
O&M Grade:	0
Clock Start/From:	
Clock To:	
1st Value:	
2nd Value:	
Value Percent:	
Continuous Index:	
Within 8" of Joint:	NO
Remarks:	M-903-037
