Profile/Photo Observation Report

Date:	03/21/2018	Weather:		Coding:	PACP 6.0
Pipe Length (ft):	14.4	Owner:	NA	Pre Clean:	Not Known
P.O.#:		Surveyor:	Selasie Honu	PSR:	P-903-040-037
Customer:		Clean Date:	01/01/1900	Shape:	C

Street:	OFF E 38TH PL	Flow Control:	Not Controlled
City:	Hobart, IN	Year Renewed:	
Location:	Other	Tape/Media #:	
Purpose:	Not Known	Dia/Height:	10"
Use:	Sanitary	Material:	VCP
Drain Area:	NA	Lining:	
Category:	NA		
Comment:

Location Details:		Direction of Survey:	Downstream
US MH:	M-903-037	DS MH:	M-903-040
		Total Length Surveyed (ft):	14.9

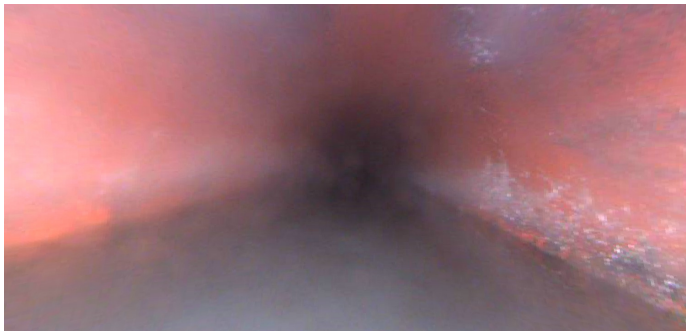
Code: **AMH**
Description: **Manhole**

Distance (ft): **.0**
Structural Grade: **0**
O&M Grade: **0**
Clock Start/From:
Clock To:
1st Value:
2nd Value:
Value Percent:
Continuous Index:
Within 8" of Joint: **NO**
Remarks: **M-903-037**

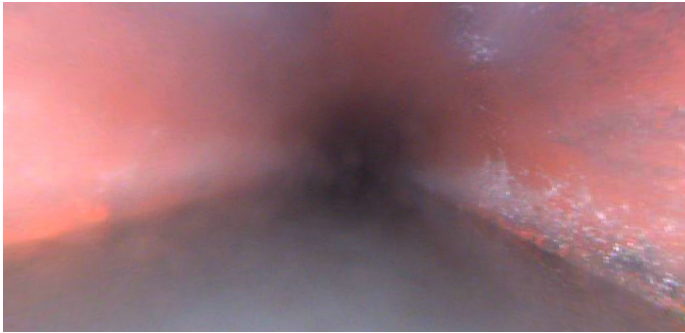
Code:	MWL
Description:	Water Level

Distance (ft):	.0
Structural Grade:	0
O&M Grade:	0
Clock Start/From:	
Clock To:	
1st Value:	
2nd Value:	
Value Percent:	5.000
Continuous Index:	
Within 8" of Joint:	NO
Remarks:

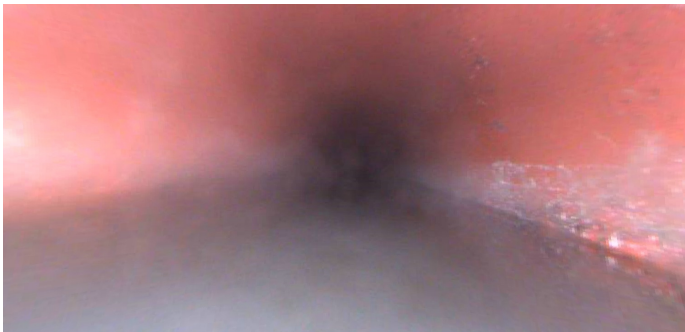
Code:	MWLS
Description:	Water Level Sag

Distance (ft):	1.2
Structural Grade:	2
O&M Grade:	3
Clock Start/From:	
Clock To:	
1st Value:	
2nd Value:	
Value Percent:	10.000
Continuous Index:	S01
Within 8" of Joint:	NO
Remarks:

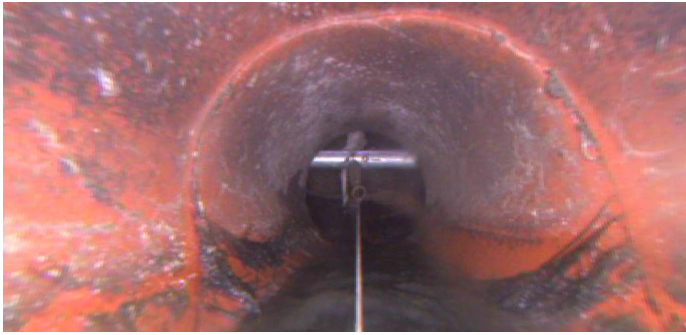
Code: **FC**
Description: **Fracture Circumferential**

Distance (ft): **1.4**
Structural Grade: **2**
O&M Grade: **0**
Clock Start/From: **7**
Clock To: **5**
1st Value:
2nd Value:
Value Percent:
Continuous Index:
Within 8" of Joint: **YES**
Remarks:

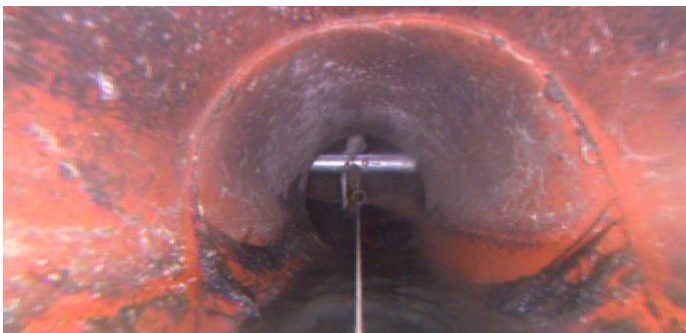
Code: **RFJ**
Description: **Roots Fine Joint**

Distance (ft): **1.4**
Structural Grade: **0**
O&M Grade: **1**
Clock Start/From: **7**
Clock To: **5**
1st Value:
2nd Value:
Value Percent:
Continuous Index:
Within 8" of Joint: **YES**
Remarks:

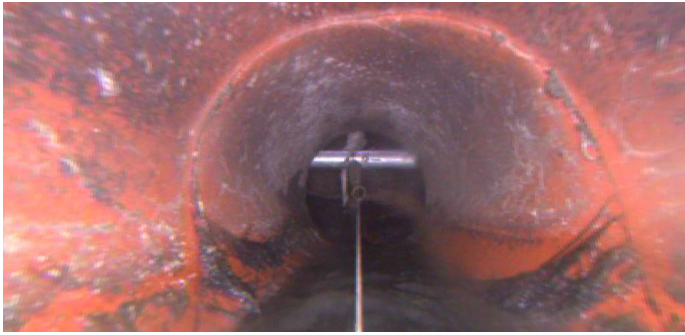
Code: **RFB**
Description: **Roots Fine Barrel**

Distance (ft): **1.4**
Structural Grade: **0**
O&M Grade: **2**
Clock Start/From: **7**
Clock To: **9**
1st Value:
2nd Value:
Value Percent:
Continuous Index:
Within 8" of Joint: **NO**
Remarks:

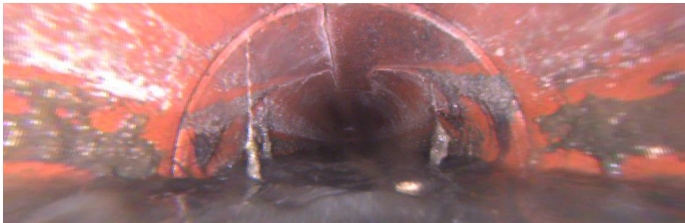
Code: **FM**
Description: **Fracture Multiple**

Distance (ft): **5.4**
Structural Grade: **4**
O&M Grade: **0**
Clock Start/From: **8**
Clock To: **4**
1st Value:
2nd Value:
Value Percent:
Continuous Index:
Within 8" of Joint: **YES**
Remarks:

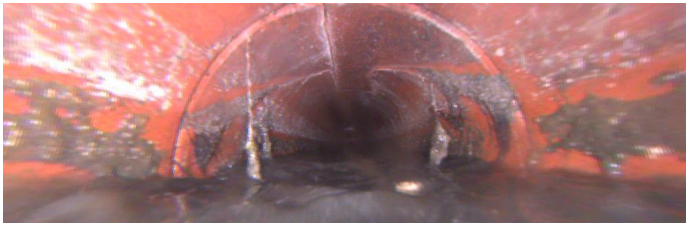
Code: **RFB**
Description: **Roots Fine Barrel**

Distance (ft): **5.4**
Structural Grade: **0**
O&M Grade: **2**
Clock Start/From: **8**
Clock To: **4**
1st Value:
2nd Value:
Value Percent:
Continuous Index:
Within 8" of Joint: **NO**
Remarks:

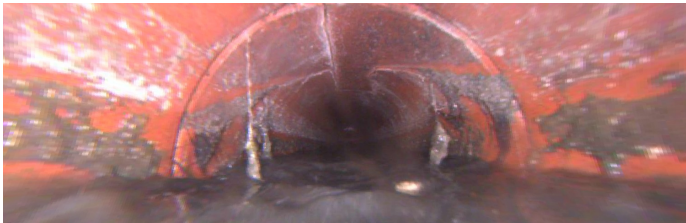
Code: **RFJ**
Description: **Roots Fine Joint**

Distance (ft): **5.4**
Structural Grade: **0**
O&M Grade: **1**
Clock Start/From: **8**
Clock To: **4**
1st Value:
2nd Value:
Value Percent:
Continuous Index:
Within 8" of Joint: **YES**
Remarks:

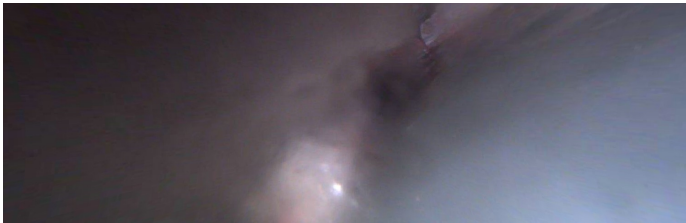
Code: **AMH**
Description: **Manhole**

Distance (ft): **14.9**
Structural Grade: **0**
O&M Grade: **0**
Clock Start/From:
Clock To:
1st Value:
2nd Value:
Value Percent:
Continuous Index:
Within 8" of Joint: **NO**
Remarks: **M-903-040**
