Profile/Photo Observation Report

Date:	03/21/2018	Weather:		Coding:	PACP 6.0
Pipe Length (ft):	14.4	Owner:	NA	Pre Clean:	Not Known
P.O.#:		Surveyor:	Selasie Honu	PSR:	P-903-040-037
Customer:		Clean Date:	01/01/1900	Shape:	C

Street:	37th ave	Flow Control:	Not Controlled
City:	Hobart, IN	Year Renewed:	
Location:	Other	Tape/Media #:	
Purpose:	Not Known	Dia/Height:	10"
Use:	Sanitary	Material:	VCP
Drain Area:	NA	Lining:	
Category:	NA		
Comment:

Location Details:		Direction of Survey:	Downstream
US MH:	M-903-037	DS MH:	M-903-040
		Total Length Surveyed (ft):	14.9

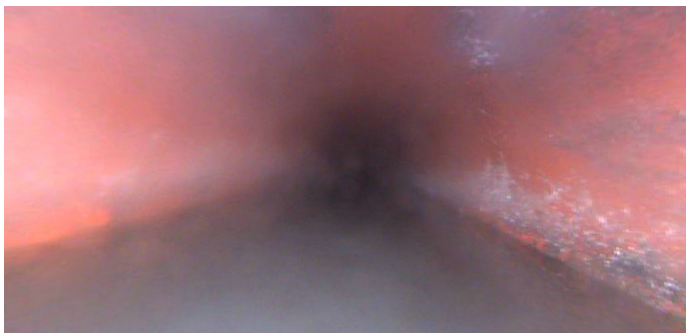
Code: **AMH**
Description: **Manhole**

Distance (ft): **.0**
Structural Grade: **0**
O&M Grade: **0**
Clock Start/From:
Clock To:
1st Value:
2nd Value:
Value Percent:
Continuous Index:
Within 8" of Joint: **NO**
Remarks: **M-903-037**

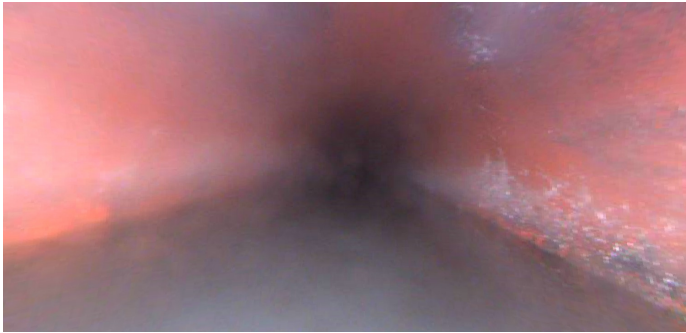
Code:	MWL
Description:	Water Level

Distance (ft):	.0
Structural Grade:	0
O&M Grade:	0
Clock Start/From:	
Clock To:	
1st Value:	
2nd Value:	
Value Percent:	5.000
Continuous Index:	
Within 8" of Joint:	NO
Remarks:

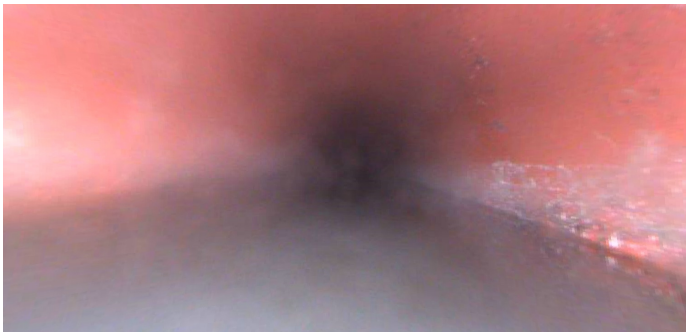
Code:	MWLS
Description:	Water Level Sag

Distance (ft):	1.2
Structural Grade:	2
O&M Grade:	3
Clock Start/From:	
Clock To:	
1st Value:	
2nd Value:	
Value Percent:	10.000
Continuous Index:	S01
Within 8" of Joint:	NO
Remarks:

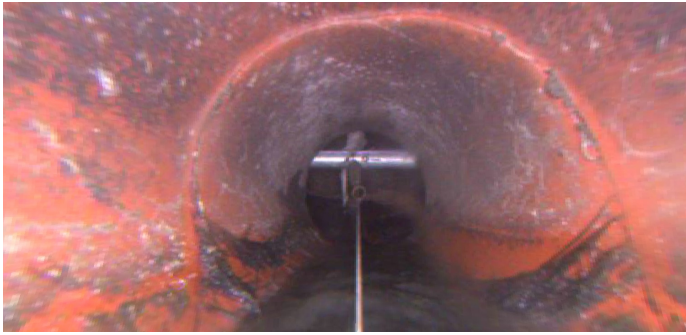
Code: **FC**
Description: **Fracture Circumferential**

Distance (ft): **1.4**
Structural Grade: **2**
O&M Grade: **0**
Clock Start/From: **7**
Clock To: **5**
1st Value:
2nd Value:
Value Percent:
Continuous Index:
Within 8" of Joint: **YES**
Remarks:

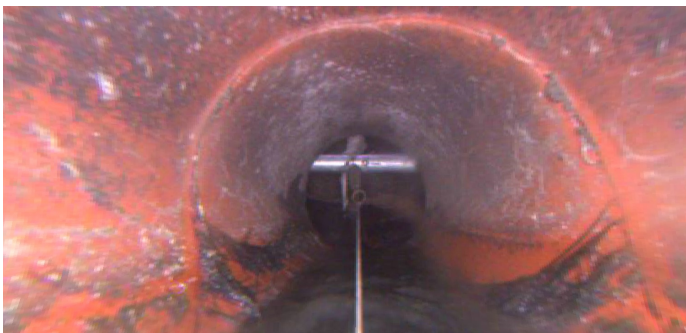
Code: **RFJ**
Description: **Roots Fine Joint**

Distance (ft): **1.4**
Structural Grade: **0**
O&M Grade: **1**
Clock Start/From: **7**
Clock To: **5**
1st Value:
2nd Value:
Value Percent:
Continuous Index:
Within 8" of Joint: **YES**
Remarks:

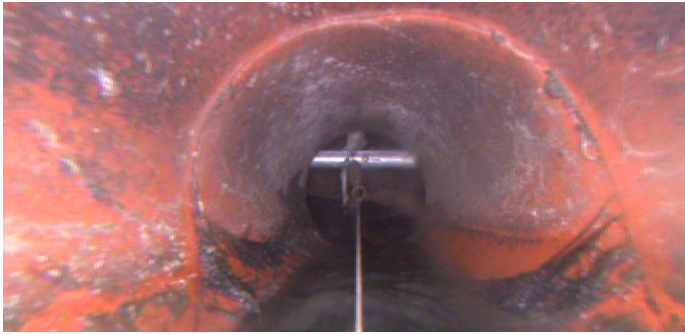
Code: **RFB**
Description: **Roots Fine Barrel**

Distance (ft): **1.4**
Structural Grade: **0**
O&M Grade: **2**
Clock Start/From: **7**
Clock To: **9**
1st Value:
2nd Value:
Value Percent:
Continuous Index:
Within 8" of Joint: **NO**
Remarks:

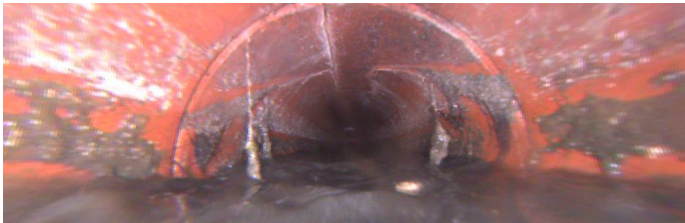
Code: **FM**
Description: **Fracture Multiple**

Distance (ft): **5.4**
Structural Grade: **4**
O&M Grade: **0**
Clock Start/From: **8**
Clock To: **4**
1st Value:
2nd Value:
Value Percent:
Continuous Index:
Within 8" of Joint: **YES**
Remarks:

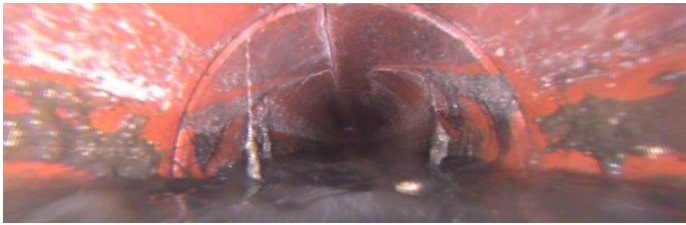
Code: **RFB**
Description: **Roots Fine Barrel**

Distance (ft): **5.4**
Structural Grade: **0**
O&M Grade: **2**
Clock Start/From: **8**
Clock To: **4**
1st Value:
2nd Value:
Value Percent:
Continuous Index:
Within 8" of Joint: **NO**
Remarks:

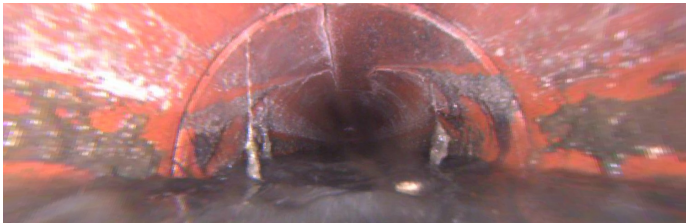
Code: **RFJ**
Description: **Roots Fine Joint**

Distance (ft): **5.4**
Structural Grade: **0**
O&M Grade: **1**
Clock Start/From: **8**
Clock To: **4**
1st Value:
2nd Value:
Value Percent:
Continuous Index:
Within 8" of Joint: **YES**
Remarks:

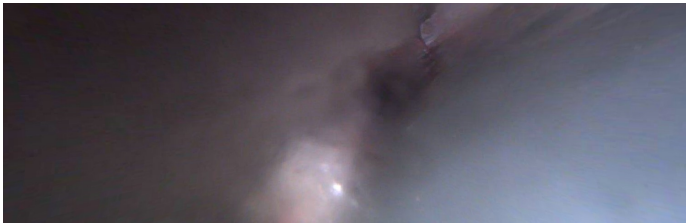
Code: **AMH**
Description: **Manhole**

Distance (ft): **14.9**
Structural Grade: **0**
O&M Grade: **0**
Clock Start/From:
Clock To:
1st Value:
2nd Value:
Value Percent:
Continuous Index:
Within 8" of Joint: **NO**
Remarks: **M-903-040**
