## Profile/Photo Observation Report

Street:	<b>37th ave</b>	Flow Control:	<b>Not Controlled</b>
City:	<b>Hobart, IN</b>	Year Renewed:	
Location:	<b>Other</b>	Tape/Media #:	
Purpose:	<b>Not Known</b>	Dia/Height:	<b>10"</b>
Use:	<b>Sanitary</b>	Material:	<b>VCP</b>
Drain Area:	<b>NA</b>	Lining:	
Category:	<b>NA</b>		
Comment:

Location Details:		Direction of Survey:	<b>Downstream</b>
US MH:	<b>M-903-037</b>	DS MH:	<b>M-903-053</b>
		Total Length Surveyed (ft):	<b>60.0</b>

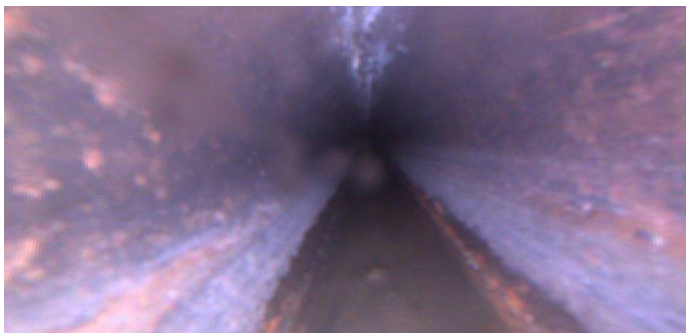
Code: **AMH**  
Description: **Manhole**

Distance (ft): **.0**  
Structural Grade: **0**  
O&M Grade: **0**  
Clock Start/From:  
Clock To:  
1st Value:  
2nd Value:  
Value Percent:  
Continuous Index:  
Within 8" of Joint: **NO**  
Remarks: **M-903-037**

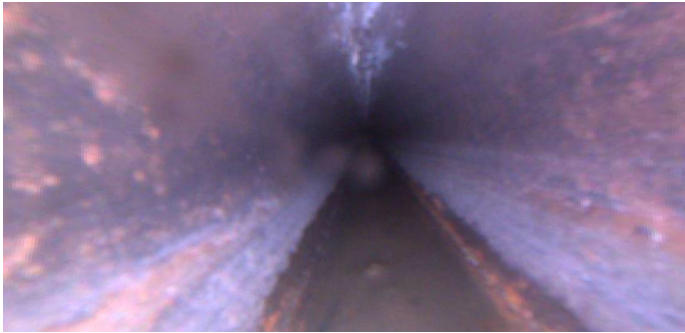
Code:	<b>MWL</b>
Description:	<b>Water Level</b>

Distance (ft):	<b>.0</b>
Structural Grade:	<b>0</b>
O&M Grade:	<b>0</b>
Clock Start/From:	
Clock To:	
1st Value:	
2nd Value:	
Value Percent:	<b>5.000</b>
Continuous Index:	
Within 8" of Joint:	<b>NO</b>
Remarks:

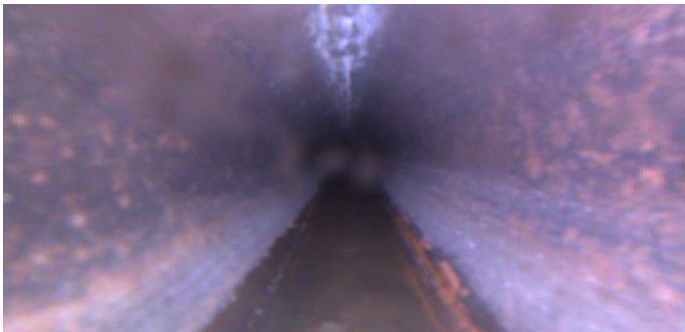
Code:	<b>DAZ</b>
Description:	<b>Deposits Attached Other</b>

Distance (ft):	<b>1.4</b>
Structural Grade:	<b>0</b>
O&M Grade:	<b>2</b>
Clock Start/From:	<b>7</b>
Clock To:	<b>5</b>
1st Value:	
2nd Value:	
Value Percent:	<b>5.000</b>
Continuous Index:	<b>S01</b>
Within 8" of Joint:	<b>YES</b>
Remarks:	<b>WANDER</b>

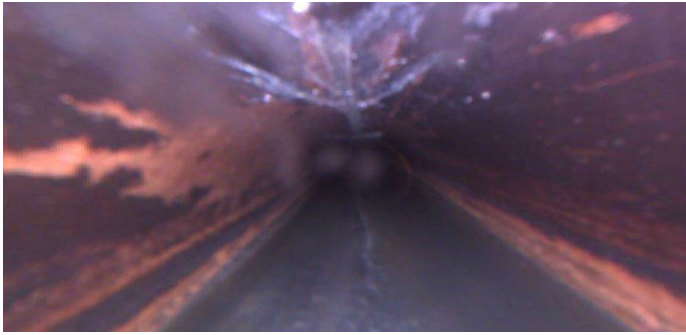
Code: **MSA**  
Description: **Abandoned Survey**

Distance (ft): **60.0**  
Structural Grade: **0**  
O&M Grade: **0**  
Clock Start/From:  
Clock To:  
1st Value:  
2nd Value:  
Value Percent:  
Continuous Index:  
Within 8" of Joint: **NO**  
Remarks: **debris**

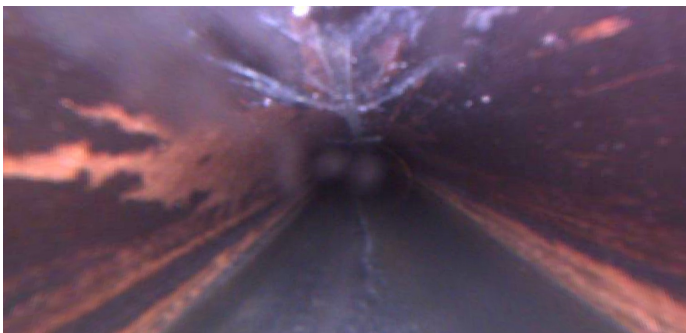
Code: **DAZ**  
Description: **Deposits Attached Other**

Distance (ft): **60.0**  
Structural Grade: **0**  
O&M Grade: **2**  
Clock Start/From: **7**  
Clock To: **5**  
1st Value:  
2nd Value:  
Value Percent: **5.000**  
Continuous Index: **F01**  
Within 8" of Joint: **YES**  
Remarks: **WANDER**
