Profile/Photo Observation Report

Street:	OFF E 38TH PL	Flow Control:	Not Controlled
City:	Hobart, IN	Year Renewed:	
Location:	Other	Tape/Media #:	
Purpose:	Not Known	Dia/Height:	12"
Use:	Sanitary	Material:	VCP
Drain Area:	NA	Lining:	
Category:	NA		
Comment:

Location Details:		Direction of Survey:	Upstream
US MH:	M-903-037	DS MH:	M-903-053
		Total Length Surveyed (ft):	1.3

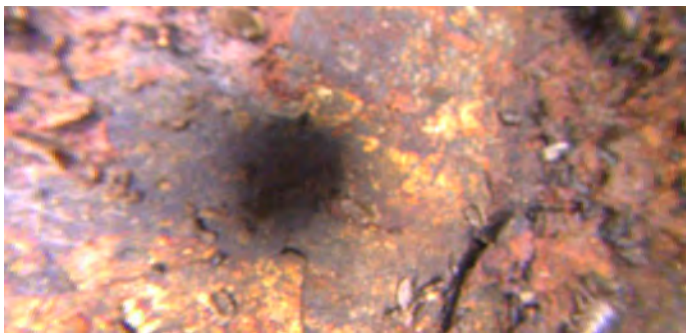
Code: **AMH**
Description: **Manhole**

Distance (ft): **.0**
Structural Grade: **0**
O&M Grade: **0**
Clock Start/From:
Clock To:
1st Value:
2nd Value:
Value Percent:
Continuous Index:
Within 8" of Joint: **NO**
Remarks: **M-903-037**

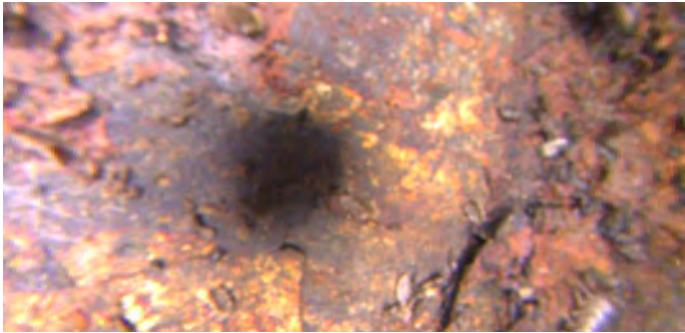
Code:	MWL
Description:	Water Level

Distance (ft):	.0
Structural Grade:	0
O&M Grade:	0
Clock Start/From:	
Clock To:	
1st Value:	
2nd Value:	
Value Percent:	5.000
Continuous Index:	
Within 8" of Joint:	NO
Remarks:

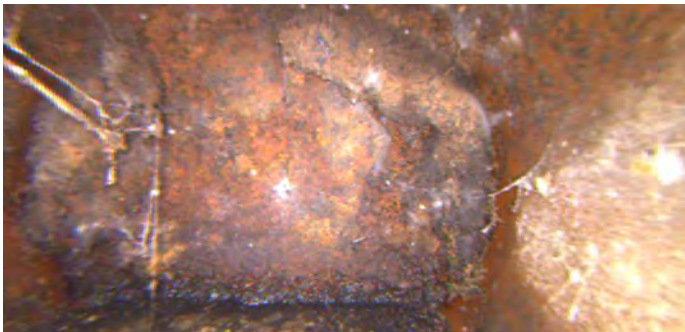
Code:	MSA
Description:	Abandoned Survey

Distance (ft):	1.3
Structural Grade:	0
O&M Grade:	0
Clock Start/From:	
Clock To:	
1st Value:	
2nd Value:	
Value Percent:	
Continuous Index:	
Within 8" of Joint:	NO
Remarks:	M-903-053, line plugged
