Profile/Photo Observation Report

Date:	03/20/2018	Weather:		Coding:	PACP 6.0
Pipe Length (ft):	219.8	Owner:	NA	Pre Clean:	Not Known
P.O.#:		Surveyor:	Selasie Honu	PSR:	P-903-039-038
Customer:		Clean Date:	01/01/1900	Shape:	C

Street:	OFF E 38TH PL	Flow Control:	Not Controlled
City:	Hobart, IN	Year Renewed:	
Location:	Other	Tape/Media #:	
Purpose:	Not Known	Dia/Height:	10"
Use:	Sanitary	Material:	PVC
Drain Area:	NA	Lining:	
Category:	NA		
Comment:

Location Details:		Direction of Survey:	Upstream
US MH:	M-903-038	DS MH:	M-903-039
		Total Length Surveyed (ft):	182.4

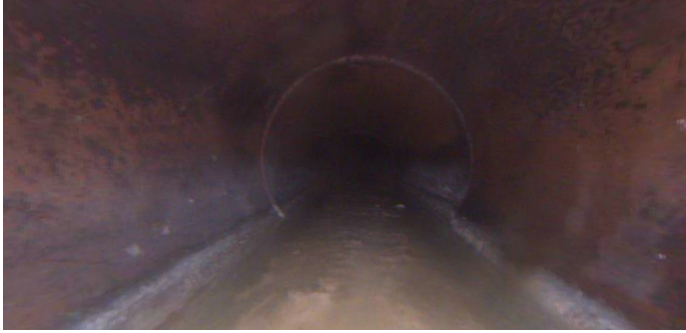
Code: **AMH**
Description: **Manhole**

Distance (ft): **.0**
Structural Grade: **0**
O&M Grade: **0**
Clock Start/From:
Clock To:
1st Value:
2nd Value:
Value Percent:
Continuous Index:
Within 8" of Joint: **NO**
Remarks: **M-903-039**

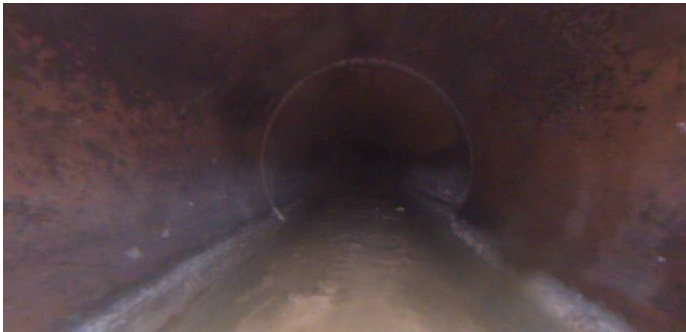
Code: **MWL**
Description: **Water Level**

Distance (ft): **.0**
Structural Grade: **0**
O&M Grade: **0**
Clock Start/From:
Clock To:
1st Value:
2nd Value:
Value Percent: **5.000**
Continuous Index:
Within 8" of Joint: **NO**
Remarks:

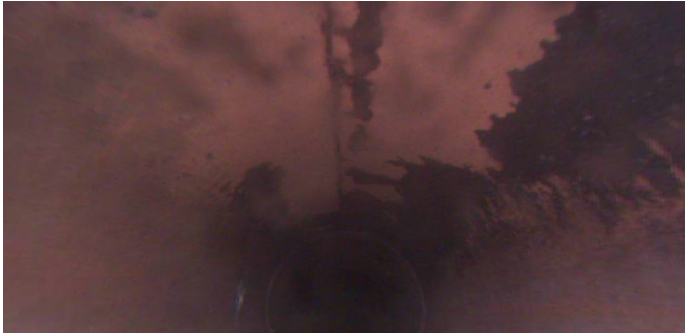
Code: **FL**
Description: **Fracture Longitudinal**

Distance (ft): **5.4**
Structural Grade: **3**
O&M Grade: **0**
Clock Start/From: **12**
Clock To:
1st Value:
2nd Value:
Value Percent:
Continuous Index:
Within 8" of Joint: **YES**
Remarks:

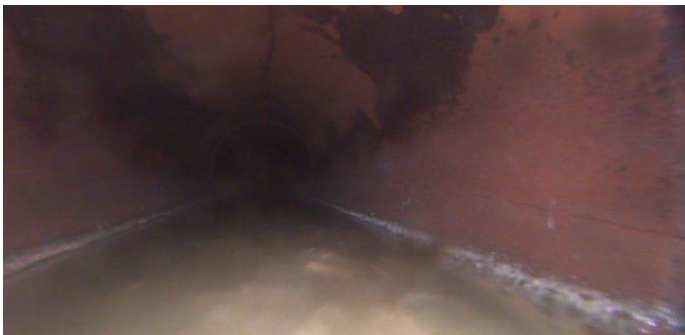
Code: **FL**
Description: **Fracture Longitudinal**

Distance (ft): **7.3**
Structural Grade: **3**
O&M Grade: **0**
Clock Start/From: **3**
Clock To:
1st Value:
2nd Value:
Value Percent:
Continuous Index:
Within 8" of Joint:
Remarks:

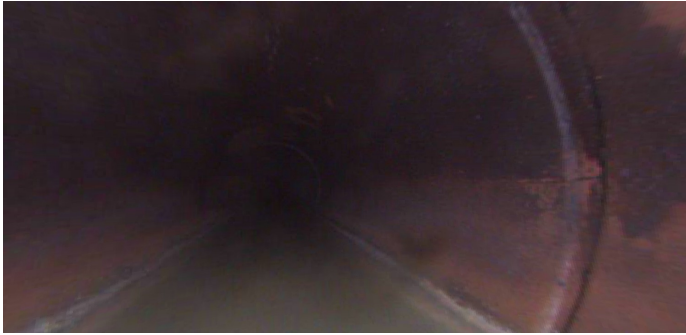
Code: **FL**
Description: **Fracture Longitudinal**

Distance (ft): **10.1**
Structural Grade: **3**
O&M Grade: **0**
Clock Start/From: **3**
Clock To:
1st Value:
2nd Value:
Value Percent:
Continuous Index:
Within 8" of Joint: **YES**
Remarks:

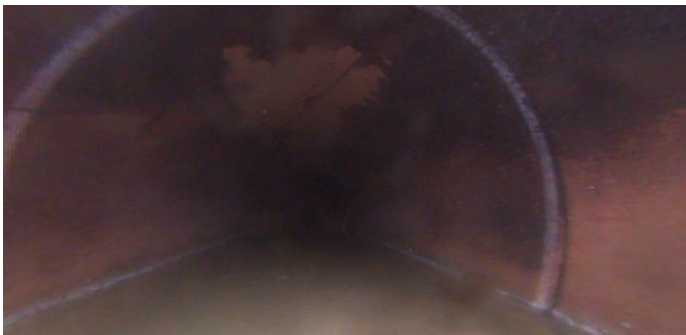
Code: **FL**
Description: **Fracture Longitudinal**

Distance (ft): **15.9**
Structural Grade: **3**
O&M Grade: **0**
Clock Start/From: **9**
Clock To:
1st Value:
2nd Value:
Value Percent:
Continuous Index:
Within 8" of Joint: **YES**
Remarks:

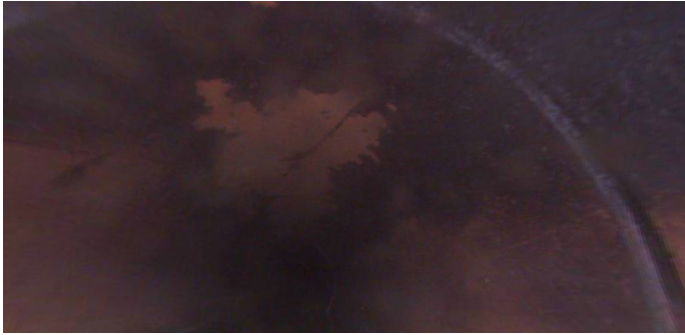
Code: **FL**
Description: **Fracture Longitudinal**

Distance (ft): **16.1**
Structural Grade: **3**
O&M Grade: **0**
Clock Start/From: **1**
Clock To:
1st Value:
2nd Value:
Value Percent:
Continuous Index:
Within 8" of Joint:
Remarks:

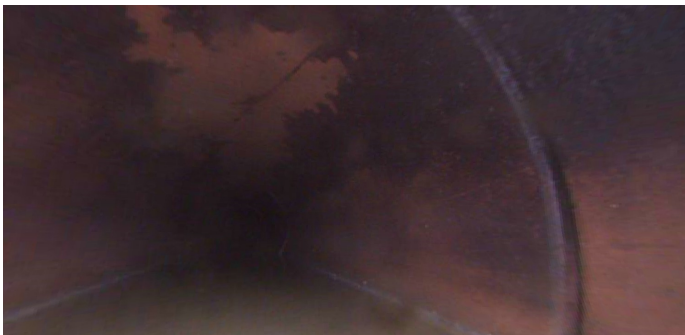
Code: **FL**
Description: **Fracture Longitudinal**

Distance (ft): **16.1**
Structural Grade: **3**
O&M Grade: **0**
Clock Start/From: **3**
Clock To:
1st Value:
2nd Value:
Value Percent:
Continuous Index:
Within 8" of Joint: **YES**
Remarks:

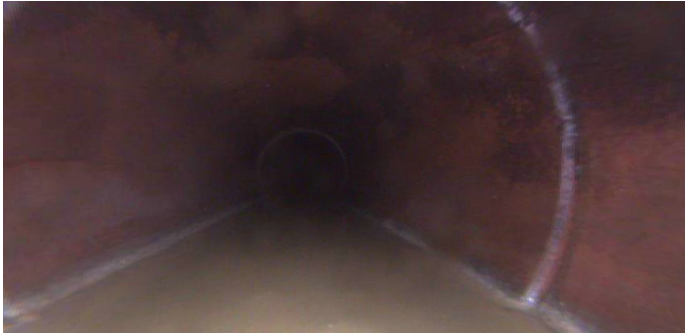
Code: **FL**
Description: **Fracture Longitudinal**

Distance (ft): **18.9**
Structural Grade: **3**
O&M Grade: **0**
Clock Start/From: **9**
Clock To:
1st Value:
2nd Value:
Value Percent:
Continuous Index:
Within 8" of Joint: **YES**
Remarks:

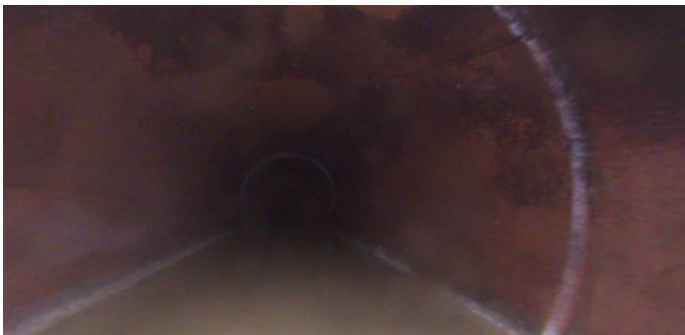
Code: **FL**
Description: **Fracture Longitudinal**

Distance (ft): **19.0**
Structural Grade: **3**
O&M Grade: **0**
Clock Start/From: **1**
Clock To:
1st Value:
2nd Value:
Value Percent:
Continuous Index:
Within 8" of Joint: **YES**
Remarks:

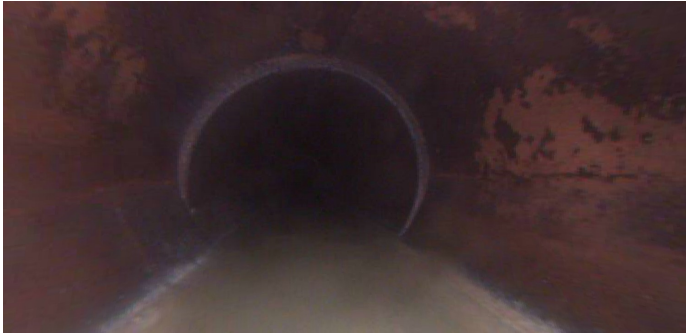
Code: **FL**
Description: **Fracture Longitudinal**

Distance (ft): **21.2**
Structural Grade: **3**
O&M Grade: **0**
Clock Start/From: **3**
Clock To:
1st Value:
2nd Value:
Value Percent:
Continuous Index:
Within 8" of Joint: **YES**
Remarks:

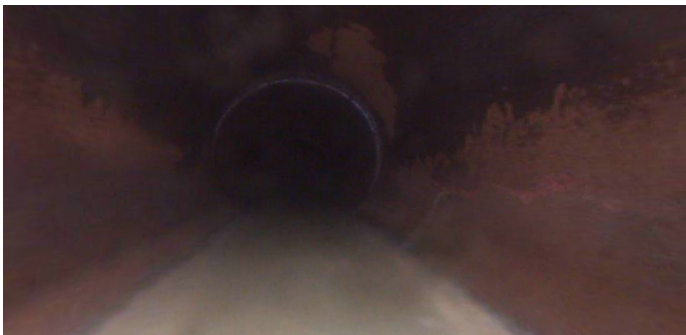
Code: **FL**
Description: **Fracture Longitudinal**

Distance (ft): **26.6**
Structural Grade: **3**
O&M Grade: **0**
Clock Start/From: **3**
Clock To:
1st Value:
2nd Value:
Value Percent:
Continuous Index:
Within 8" of Joint:
Remarks:

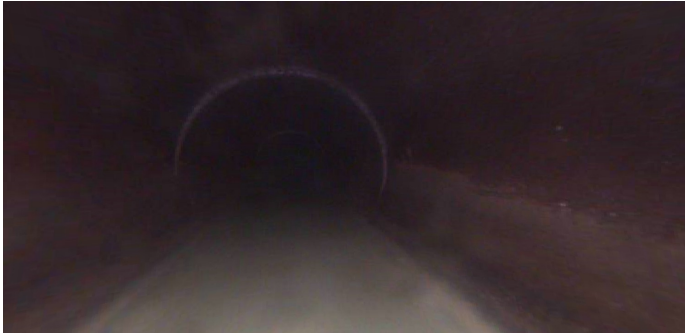
Code: **FL**
Description: **Fracture Longitudinal**

Distance (ft): **29.9**
Structural Grade: **3**
O&M Grade: **0**
Clock Start/From: **3**
Clock To:
1st Value: **4.000**
2nd Value:
Value Percent:
Continuous Index:
Within 8" of Joint:
Remarks:

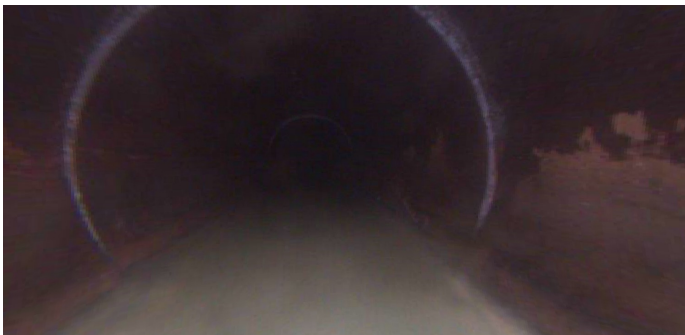
Code: **FL**
Description: **Fracture Longitudinal**

Distance (ft): **30.7**
Structural Grade: **3**
O&M Grade: **0**
Clock Start/From: **9**
Clock To:
1st Value: **4.000**
2nd Value:
Value Percent:
Continuous Index:
Within 8" of Joint:
Remarks:

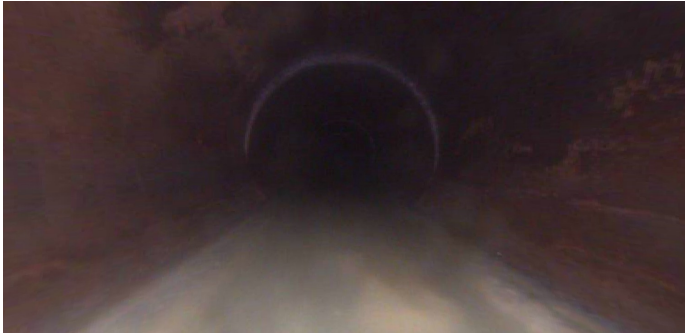
Code: **FL**
Description: **Fracture Longitudinal**

Distance (ft): **32.8**
Structural Grade: **3**
O&M Grade: **0**
Clock Start/From: **4**
Clock To:
1st Value:
2nd Value:
Value Percent:
Continuous Index:
Within 8" of Joint: **YES**
Remarks:

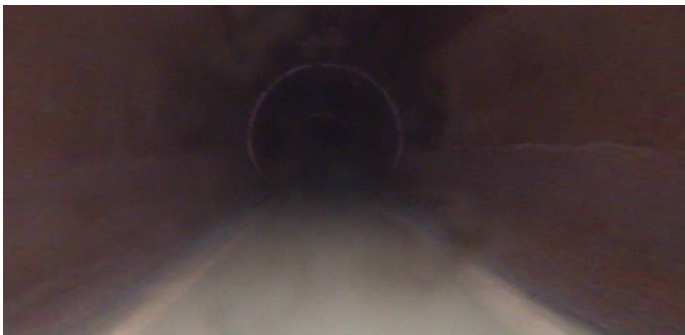
Code: **FL**
Description: **Fracture Longitudinal**

Distance (ft): **35.3**
Structural Grade: **3**
O&M Grade: **0**
Clock Start/From: **4**
Clock To:
1st Value:
2nd Value:
Value Percent:
Continuous Index:
Within 8" of Joint: **YES**
Remarks:

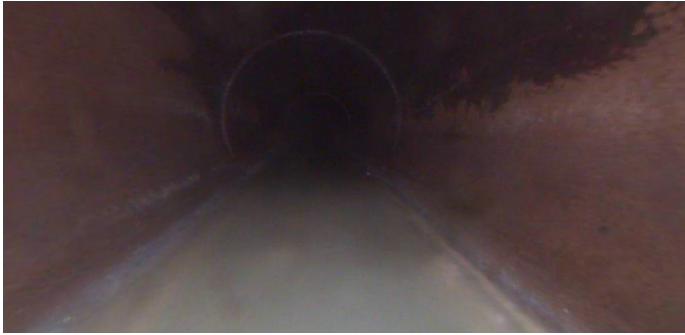
Code: **FL**
Description: **Fracture Longitudinal**

Distance (ft): **41.7**
Structural Grade: **3**
O&M Grade: **0**
Clock Start/From: **3**
Clock To:
1st Value:
2nd Value:
Value Percent:
Continuous Index:
Within 8" of Joint: **YES**
Remarks:

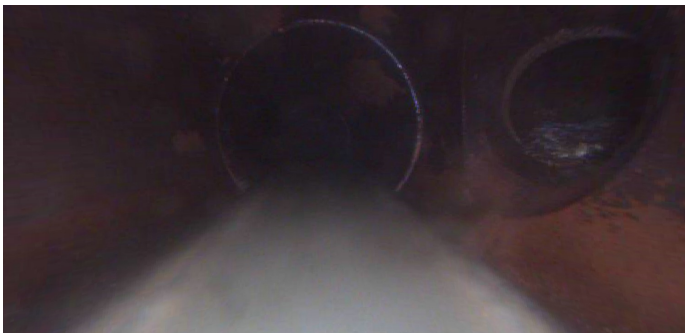
Code: **TF**
Description: **Tap Factory**

Distance (ft): **68.8**
Structural Grade: **0**
O&M Grade: **0**
Clock Start/From: **3**
Clock To:
1st Value: **4.000**
2nd Value:
Value Percent:
Continuous Index:
Within 8" of Joint:
Remarks:

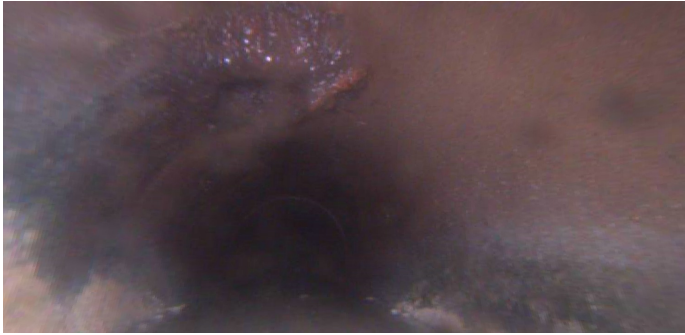
Code: **TBI**
Description: **Tap Break-in Intruding**

Distance (ft): **94.6**
Structural Grade: **0**
O&M Grade: **2**
Clock Start/From: **12**
Clock To:
1st Value: **4.000**
2nd Value: **1.000**
Value Percent:
Continuous Index:
Within 8" of Joint:
Remarks:

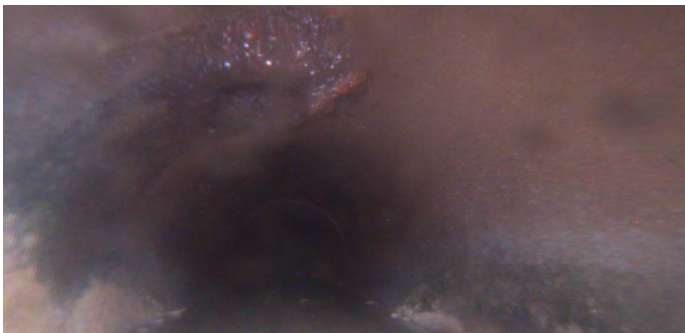
Code: **DAE**
Description: **Deposits Attached Encrustation**

Distance (ft): **94.6**
Structural Grade: **0**
O&M Grade: **2**
Clock Start/From: **12**
Clock To:
1st Value:
2nd Value:
Value Percent: **5.000**
Continuous Index:
Within 8" of Joint: **NO**
Remarks:

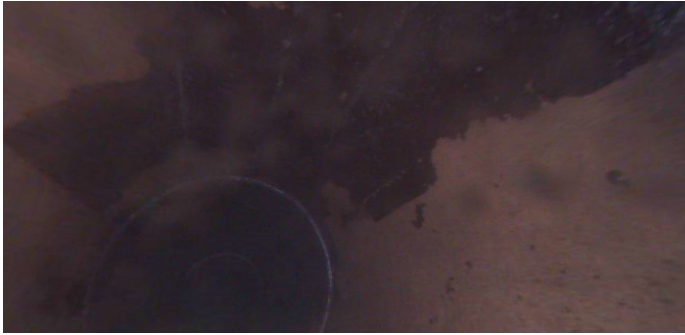
Code: **FM**
Description: **Fracture Multiple**

Distance (ft): **110.6**
Structural Grade: **4**
O&M Grade: **0**
Clock Start/From: **12**
Clock To: **2**
1st Value:
2nd Value:
Value Percent:
Continuous Index:
Within 8" of Joint: **YES**
Remarks:

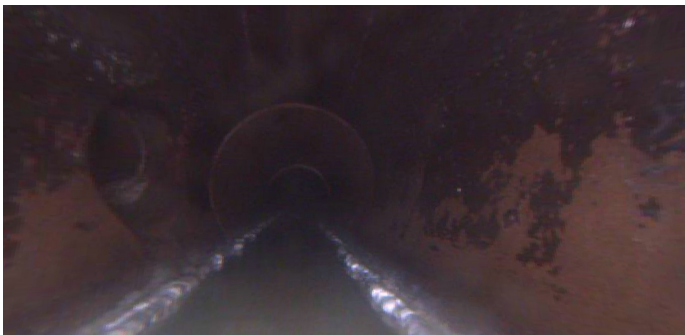
Code: **FL**
Description: **Fracture Longitudinal**

Distance (ft): **161.1**
Structural Grade: **3**
O&M Grade: **0**
Clock Start/From: **9**
Clock To:
1st Value: **4.000**
2nd Value:
Value Percent:
Continuous Index:
Within 8" of Joint:
Remarks:

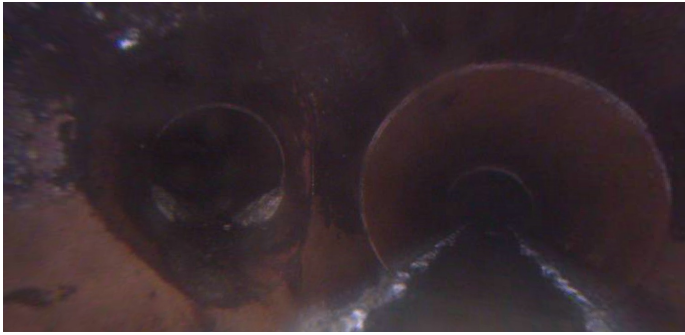
Code: **TF**
Description: **Tap Factory**

Distance (ft): **161.8**
Structural Grade: **0**
O&M Grade: **0**
Clock Start/From: **9**
Clock To:
1st Value: **4.000**
2nd Value:
Value Percent:
Continuous Index:
Within 8" of Joint:
Remarks:

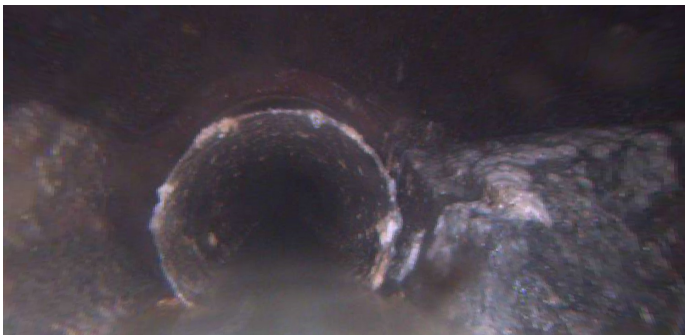
Code: **AMH**
Description: **Manhole**

Distance (ft): **182.4**
Structural Grade: **0**
O&M Grade: **0**
Clock Start/From:
Clock To:
1st Value:
2nd Value:
Value Percent:
Continuous Index:
Within 8" of Joint: **NO**
Remarks: **M-903-038**
