## Profile/Photo Observation Report

Street:	<b>37th ave</b>	Flow Control:	<b>Not Controlled</b>
City:	<b>Hobart, IN</b>	Year Renewed:	
Location:	<b>Other</b>	Tape/Media #:	
Purpose:	<b>Not Known</b>	Dia/Height:	<b>10"</b>
Use:	<b>Sanitary</b>	Material:	<b>PVC</b>
Drain Area:	<b>NA</b>	Lining:	
Category:	<b>NA</b>		
Comment:

Location Details:		Direction of Survey:	<b>Upstream</b>
US MH:	<b>M-903-038</b>	DS MH:	<b>M-903-039</b>
		Total Length Surveyed (ft):	<b>182.4</b>

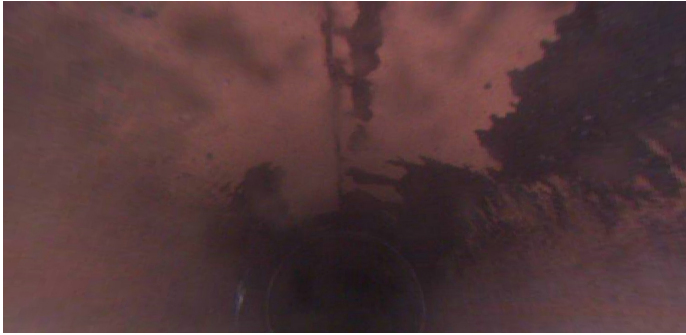
Code: **FL**  
Description: **Fracture Longitudinal**

Distance (ft): **5.4**  
Structural Grade: **3**  
O&M Grade: **0**  
Clock Start/From: **12**  
Clock To:  
1st Value:  
2nd Value:  
Value Percent:  
Continuous Index:  
Within 8" of Joint: **YES**  
Remarks:

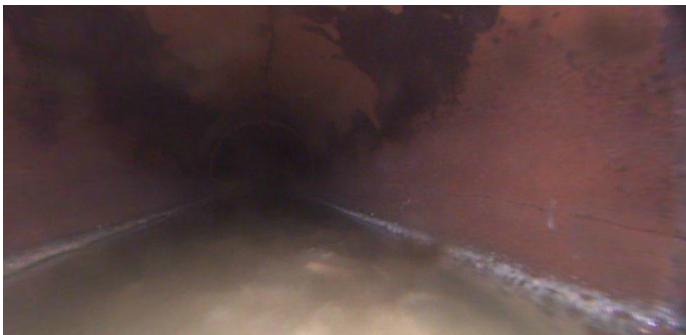
Code: **FL**  
Description: **Fracture Longitudinal**

Distance (ft): **7.3**  
Structural Grade: **3**  
O&M Grade: **0**  
Clock Start/From: **3**  
Clock To:  
1st Value:  
2nd Value:  
Value Percent:  
Continuous Index:  
Within 8" of Joint:  
Remarks:

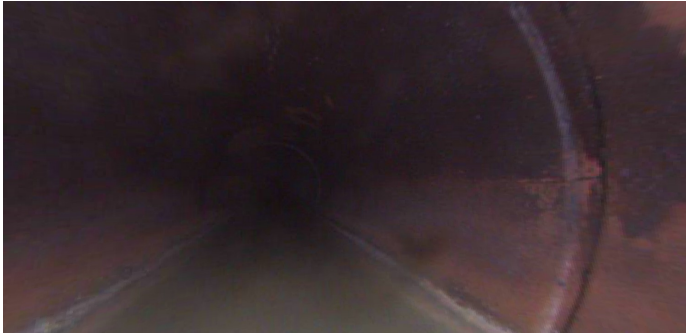
Code: **FL**  
Description: **Fracture Longitudinal**

Distance (ft): **10.1**  
Structural Grade: **3**  
O&M Grade: **0**  
Clock Start/From: **3**  
Clock To:  
1st Value:  
2nd Value:  
Value Percent:  
Continuous Index:  
Within 8" of Joint: **YES**  
Remarks:

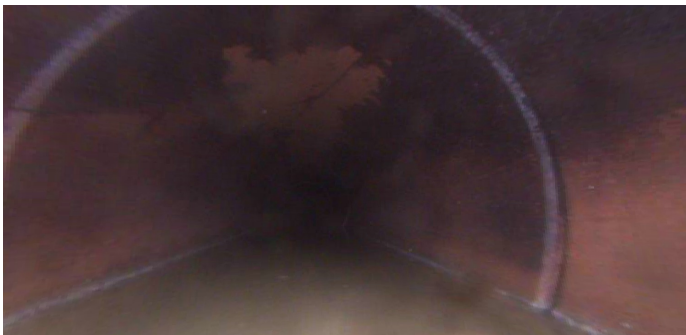
Code: **FL**  
Description: **Fracture Longitudinal**

Distance (ft): **15.9**  
Structural Grade: **3**  
O&M Grade: **0**  
Clock Start/From: **9**  
Clock To:  
1st Value:  
2nd Value:  
Value Percent:  
Continuous Index:  
Within 8" of Joint: **YES**  
Remarks:

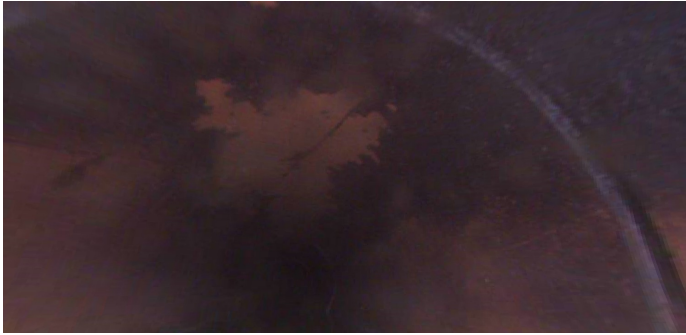
Code: **FL**  
Description: **Fracture Longitudinal**

Distance (ft): **16.1**  
Structural Grade: **3**  
O&M Grade: **0**  
Clock Start/From: **1**  
Clock To:  
1st Value:  
2nd Value:  
Value Percent:  
Continuous Index:  
Within 8" of Joint:  
Remarks:

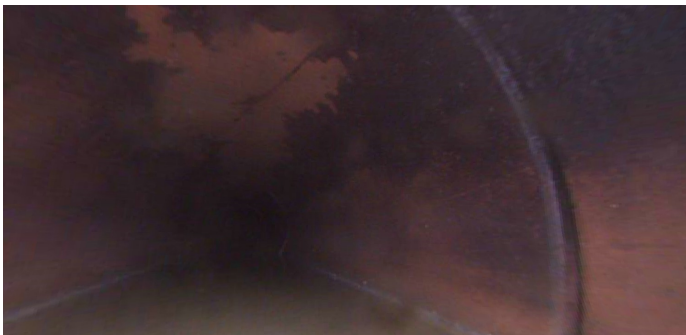
Code: **FL**  
Description: **Fracture Longitudinal**

Distance (ft): **16.1**  
Structural Grade: **3**  
O&M Grade: **0**  
Clock Start/From: **3**  
Clock To:  
1st Value:  
2nd Value:  
Value Percent:  
Continuous Index:  
Within 8" of Joint: **YES**  
Remarks:

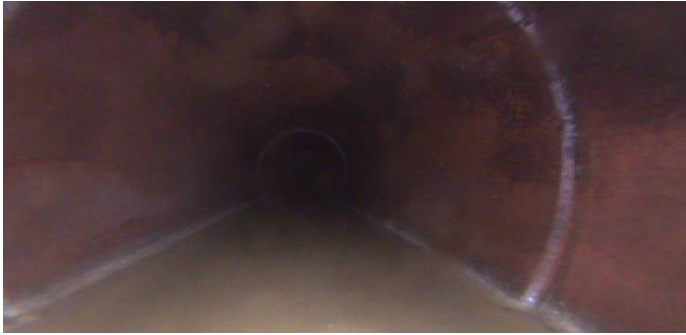
Code: **FL**  
Description: **Fracture Longitudinal**

Distance (ft): **18.9**  
Structural Grade: **3**  
O&M Grade: **0**  
Clock Start/From: **9**  
Clock To:  
1st Value:  
2nd Value:  
Value Percent:  
Continuous Index:  
Within 8" of Joint: **YES**  
Remarks:

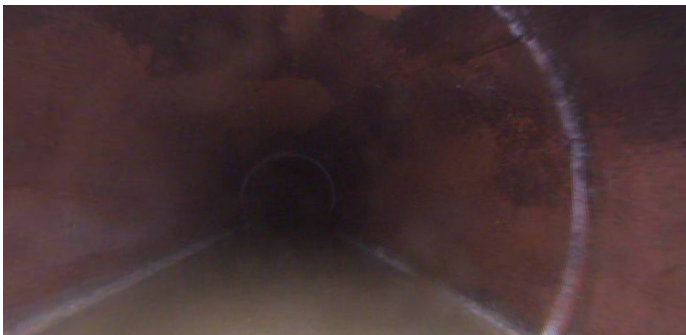
Code: **FL**  
Description: **Fracture Longitudinal**

Distance (ft): **19.0**  
Structural Grade: **3**  
O&M Grade: **0**  
Clock Start/From: **1**  
Clock To:  
1st Value:  
2nd Value:  
Value Percent:  
Continuous Index:  
Within 8" of Joint: **YES**  
Remarks:

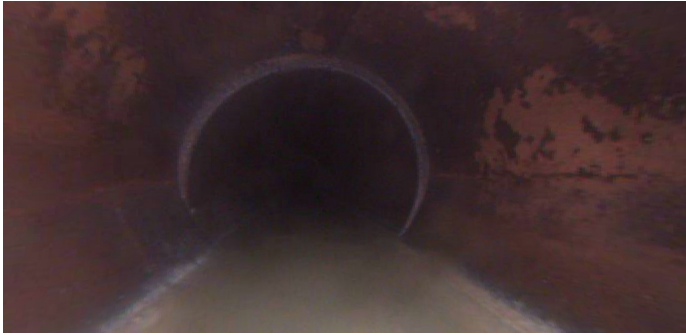
Code: **FL**  
Description: **Fracture Longitudinal**

Distance (ft): **21.2**  
Structural Grade: **3**  
O&M Grade: **0**  
Clock Start/From: **3**  
Clock To:  
1st Value:  
2nd Value:  
Value Percent:  
Continuous Index:  
Within 8" of Joint: **YES**  
Remarks:

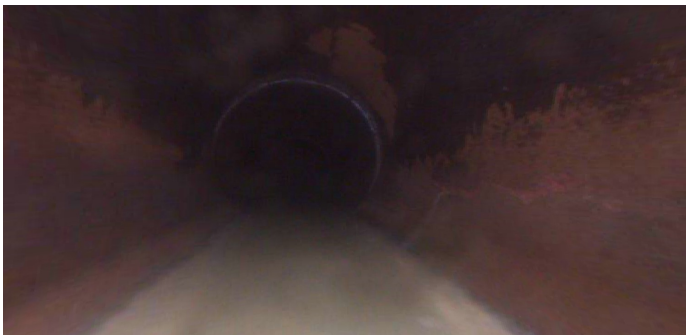
Code: **FL**  
Description: **Fracture Longitudinal**

Distance (ft): **26.6**  
Structural Grade: **3**  
O&M Grade: **0**  
Clock Start/From: **3**  
Clock To:  
1st Value:  
2nd Value:  
Value Percent:  
Continuous Index:  
Within 8" of Joint:  
Remarks:

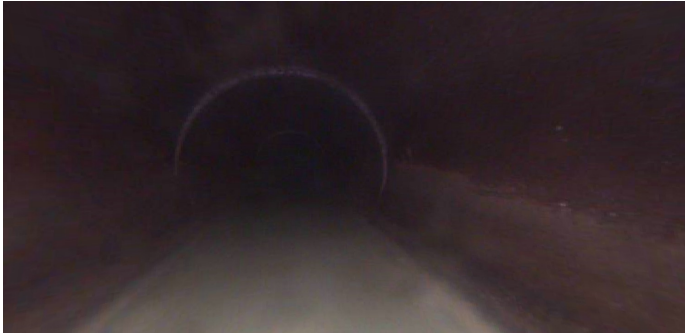
Code: **FL**  
Description: **Fracture Longitudinal**

Distance (ft): **29.9**  
Structural Grade: **3**  
O&M Grade: **0**  
Clock Start/From: **3**  
Clock To:  
1st Value: **4.000**  
2nd Value:  
Value Percent:  
Continuous Index:  
Within 8" of Joint:  
Remarks:

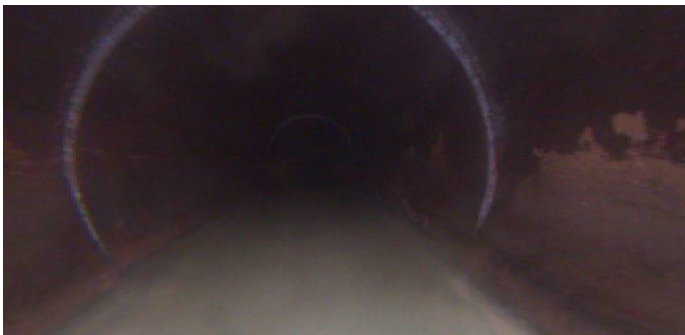
Code: **FL**  
Description: **Fracture Longitudinal**

Distance (ft): **30.7**  
Structural Grade: **3**  
O&M Grade: **0**  
Clock Start/From: **9**  
Clock To:  
1st Value: **4.000**  
2nd Value:  
Value Percent:  
Continuous Index:  
Within 8" of Joint:  
Remarks:

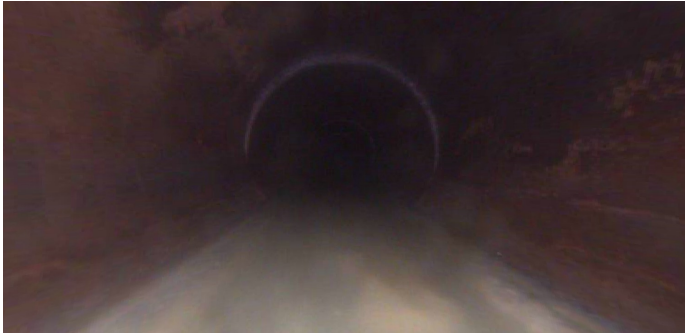
Code: **FL**  
Description: **Fracture Longitudinal**

Distance (ft): **32.8**  
Structural Grade: **3**  
O&M Grade: **0**  
Clock Start/From: **4**  
Clock To:  
1st Value:  
2nd Value:  
Value Percent:  
Continuous Index:  
Within 8" of Joint: **YES**  
Remarks:

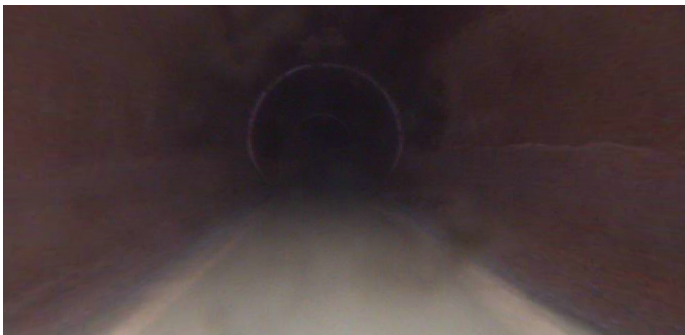
Code: **FL**  
Description: **Fracture Longitudinal**

Distance (ft): **35.3**  
Structural Grade: **3**  
O&M Grade: **0**  
Clock Start/From: **4**  
Clock To:  
1st Value:  
2nd Value:  
Value Percent:  
Continuous Index:  
Within 8" of Joint: **YES**  
Remarks:

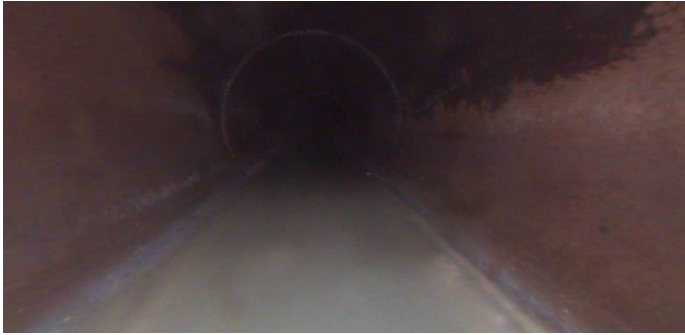
Code: **FL**  
Description: **Fracture Longitudinal**

Distance (ft): **41.7**  
Structural Grade: **3**  
O&M Grade: **0**  
Clock Start/From: **3**  
Clock To:  
1st Value:  
2nd Value:  
Value Percent:  
Continuous Index:  
Within 8" of Joint: **YES**  
Remarks:

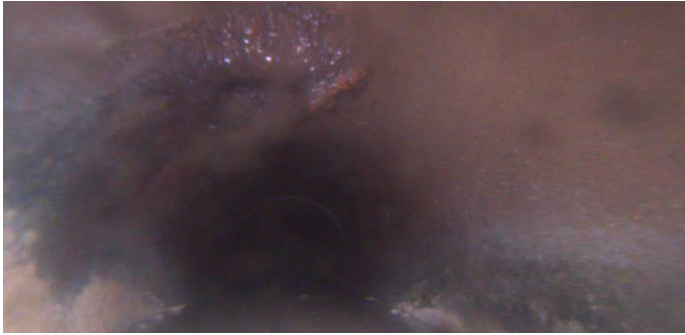
Code: **TBI**  
Description: **Tap Break-in Intruding**

Distance (ft): **94.6**  
Structural Grade: **0**  
O&M Grade: **2**  
Clock Start/From: **12**  
Clock To:  
1st Value: **4.000**  
2nd Value: **1.000**  
Value Percent:  
Continuous Index:  
Within 8" of Joint:  
Remarks:

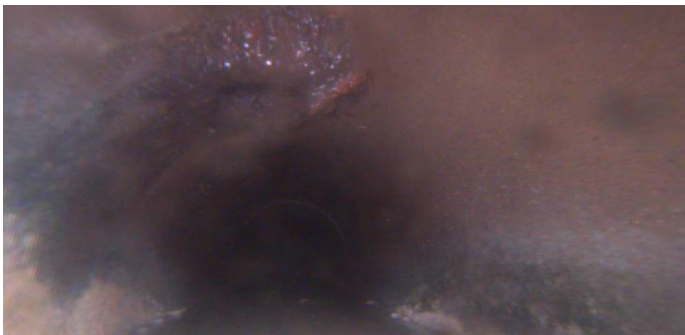
Code: **DAE**  
Description: **Deposits Attached Encrustation**

Distance (ft): **94.6**  
Structural Grade: **0**  
O&M Grade: **2**  
Clock Start/From: **12**  
Clock To:  
1st Value:  
2nd Value:  
Value Percent: **5.000**  
Continuous Index:  
Within 8" of Joint: **NO**  
Remarks:

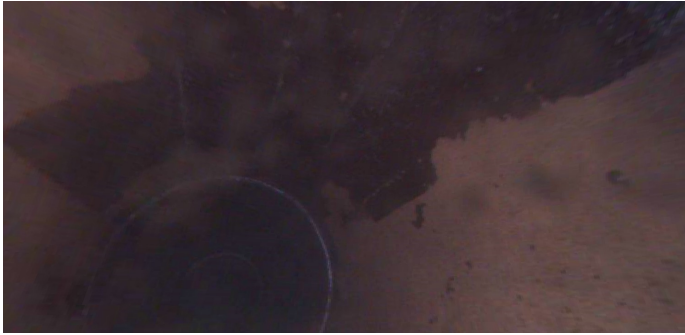
Code: **FM**  
Description: **Fracture Multiple**

Distance (ft): **110.6**  
Structural Grade: **4**  
O&M Grade: **0**  
Clock Start/From: **12**  
Clock To: **2**  
1st Value:  
2nd Value:  
Value Percent:  
Continuous Index:  
Within 8" of Joint: **YES**  
Remarks:

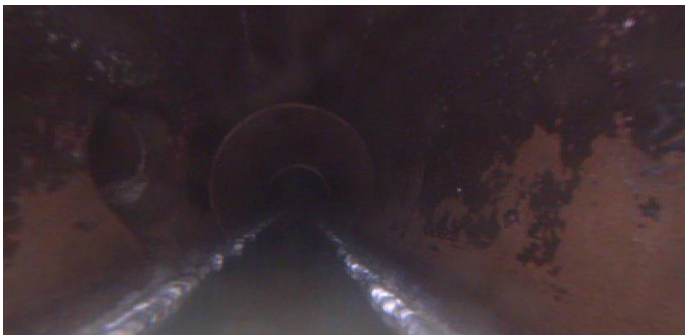
Code: **FL**  
Description: **Fracture Longitudinal**

Distance (ft): **161.1**  
Structural Grade: **3**  
O&M Grade: **0**  
Clock Start/From: **9**  
Clock To:  
1st Value: **4.000**  
2nd Value:  
Value Percent:  
Continuous Index:  
Within 8" of Joint:  
Remarks:
