Profile/Photo Observation Report

Date:	03/20/2018	Weather:		Coding:	PACP 6.0
Pipe Length (ft):	175.3	Owner:	NA	Pre Clean:	Not Known
P.O.#:		Surveyor:	Justin Gonzales	PSR:	P-903-041-040
Customer:		Clean Date:	01/01/1900	Shape:	C

Street:	E 38TH PL	Flow Control:	Not Controlled
City:	Hobart, IN	Year Renewed:	
Location:	Other	Tape/Media #:	
Purpose:	Not Known	Dia/Height:	10"
Use:	Sanitary	Material:	VCP
Drain Area:	NA	Lining:	
Category:	NA		
Comment:

Location Details:		Direction of Survey:	Upstream
US MH:	M-903-040	DS MH:	M-903-041
		Total Length Surveyed (ft):	171.7

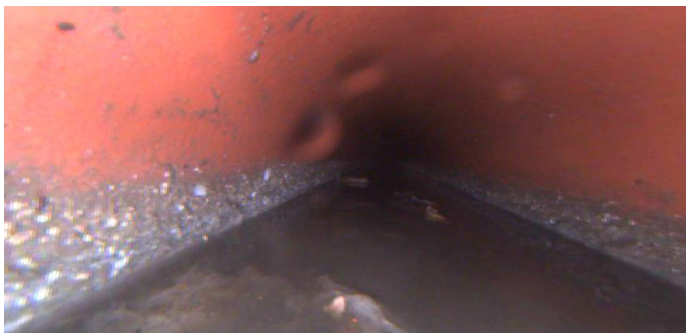
Code: **AMH**
Description: **Manhole**

Distance (ft): **.0**
Structural Grade: **0**
O&M Grade: **0**
Clock Start/From:
Clock To:
1st Value:
2nd Value:
Value Percent:
Continuous Index:
Within 8" of Joint: **NO**
Remarks: **M-903-041**

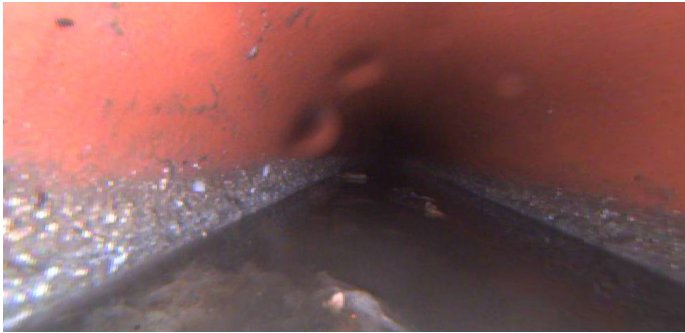
Code:	MWL
Description:	Water Level

Distance (ft):	.0
Structural Grade:	0
O&M Grade:	0
Clock Start/From:	
Clock To:	
1st Value:	
2nd Value:	
Value Percent:	15.000
Continuous Index:	
Within 8" of Joint:	NO
Remarks:

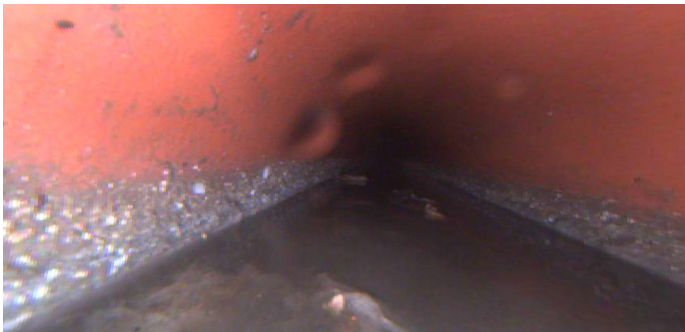
Code:	DAZ
Description:	Deposits Attached Other

Distance (ft):	.0
Structural Grade:	0
O&M Grade:	2
Clock Start/From:	8
Clock To:	4
1st Value:	
2nd Value:	
Value Percent:	5.000
Continuous Index:	S01
Within 8" of Joint:	YES
Remarks:	WANDER

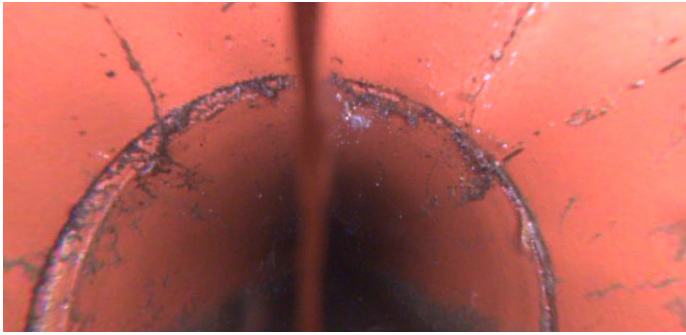
Code: **RFJ**
Description: **Roots Fine Joint**

Distance (ft): **10.5**
Structural Grade: **0**
O&M Grade: **1**
Clock Start/From: **8**
Clock To: **4**
1st Value:
2nd Value:
Value Percent:
Continuous Index: **S02**
Within 8" of Joint: **YES**
Remarks:

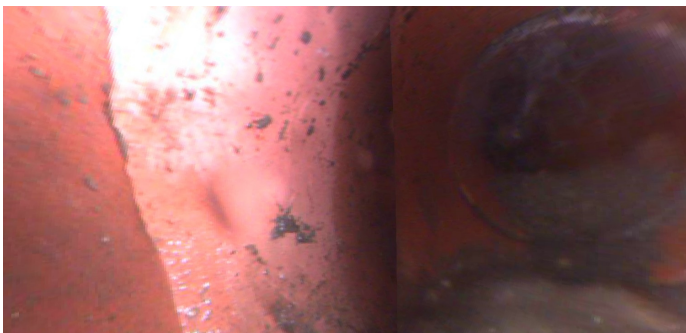
Code: **TF**
Description: **Tap Factory**

Distance (ft): **39.0**
Structural Grade: **0**
O&M Grade: **0**
Clock Start/From: **3**
Clock To:
1st Value: **4.000**
2nd Value:
Value Percent:
Continuous Index:
Within 8" of Joint:
Remarks:

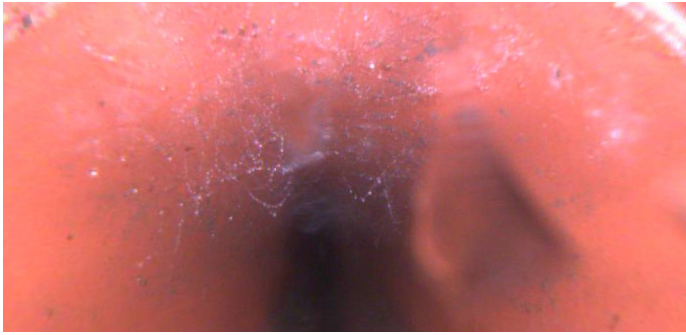
Code: **RFJ**
Description: **Roots Fine Joint**

Distance (ft): **45.1**
Structural Grade: **0**
O&M Grade: **1**
Clock Start/From: **8**
Clock To: **4**
1st Value:
2nd Value:
Value Percent:
Continuous Index: **F02**
Within 8" of Joint: **YES**
Remarks:

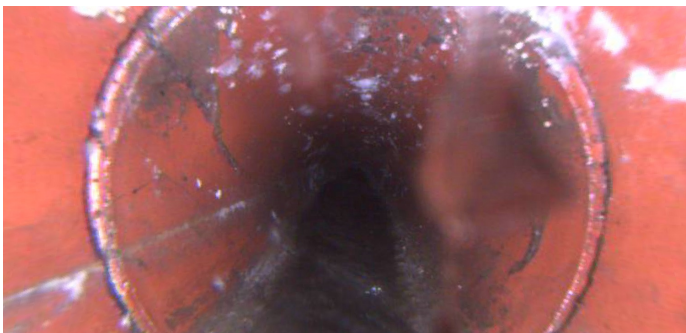
Code: **RFJ**
Description: **Roots Fine Joint**

Distance (ft): **72.2**
Structural Grade: **0**
O&M Grade: **1**
Clock Start/From: **10**
Clock To:
1st Value:
2nd Value:
Value Percent:
Continuous Index:
Within 8" of Joint: **YES**
Remarks:

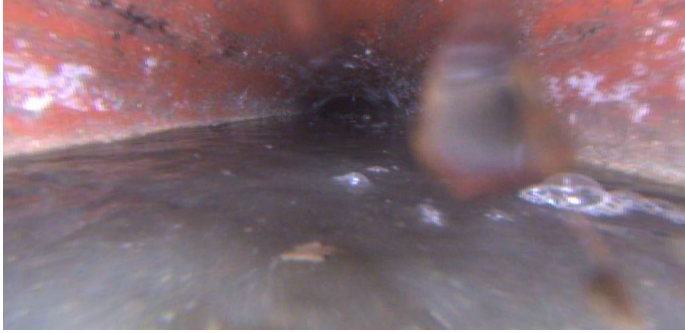
Code: **MWLS**
Description: **Water Level Sag**

Distance (ft): **75.4**
Structural Grade: **3**
O&M Grade: **3**
Clock Start/From:
Clock To:
1st Value:
2nd Value:
Value Percent: **50.000**
Continuous Index:
Within 8" of Joint: **NO**
Remarks:

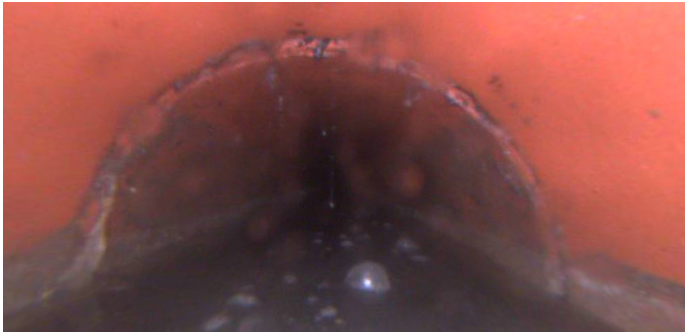
Code: **RFJ**
Description: **Roots Fine Joint**

Distance (ft): **83.3**
Structural Grade: **0**
O&M Grade: **1**
Clock Start/From: **8**
Clock To: **4**
1st Value:
2nd Value:
Value Percent:
Continuous Index:
Within 8" of Joint: **YES**
Remarks:

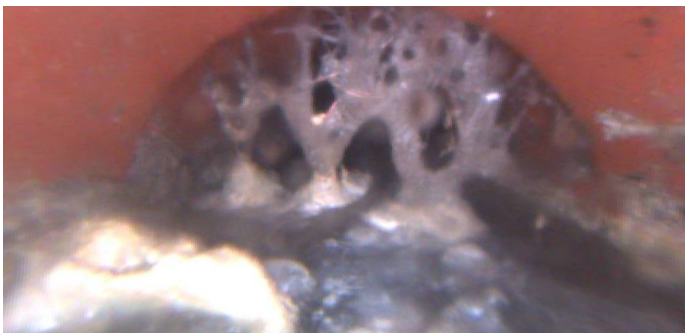
Code: **RMJ**
Description: **Roots Medium Joint**

Distance (ft): **105.3**
Structural Grade: **0**
O&M Grade: **3**
Clock Start/From: **8**
Clock To: **4**
1st Value:
2nd Value:
Value Percent: **10.000**
Continuous Index:
Within 8" of Joint: **YES**
Remarks:

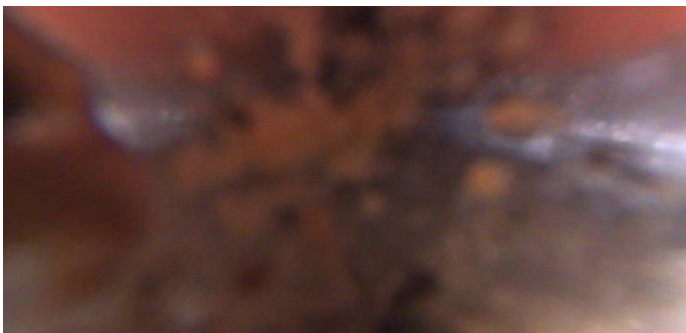
Code: **MGO**
Description: **General Observation**

Distance (ft): **115.1**
Structural Grade: **0**
O&M Grade: **0**
Clock Start/From:
Clock To:
1st Value:
2nd Value:
Value Percent:
Continuous Index:
Within 8" of Joint: **NO**
Remarks: **FRONT LENS OBSTRUCTED**

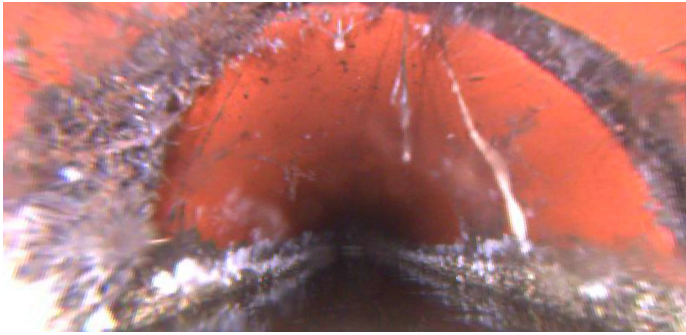
Code: **RMJ**
Description: **Roots Medium Joint**

Distance (ft): **116.8**
Structural Grade: **0**
O&M Grade: **3**
Clock Start/From: **7**
Clock To: **5**
1st Value:
2nd Value:
Value Percent: **10.000**
Continuous Index:
Within 8" of Joint: **YES**
Remarks:

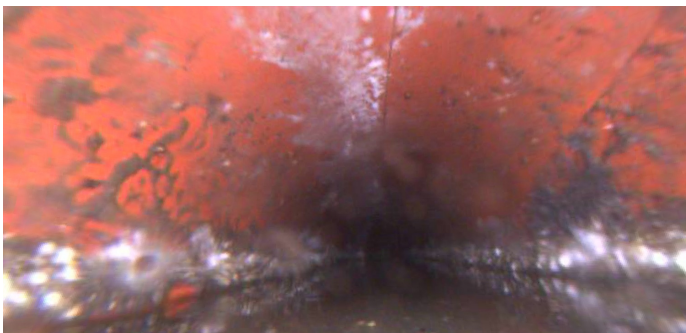
Code: **FM**
Description: **Fracture Multiple**

Distance (ft): **119.9**
Structural Grade: **4**
O&M Grade: **0**
Clock Start/From: **10**
Clock To: **2**
1st Value:
2nd Value:
Value Percent:
Continuous Index:
Within 8" of Joint:
Remarks:

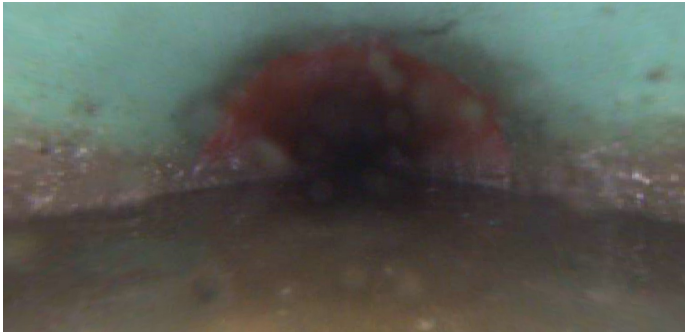
Code: **RPR**
Description: **Repair Point Pipe Replaced**

Distance (ft): **159.2**
Structural Grade: **0**
O&M Grade: **0**
Clock Start/From:
Clock To:
1st Value:
2nd Value:
Value Percent:
Continuous Index:
Within 8" of Joint: **NO**
Remarks: **VCP TO PVC**

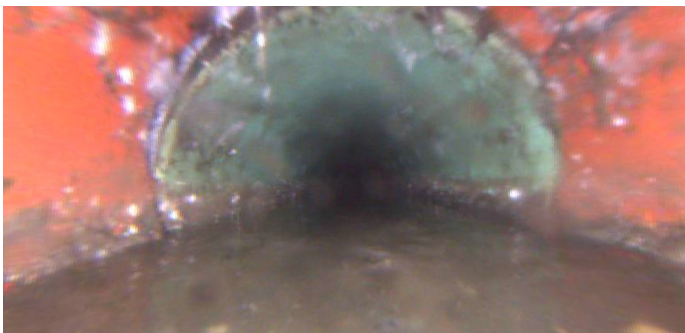
Code: **RPR**
Description: **Repair Point Pipe Replaced**

Distance (ft): **161.6**
Structural Grade: **0**
O&M Grade: **0**
Clock Start/From:
Clock To:
1st Value:
2nd Value:
Value Percent:
Continuous Index:
Within 8" of Joint: **NO**
Remarks: **PVC TO VCP; PVC END**
