## Profile/Photo Observation Report

Date:	<b>03/20/2018</b>	Weather:		Coding:	<b>PACP 6.0</b>
Pipe Length (ft):	<b>175.3</b>	Owner:	<b>NA</b>	Pre Clean:	<b>Not Known</b>
P.O.#:		Surveyor:	<b>Justin Gonzales</b>	PSR:	<b>P-903-041-040</b>
Customer:		Clean Date:	<b>01/01/1900</b>	Shape:	<b>C</b>

Street:	<b>38th pl</b>	Flow Control:	<b>Not Controlled</b>
City:	<b>Hobart, IN</b>	Year Renewed:	
Location:	<b>Other</b>	Tape/Media #:	
Purpose:	<b>Not Known</b>	Dia/Height:	<b>10"</b>
Use:	<b>Sanitary</b>	Material:	<b>VCP</b>
Drain Area:	<b>NA</b>	Lining:	
Category:	<b>NA</b>		
Comment:

Location Details:		Direction of Survey:	<b>Upstream</b>
US MH:	<b>M-903-040</b>	DS MH:	<b>M-903-041</b>
		Total Length Surveyed (ft):	<b>171.7</b>

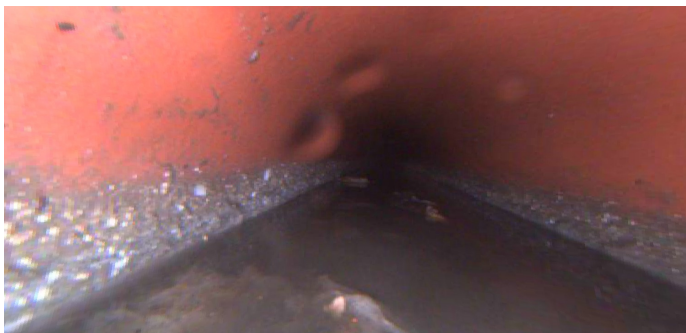
Code: **AMH**  
Description: **Manhole**

Distance (ft): **.0**  
Structural Grade: **0**  
O&M Grade: **0**  
Clock Start/From:  
Clock To:  
1st Value:  
2nd Value:  
Value Percent:  
Continuous Index:  
Within 8" of Joint: **NO**  
Remarks: **M-903-041**

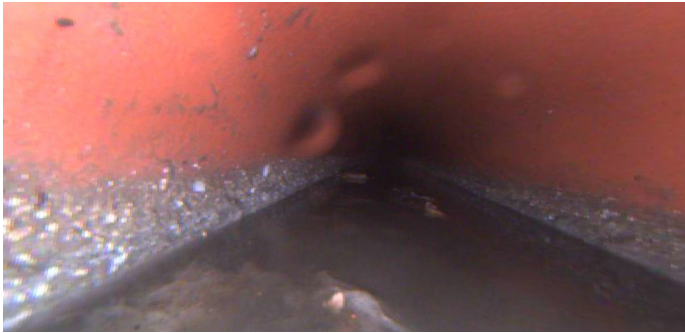
Code:	<b>MWL</b>
Description:	<b>Water Level</b>

Distance (ft):	<b>.0</b>
Structural Grade:	<b>0</b>
O&M Grade:	<b>0</b>
Clock Start/From:	
Clock To:	
1st Value:	
2nd Value:	
Value Percent:	<b>15.000</b>
Continuous Index:	
Within 8" of Joint:	<b>NO</b>
Remarks:

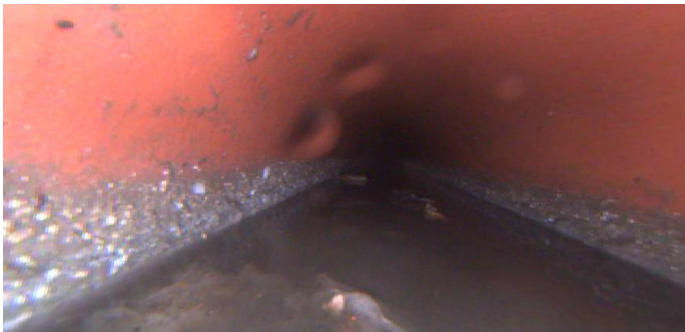
Code:	<b>DAZ</b>
Description:	<b>Deposits Attached Other</b>

Distance (ft):	<b>.0</b>
Structural Grade:	<b>0</b>
O&M Grade:	<b>2</b>
Clock Start/From:	<b>8</b>
Clock To:	<b>4</b>
1st Value:	
2nd Value:	
Value Percent:	<b>5.000</b>
Continuous Index:	<b>S01</b>
Within 8" of Joint:	<b>YES</b>
Remarks:	<b>WANDER</b>

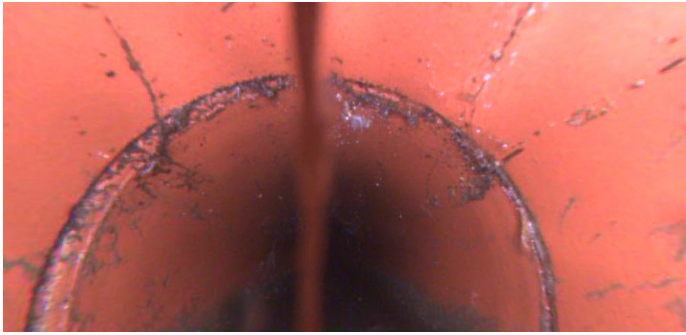
Code: **RFJ**  
Description: **Roots Fine Joint**

Distance (ft): **10.5**  
Structural Grade: **0**  
O&M Grade: **1**  
Clock Start/From: **8**  
Clock To: **4**  
1st Value:  
2nd Value:  
Value Percent:  
Continuous Index: **S02**  
Within 8" of Joint: **YES**  
Remarks:

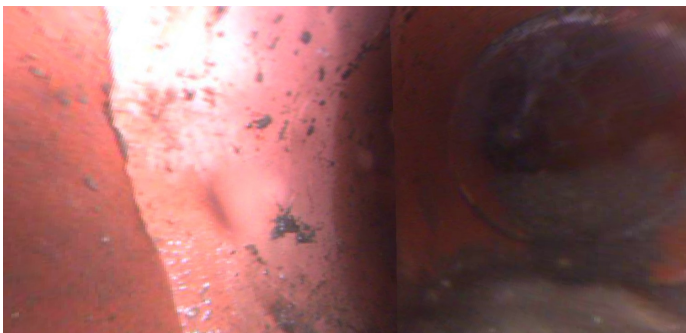
Code: **TF**  
Description: **Tap Factory**

Distance (ft): **39.0**  
Structural Grade: **0**  
O&M Grade: **0**  
Clock Start/From: **3**  
Clock To:  
1st Value: **4.000**  
2nd Value:  
Value Percent:  
Continuous Index:  
Within 8" of Joint:  
Remarks:

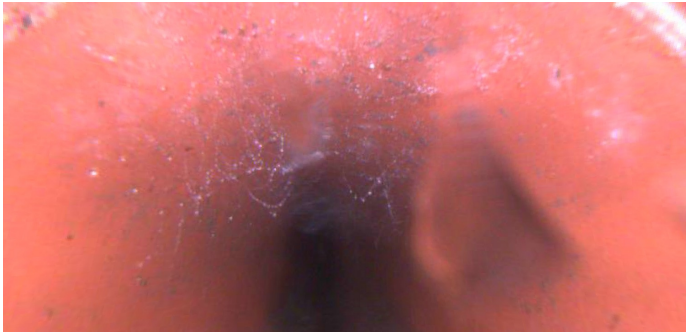
Code: **RFJ**  
Description: **Roots Fine Joint**

Distance (ft): **45.1**  
Structural Grade: **0**  
O&M Grade: **1**  
Clock Start/From: **8**  
Clock To: **4**  
1st Value:  
2nd Value:  
Value Percent:  
Continuous Index: **F02**  
Within 8" of Joint: **YES**  
Remarks:

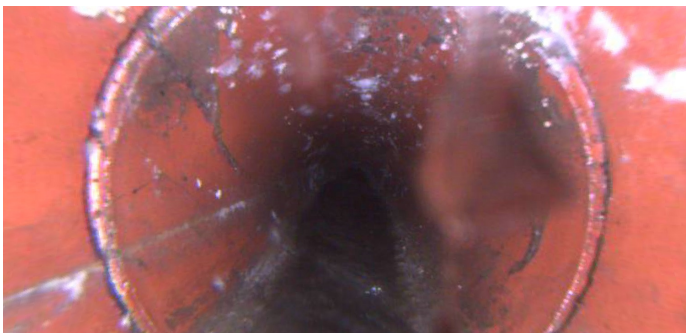
Code: **RFJ**  
Description: **Roots Fine Joint**

Distance (ft): **72.2**  
Structural Grade: **0**  
O&M Grade: **1**  
Clock Start/From: **10**  
Clock To:  
1st Value:  
2nd Value:  
Value Percent:  
Continuous Index:  
Within 8" of Joint: **YES**  
Remarks:

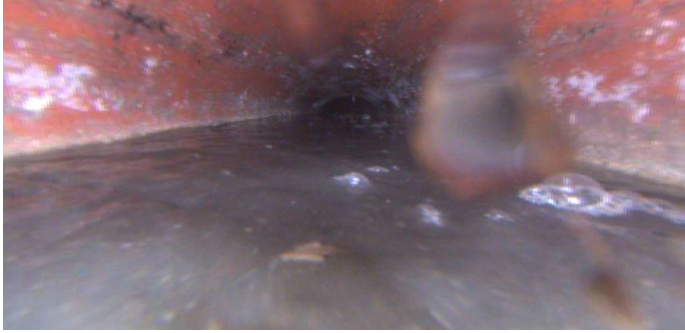
Code: **MWLS**  
Description: **Water Level Sag**

Distance (ft): **75.4**  
Structural Grade: **3**  
O&M Grade: **3**  
Clock Start/From:  
Clock To:  
1st Value:  
2nd Value:  
Value Percent: **50.000**  
Continuous Index:  
Within 8" of Joint: **NO**  
Remarks:

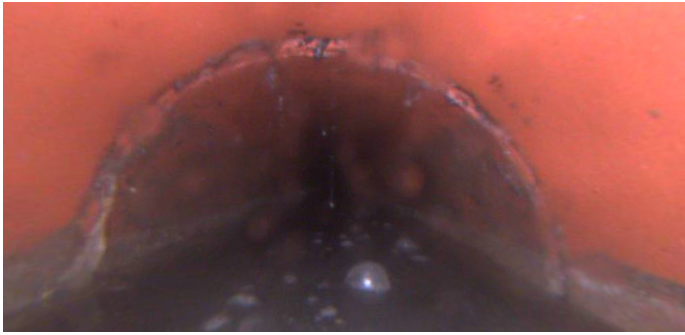
Code: **RFJ**  
Description: **Roots Fine Joint**

Distance (ft): **83.3**  
Structural Grade: **0**  
O&M Grade: **1**  
Clock Start/From: **8**  
Clock To: **4**  
1st Value:  
2nd Value:  
Value Percent:  
Continuous Index:  
Within 8" of Joint: **YES**  
Remarks:

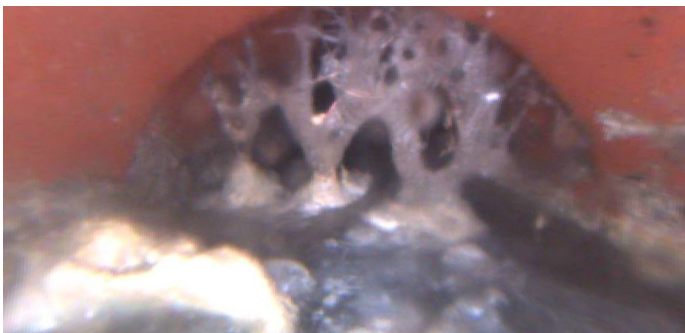
Code: **RMJ**  
Description: **Roots Medium Joint**

Distance (ft): **105.3**  
Structural Grade: **0**  
O&M Grade: **3**  
Clock Start/From: **8**  
Clock To: **4**  
1st Value:  
2nd Value:  
Value Percent: **10.000**  
Continuous Index:  
Within 8" of Joint: **YES**  
Remarks:

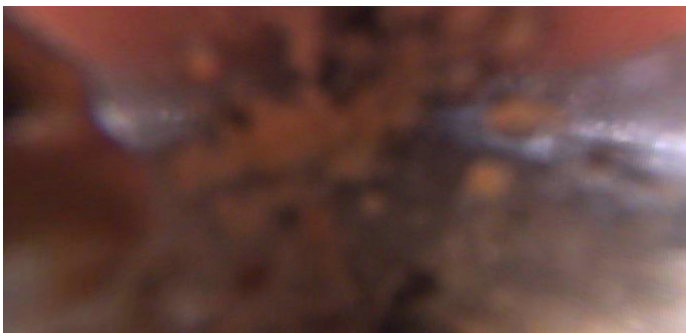
Code: **MGO**  
Description: **General Observation**

Distance (ft): **115.1**  
Structural Grade: **0**  
O&M Grade: **0**  
Clock Start/From:  
Clock To:  
1st Value:  
2nd Value:  
Value Percent:  
Continuous Index:  
Within 8" of Joint: **NO**  
Remarks: **FRONT LENS OBSTRUCTED**

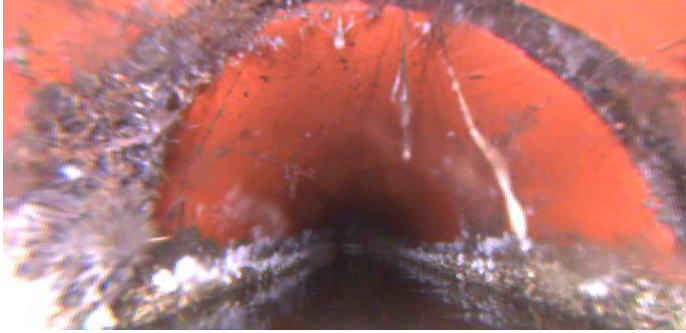
Code: **RMJ**  
Description: **Roots Medium Joint**

Distance (ft): **116.8**  
Structural Grade: **0**  
O&M Grade: **3**  
Clock Start/From: **7**  
Clock To: **5**  
1st Value:  
2nd Value:  
Value Percent: **10.000**  
Continuous Index:  
Within 8" of Joint: **YES**  
Remarks:

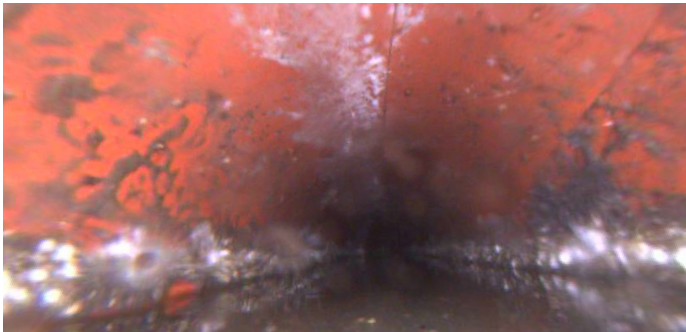
Code: **FM**  
Description: **Fracture Multiple**

Distance (ft): **119.9**  
Structural Grade: **4**  
O&M Grade: **0**  
Clock Start/From: **10**  
Clock To: **2**  
1st Value:  
2nd Value:  
Value Percent:  
Continuous Index:  
Within 8" of Joint:  
Remarks:

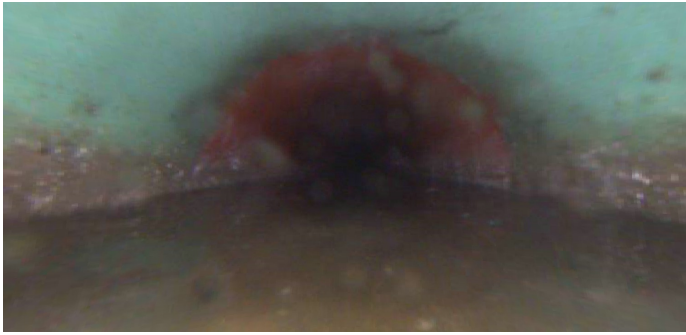
Code: **RPR**  
Description: **Repair Point Pipe Replaced**

Distance (ft): **159.2**  
Structural Grade: **0**  
O&M Grade: **0**  
Clock Start/From:  
Clock To:  
1st Value:  
2nd Value:  
Value Percent:  
Continuous Index:  
Within 8" of Joint: **NO**  
Remarks: **VCP TO PVC**

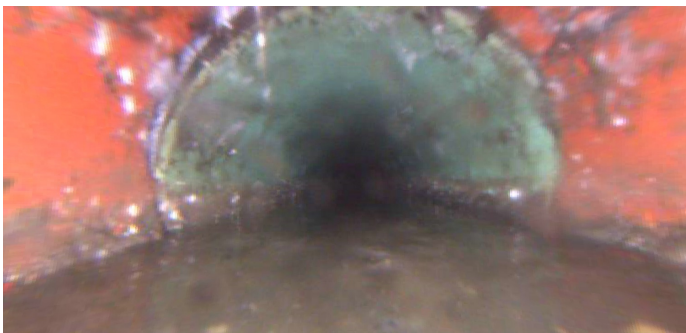
Code: **RPR**  
Description: **Repair Point Pipe Replaced**

Distance (ft): **161.6**  
Structural Grade: **0**  
O&M Grade: **0**  
Clock Start/From:  
Clock To:  
1st Value:  
2nd Value:  
Value Percent:  
Continuous Index:  
Within 8" of Joint: **NO**  
Remarks: **PVC TO VCP; PVC END**
