## Profile/Photo Observation Report

Street:	<b>E 38TH PL</b>	Flow Control:	<b>Not Controlled</b>
City:	<b>Hobart, IN</b>	Year Renewed:	
Location:	<b>Other</b>	Tape/Media #:	
Purpose:	<b>Not Known</b>	Dia/Height:	<b>10"</b>
Use:	<b>Sanitary</b>	Material:	<b>VCP</b>
Drain Area:	<b>NA</b>	Lining:	
Category:	<b>NA</b>		
Comment:

Location Details:		Direction of Survey:	<b>Downstream</b>
US MH:	<b>M-903-041</b>	DS MH:	<b>M-903-042</b>
		Total Length Surveyed (ft):	<b>50.2</b>

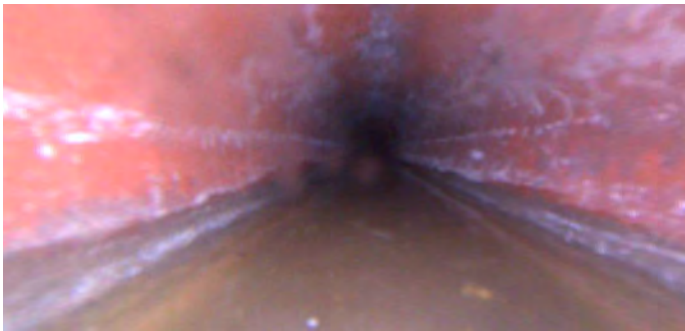
Code: **AMH**  
Description: **Manhole**

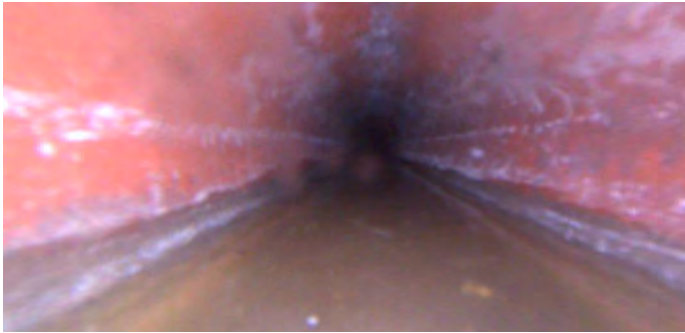
Code:	<b>MWL</b>
Description:	<b>Water Level</b>

Distance (ft):	<b>.0</b>
Structural Grade:	<b>0</b>
O&M Grade:	<b>0</b>
Clock Start/From:	
Clock To:	
1st Value:	
2nd Value:	
Value Percent:	<b>5.000</b>
Continuous Index:	
Within 8" of Joint:	<b>NO</b>
Remarks:

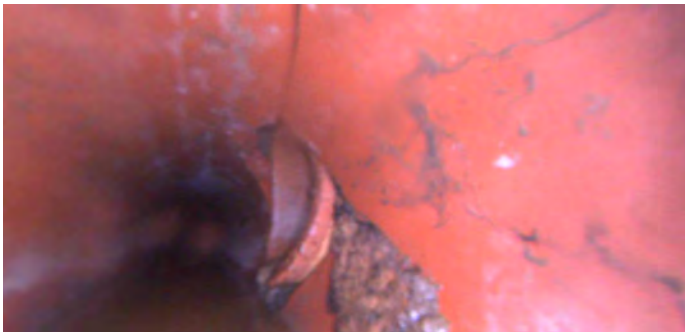
Code:	<b>FM</b>
Description:	<b>Fracture Multiple</b>

Distance (ft):	<b>5.7</b>
Structural Grade:	<b>4</b>
O&M Grade:	<b>0</b>
Clock Start/From:	<b>11</b>
Clock To:	<b>5</b>
1st Value:	
2nd Value:	
Value Percent:	
Continuous Index:	
Within 8" of Joint:	
Remarks:

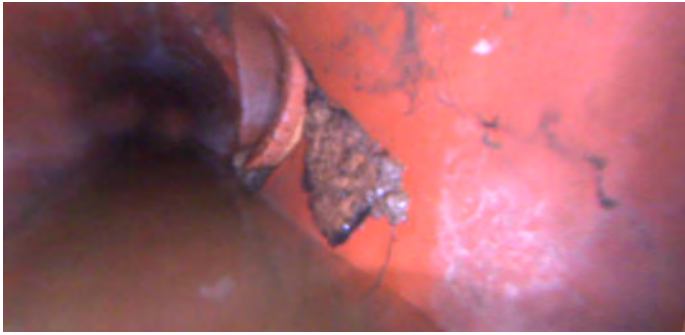
Code: **HVV**  
Description: **Hole Void Visible**

Distance (ft): **5.7**  
Structural Grade: **5**  
O&M Grade: **0**  
Clock Start/From: **3**  
Clock To: **5**  
1st Value:  
2nd Value:  
Value Percent:  
Continuous Index:  
Within 8" of Joint:  
Remarks:

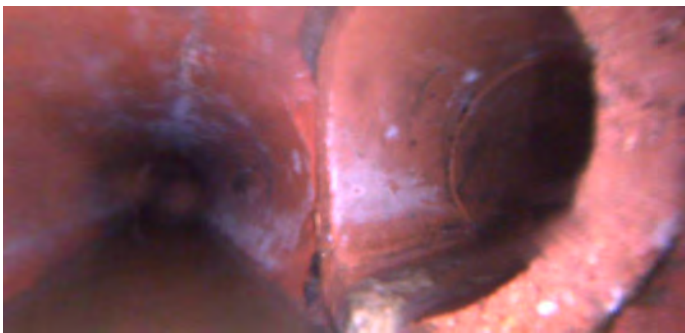
Code: **TBI**  
Description: **Tap Break-in Intruding**

Distance (ft): **6.4**  
Structural Grade: **0**  
O&M Grade: **2**  
Clock Start/From: **3**  
Clock To:  
1st Value: **4.000**  
2nd Value: **1.000**  
Value Percent:  
Continuous Index:  
Within 8" of Joint:  
Remarks:

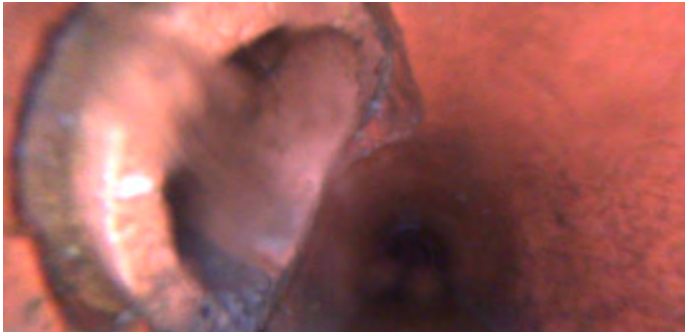
Code: **TBI**  
Description: **Tap Break-in Intruding**

Distance (ft): **10.5**  
Structural Grade: **0**  
O&M Grade: **2**  
Clock Start/From: **9**  
Clock To:  
1st Value: **4.000**  
2nd Value: **1.000**  
Value Percent:  
Continuous Index:  
Within 8" of Joint:  
Remarks:

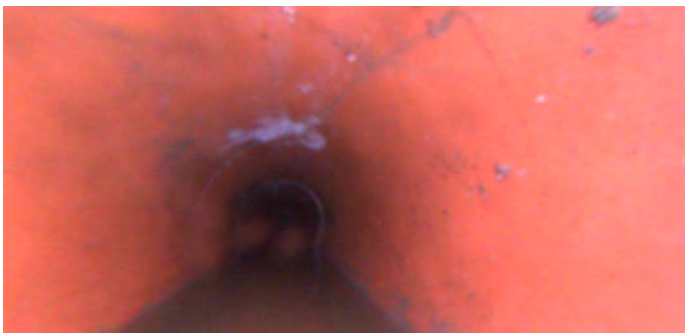
Code: **FM**  
Description: **Fracture Multiple**

Distance (ft): **12.7**  
Structural Grade: **4**  
O&M Grade: **0**  
Clock Start/From: **7**  
Clock To: **5**  
1st Value:  
2nd Value:  
Value Percent:  
Continuous Index:  
Within 8" of Joint:  
Remarks:

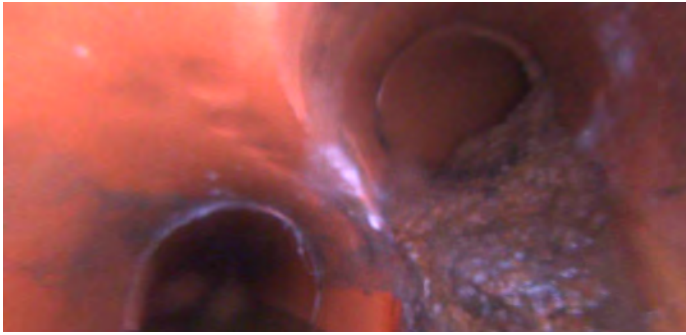
Code: **TF**  
Description: **Tap Factory**

Distance (ft): **21.3**  
Structural Grade: **0**  
O&M Grade: **0**  
Clock Start/From: **2**  
Clock To:  
1st Value: **4.000**  
2nd Value:  
Value Percent:  
Continuous Index:  
Within 8" of Joint:  
Remarks:

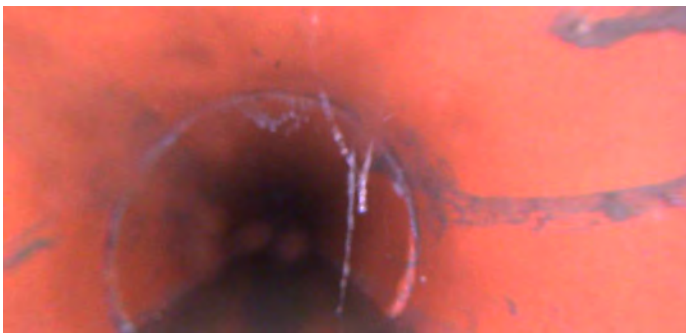
Code: **RFJ**  
Description: **Roots Fine Joint**

Distance (ft): **32.7**  
Structural Grade: **0**  
O&M Grade: **1**  
Clock Start/From: **1**  
Clock To:  
1st Value:  
2nd Value:  
Value Percent:  
Continuous Index:  
Within 8" of Joint: **YES**  
Remarks:

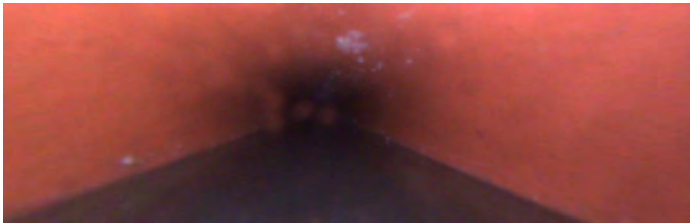
Code:	MSA
Description:	Abandoned Survey
Distance (ft):	50.2
Structural Grade:	0
O&M Grade:	0
Clock Start/From:	
Clock To:	
1st Value:	
2nd Value:	
Value Percent:	
Continuous Index:	
Within 8" of Joint:	NO
Remarks:	CAMERA STOPPED
