Profile/Photo Observation Report

| Street: | 38th pl | Flow Control: | Not Controlled |
| City: | Hobart, IN | Year Renewed: | |

| US MH: | M-903-041 | DS MH: | M-903-042 |

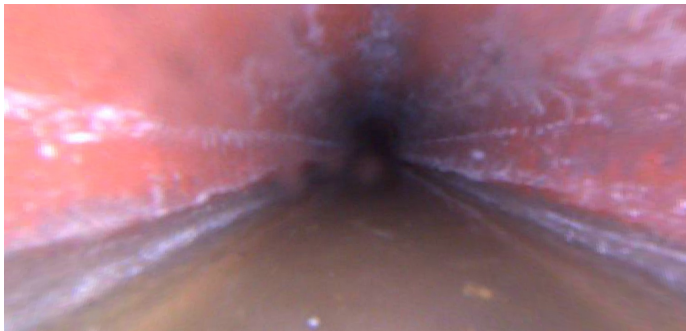
Code: **AMH**
Description: **Manhole**

Distance (ft): **.0**
Structural Grade: **0**
O&M Grade: **0**
Clock Start/From:
Clock To:
1st Value:
2nd Value:
Value Percent:
Continuous Index:
Within 8" of Joint: **NO**
Remarks: **M-903-041**

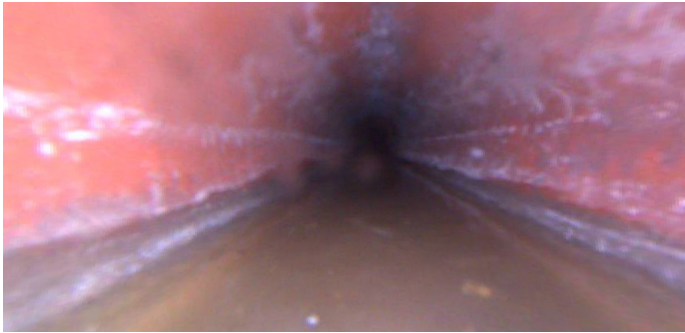
| Description: | Water Level |

| Value Percent: | 5.000 |

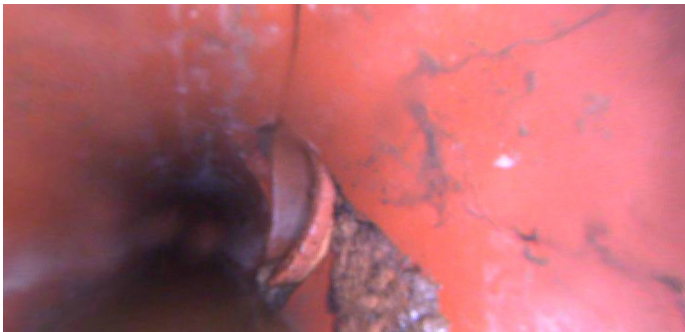
| Description: | Fracture Multiple |

| Distance (ft): | 5.7 |
| Structural Grade: | 4 |
| Clock Start/From: | 11 |
| Clock To: | 5 |

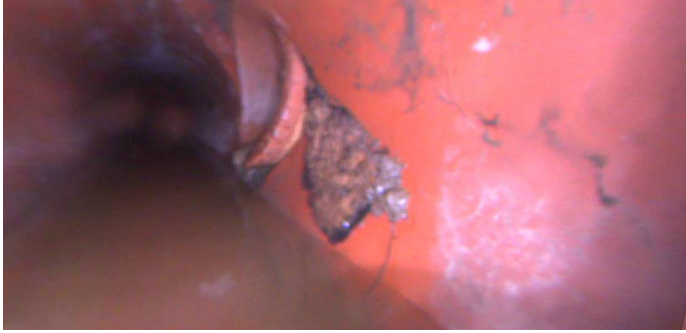
Code: **HVV**
Description: **Hole Void Visible**

Distance (ft): **5.7**
Structural Grade: **5**
O&M Grade: **0**
Clock Start/From: **3**
Clock To: **5**
1st Value:
2nd Value:
Value Percent:
Continuous Index:
Within 8" of Joint:
Remarks:

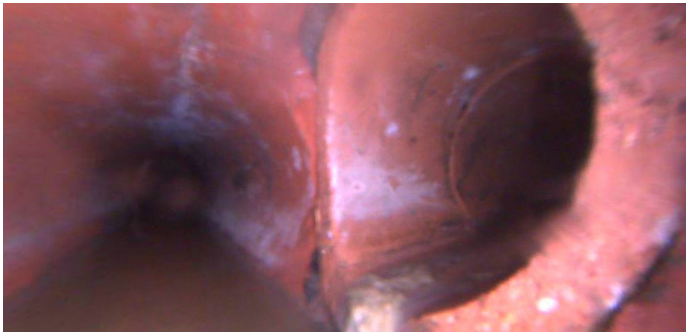
Code: **TBI**
Description: **Tap Break-in Intruding**

Distance (ft): **6.4**
Structural Grade: **0**
O&M Grade: **2**
Clock Start/From: **3**
Clock To:
1st Value: **4.000**
2nd Value: **1.000**
Value Percent:
Continuous Index:
Within 8" of Joint:
Remarks:

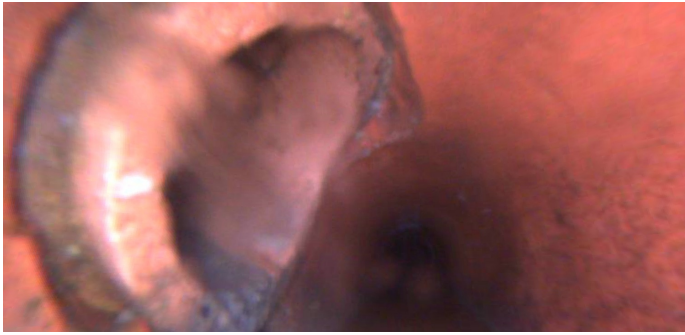
Code: **TBI**
Description: **Tap Break-in Intruding**

Distance (ft): **10.5**
Structural Grade: **0**
O&M Grade: **2**
Clock Start/From: **9**
Clock To:
1st Value: **4.000**
2nd Value: **1.000**
Value Percent:
Continuous Index:
Within 8" of Joint:
Remarks:

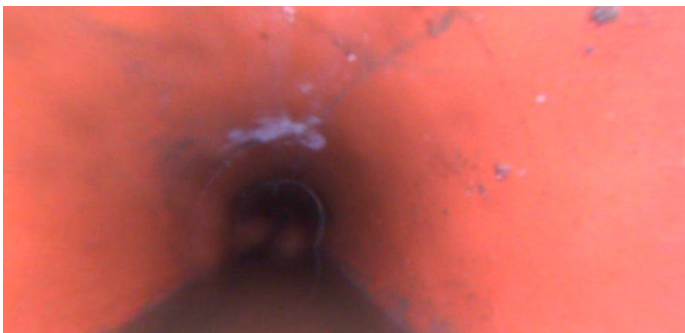
Code: **FM**
Description: **Fracture Multiple**

Distance (ft): **12.7**
Structural Grade: **4**
O&M Grade: **0**
Clock Start/From: **7**
Clock To: **5**
1st Value:
2nd Value:
Value Percent:
Continuous Index:
Within 8" of Joint:
Remarks:

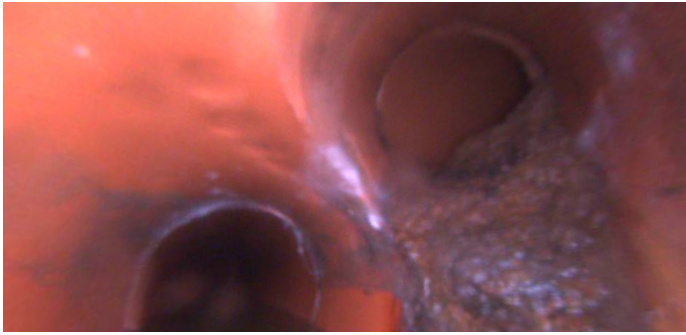
Code: **TF**
Description: **Tap Factory**

Distance (ft): **21.3**
Structural Grade: **0**
O&M Grade: **0**
Clock Start/From: **2**
Clock To:
1st Value: **4.000**
2nd Value:
Value Percent:
Continuous Index:
Within 8" of Joint:
Remarks:

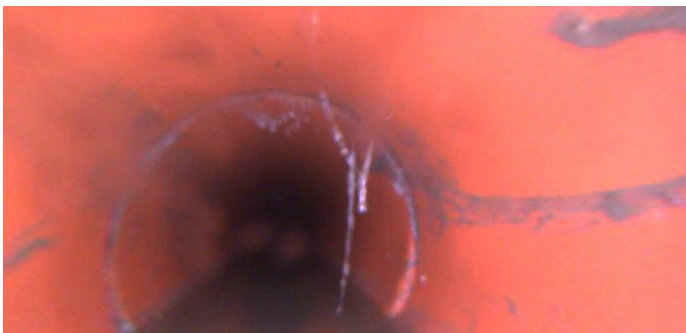
Code: **RFJ**
Description: **Roots Fine Joint**

Distance (ft): **32.7**
Structural Grade: **0**
O&M Grade: **1**
Clock Start/From: **1**
Clock To:
1st Value:
2nd Value:
Value Percent:
Continuous Index:
Within 8" of Joint: **YES**
Remarks:

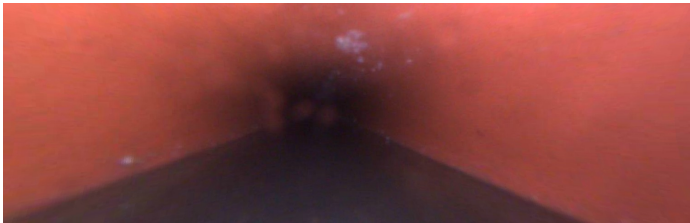
| Description: | Abandoned Survey |
| Distance (ft): | 50.2 |
| Remarks: | cAMERA STOPPED |
