Profile/Photo Observation Report

Date:	03/21/2018	Weather:		Coding:	PACP 6.0
Pipe Length (ft):	278.5	Owner:	NA	Pre Clean:	Not Known
P.O.#:		Surveyor:	Selasie Honu	PSR:	P-903-042-041
Customer:		Clean Date:	01/01/1900	Shape:	C

Street:	E 38TH PL	Flow Control:	Not Controlled
City:	Hobart, IN	Year Renewed:	
Location:	Other	Tape/Media #:	
Purpose:	Not Known	Dia/Height:	10"
Use:	Sanitary	Material:	VCP
Drain Area:	NA	Lining:	
Category:	NA		
Comment:

Location Details:		Direction of Survey:	Upstream
US MH:	M-903-041	DS MH:	M-903-042
		Total Length Surveyed (ft):	272.8

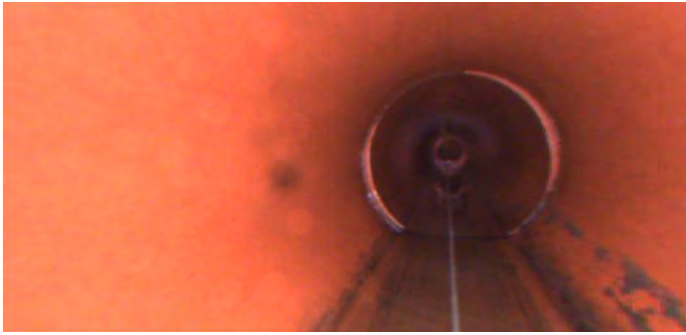
Code: **MGO**
Description: **General Observation**

Distance (ft): **5.3**
Structural Grade: **0**
O&M Grade: **0**
Clock Start/From:
Clock To:
1st Value:
2nd Value:
Value Percent:
Continuous Index:
Within 8" of Joint: **NO**
Remarks: **switched to rear view**

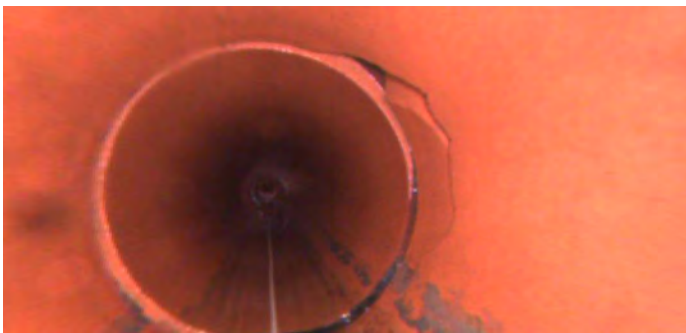
Code: **FC**
Description: **Fracture Circumferential**

Distance (ft): **10.1**
Structural Grade: **2**
O&M Grade: **0**
Clock Start/From: **1**
Clock To: **4**
1st Value:
2nd Value:
Value Percent:
Continuous Index:
Within 8" of Joint: **YES**
Remarks:

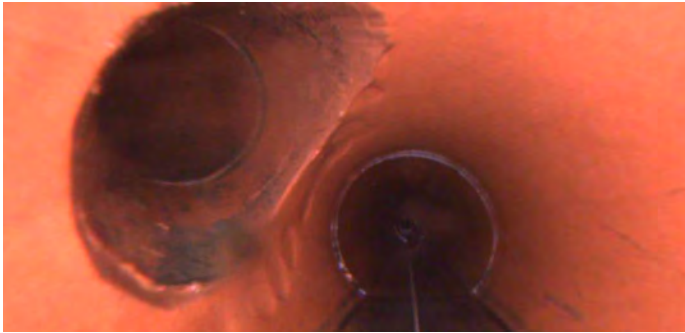
Code: **TF**
Description: **Tap Factory**

Distance (ft): **16.2**
Structural Grade: **0**
O&M Grade: **0**
Clock Start/From: **2**
Clock To:
1st Value: **4.000**
2nd Value:
Value Percent:
Continuous Index:
Within 8" of Joint:
Remarks:

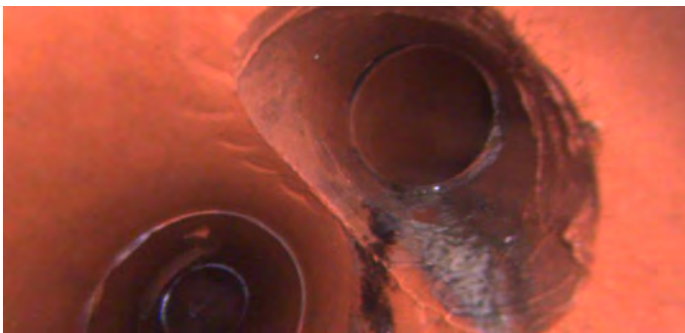
Code: **TF**
Description: **Tap Factory**

Distance (ft): **18.2**
Structural Grade: **0**
O&M Grade: **0**
Clock Start/From: **10**
Clock To:
1st Value: **4.000**
2nd Value:
Value Percent:
Continuous Index:
Within 8" of Joint:
Remarks:

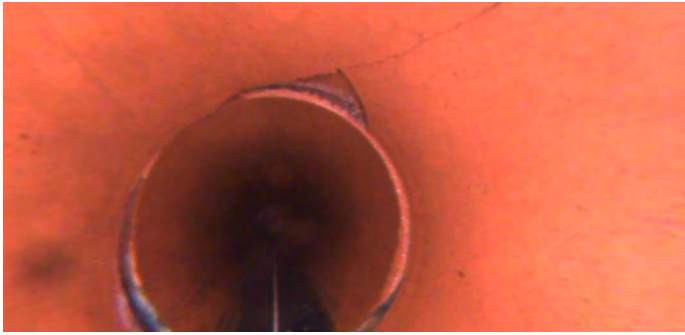
Code: **HVV**
Description: **Hole Void Visible**

Distance (ft): **41.4**
Structural Grade: **5**
O&M Grade: **0**
Clock Start/From: **12**
Clock To: **1**
1st Value:
2nd Value:
Value Percent:
Continuous Index:
Within 8" of Joint: **YES**
Remarks:

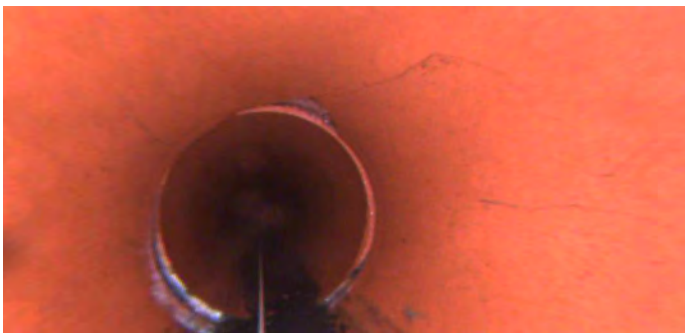
Code: **FM**
Description: **Fracture Multiple**

Distance (ft): **41.6**
Structural Grade: **4**
O&M Grade: **0**
Clock Start/From: **11**
Clock To: **3**
1st Value:
2nd Value:
Value Percent:
Continuous Index:
Within 8" of Joint: **YES**
Remarks:

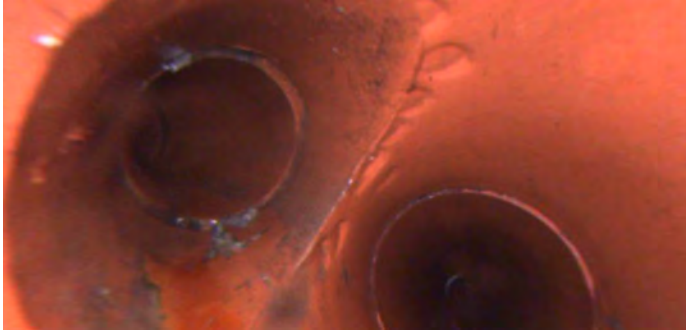
Code: **TF**
Description: **Tap Factory**

Distance (ft): **63.4**
Structural Grade: **0**
O&M Grade: **0**
Clock Start/From: **2**
Clock To:
1st Value: **4.000**
2nd Value:
Value Percent:
Continuous Index:
Within 8" of Joint:
Remarks:

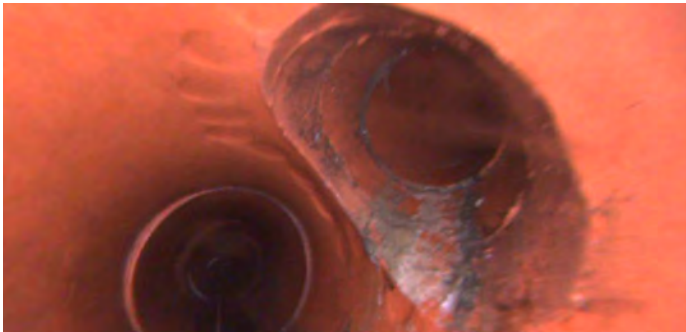
Code: **TF**
Description: **Tap Factory**

Distance (ft): **65.7**
Structural Grade: **0**
O&M Grade: **0**
Clock Start/From: **10**
Clock To:
1st Value: **4.000**
2nd Value:
Value Percent:
Continuous Index:
Within 8" of Joint:
Remarks:

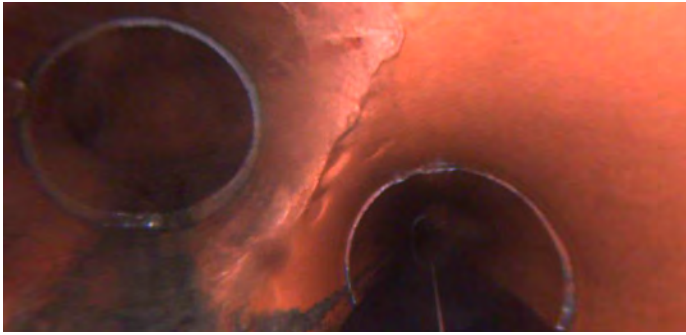
Code: **TFA**
Description: **Tap Factory Active**

Distance (ft): **121.6**
Structural Grade: **0**
O&M Grade: **0**
Clock Start/From: **2**
Clock To:
1st Value: **4.000**
2nd Value:
Value Percent:
Continuous Index:
Within 8" of Joint:
Remarks:

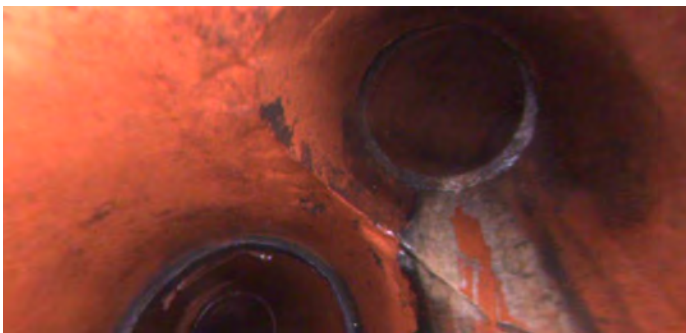
Code: **TF**
Description: **Tap Factory**

Distance (ft): **123.7**
Structural Grade: **0**
O&M Grade: **0**
Clock Start/From: **10**
Clock To:
1st Value: **4.000**
2nd Value:
Value Percent:
Continuous Index:
Within 8" of Joint:
Remarks:

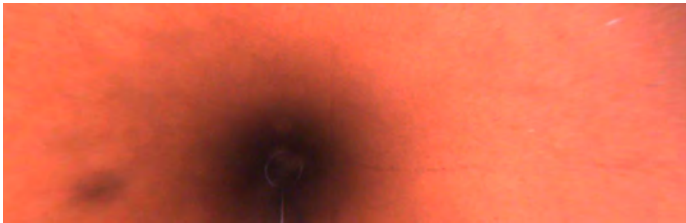
Code: **FL**
Description: **Fracture Longitudinal**

Distance (ft): **172.6**
Structural Grade: **3**
O&M Grade: **0**
Clock Start/From: **3**
Clock To:
1st Value:
2nd Value:
Value Percent:
Continuous Index:
Within 8" of Joint:
Remarks:

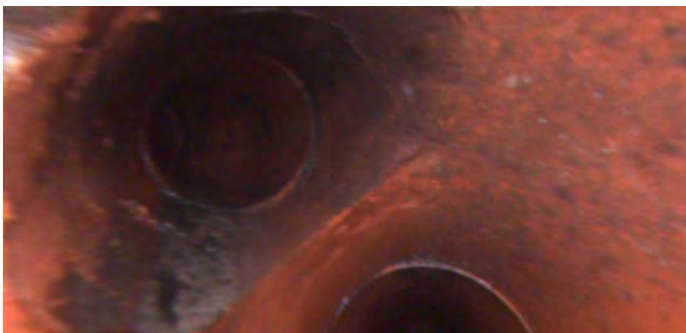
Code: **TF**
Description: **Tap Factory**

Distance (ft): **196.9**
Structural Grade: **0**
O&M Grade: **0**
Clock Start/From: **1**
Clock To:
1st Value: **4.000**
2nd Value:
Value Percent:
Continuous Index:
Within 8" of Joint:
Remarks:

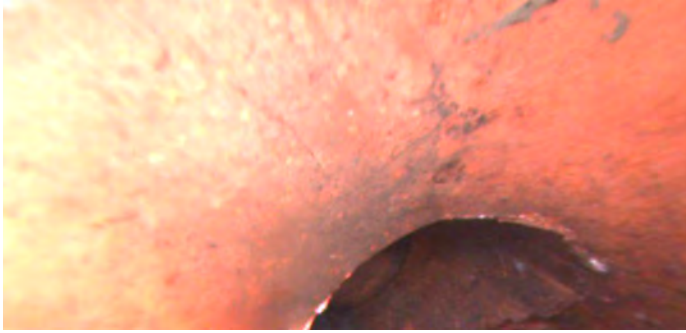
Code: **CL**
Description: **Crack Longitudinal**

Distance (ft): **197.2**
Structural Grade: **2**
O&M Grade: **0**
Clock Start/From: **1**
Clock To:
1st Value:
2nd Value:
Value Percent:
Continuous Index:
Within 8" of Joint:
Remarks:

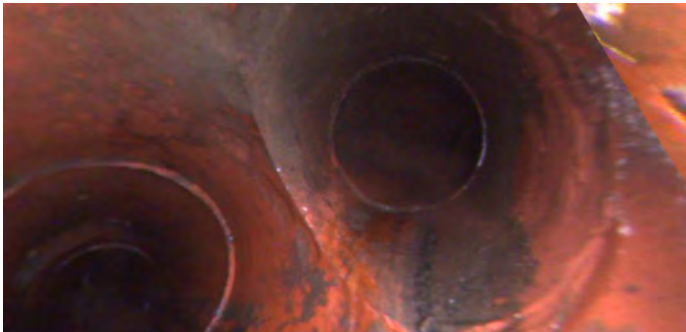
Code: **TF**
Description: **Tap Factory**

Distance (ft): **198.8**
Structural Grade: **0**
O&M Grade: **0**
Clock Start/From: **10**
Clock To:
1st Value: **4.000**
2nd Value:
Value Percent:
Continuous Index:
Within 8" of Joint:
Remarks:

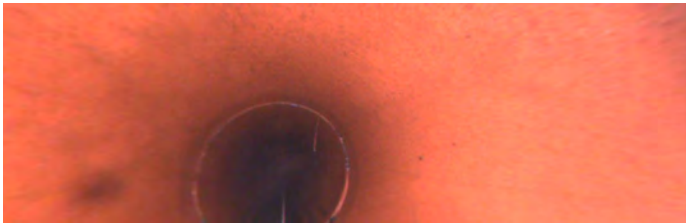
Code: **RFJ**
Description: **Roots Fine Joint**

Distance (ft): **238.5**
Structural Grade: **0**
O&M Grade: **1**
Clock Start/From: **1**
Clock To:
1st Value:
2nd Value:
Value Percent:
Continuous Index:
Within 8" of Joint: **YES**
Remarks:

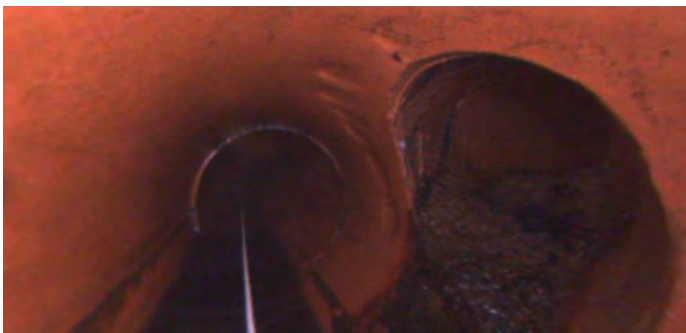
Code: **TFA**
Description: **Tap Factory Active**

Distance (ft): **249.6**
Structural Grade: **0**
O&M Grade: **0**
Clock Start/From: **9**
Clock To:
1st Value: **4.000**
2nd Value:
Value Percent:
Continuous Index:
Within 8" of Joint:
Remarks:

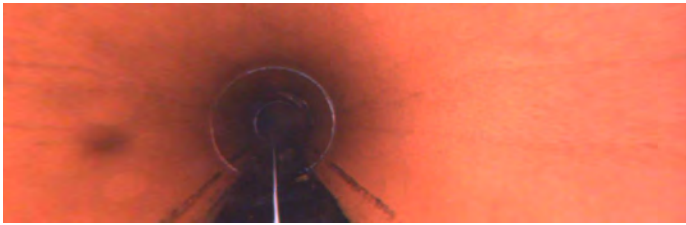
Code: **FL**
Description: **Fracture Longitudinal**

Distance (ft): **251.4**
Structural Grade: **3**
O&M Grade: **0**
Clock Start/From: **2**
Clock To:
1st Value:
2nd Value:
Value Percent:
Continuous Index: **S01**
Within 8" of Joint:
Remarks:

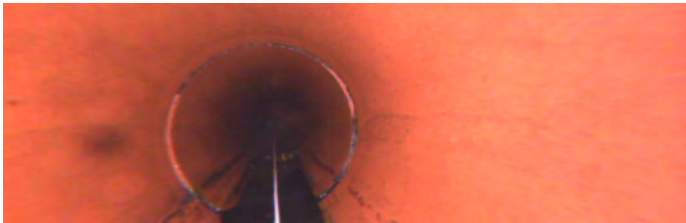
Code: **FL**
Description: **Fracture Longitudinal**

Distance (ft): **256.4**
Structural Grade: **3**
O&M Grade: **0**
Clock Start/From: **3**
Clock To:
1st Value:
2nd Value:
Value Percent:
Continuous Index:
Within 8" of Joint: **YES**
Remarks:

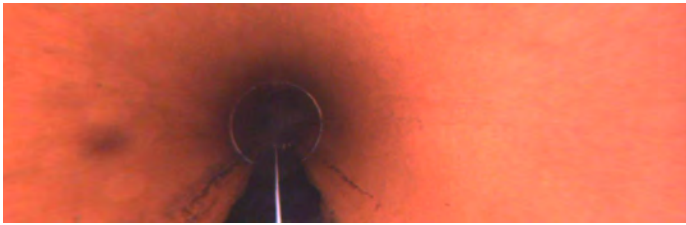
Code: **FL**
Description: **Fracture Longitudinal**

Distance (ft): **257.2**
Structural Grade: **3**
O&M Grade: **0**
Clock Start/From: **2**
Clock To:
1st Value:
2nd Value:
Value Percent:
Continuous Index: **F01**
Within 8" of Joint:
Remarks:

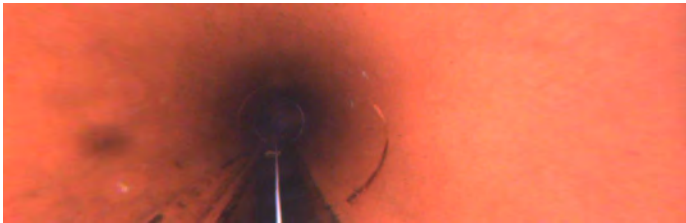
Code: **FC**
Description: **Fracture Circumferential**

Distance (ft): **258.6**
Structural Grade: **2**
O&M Grade: **0**
Clock Start/From: **7**
Clock To: **5**
1st Value:
2nd Value:
Value Percent:
Continuous Index:
Within 8" of Joint:
Remarks:

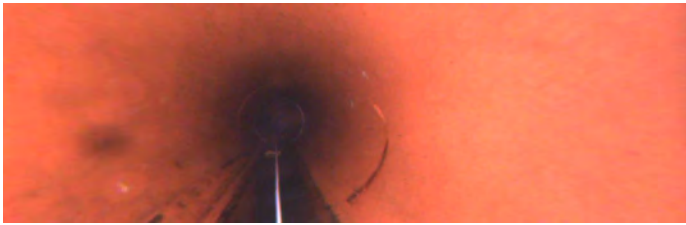
Code: **DAE**
Description: **Deposits Attached Encrustation**

Distance (ft): **258.6**
Structural Grade: **0**
O&M Grade: **2**
Clock Start/From: **3**
Clock To: **5**
1st Value:
2nd Value:
Value Percent: **5.000**
Continuous Index:
Within 8" of Joint: **NO**
Remarks:

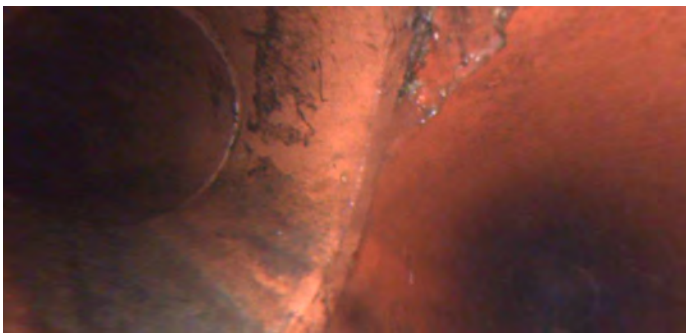
Code: **TBI**
Description: **Tap Break-in Intruding**

Distance (ft): **259.8**
Structural Grade: **0**
O&M Grade: **2**
Clock Start/From: **3**
Clock To:
1st Value: **4.000**
2nd Value: **1.000**
Value Percent:
Continuous Index:
Within 8" of Joint:
Remarks:

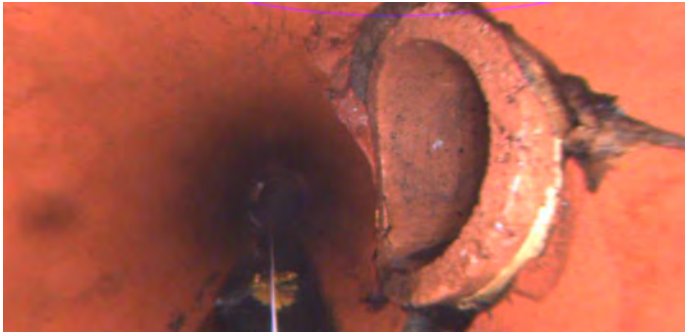
Code: **TBI**
Description: **Tap Break-in Intruding**

Distance (ft): **264.4**
Structural Grade: **0**
O&M Grade: **2**
Clock Start/From: **9**
Clock To:
1st Value: **4.000**
2nd Value: **1.000**
Value Percent:
Continuous Index:
Within 8" of Joint:
Remarks:

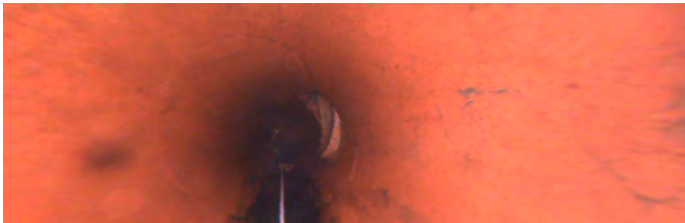
Code: **FC**
Description: **Fracture Circumferential**

Distance (ft): **265.4**
Structural Grade: **2**
O&M Grade: **0**
Clock Start/From: **3**
Clock To: **3**
1st Value:
2nd Value:
Value Percent:
Continuous Index:
Within 8" of Joint:
Remarks:
