Profile/Photo Observation Report

Date:	03/21/2018	Weather:		Coding:	PACP 6.0
Pipe Length (ft):	278.5	Owner:	NA	Pre Clean:	Not Known
P.O.#:		Surveyor:	Selasie Honu	PSR:	P-903-042-041
Customer:		Clean Date:	01/01/1900	Shape:	C

Street:	38th pl	Flow Control:	Not Controlled
City:	Hobart, IN	Year Renewed:	
Location:	Other	Tape/Media #:	
Purpose:	Not Known	Dia/Height:	10"
Use:	Sanitary	Material:	VCP
Drain Area:	NA	Lining:	
Category:	NA		
Comment:			
Location Details:		Direction of Survey:	Upstream
US MH:	M-903-041	DS MH:	M-903-042
		Total Length Surveyed (ft):	272.8

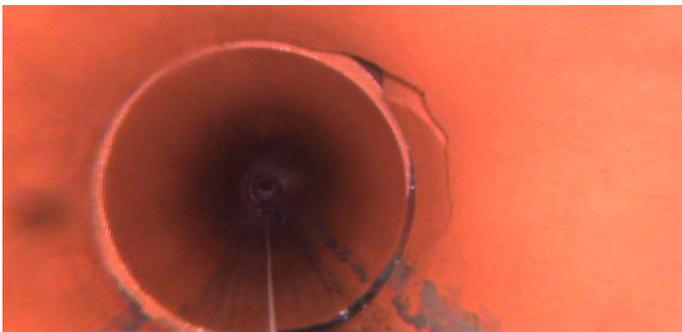
Code: **FC**
Description: **Fracture Circumferential**

Distance (ft): **10.1**
Structural Grade: **2**
O&M Grade: **0**
Clock Start/From: **1**
Clock To: **4**
1st Value:
2nd Value:
Value Percent:
Continuous Index:
Within 8" of Joint: **YES**
Remarks:

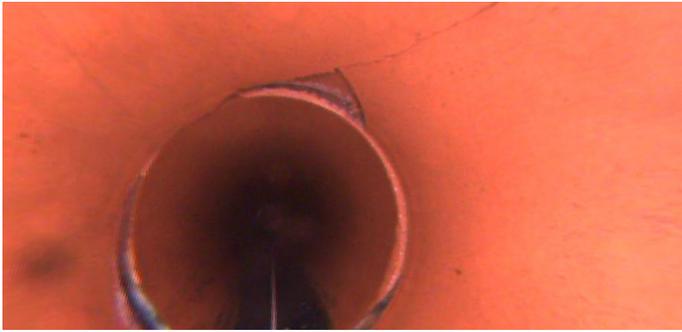
Code: **HVV**
Description: **Hole Void Visible**

Distance (ft): **41.4**
Structural Grade: **5**
O&M Grade: **0**
Clock Start/From: **12**
Clock To: **1**
1st Value:
2nd Value:
Value Percent:
Continuous Index:
Within 8" of Joint: **YES**
Remarks:

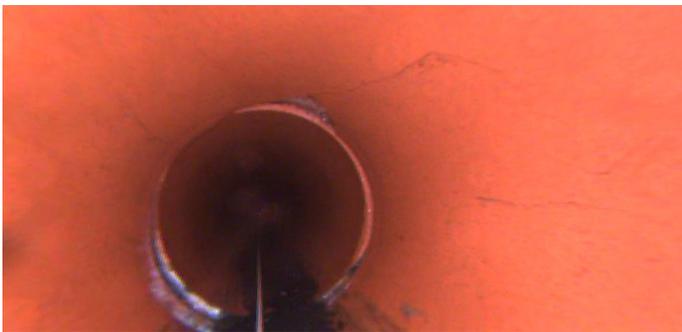
Code: **FM**
Description: **Fracture Multiple**

Distance (ft): **41.6**
Structural Grade: **4**
O&M Grade: **0**
Clock Start/From: **11**
Clock To: **3**
1st Value:
2nd Value:
Value Percent:
Continuous Index:
Within 8" of Joint: **YES**
Remarks:

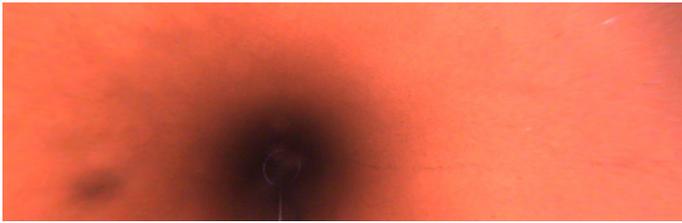
Code: **FL**
Description: **Fracture Longitudinal**

Distance (ft): **172.6**
Structural Grade: **3**
O&M Grade: **0**
Clock Start/From: **3**
Clock To:
1st Value:
2nd Value:
Value Percent:
Continuous Index:
Within 8" of Joint:
Remarks:

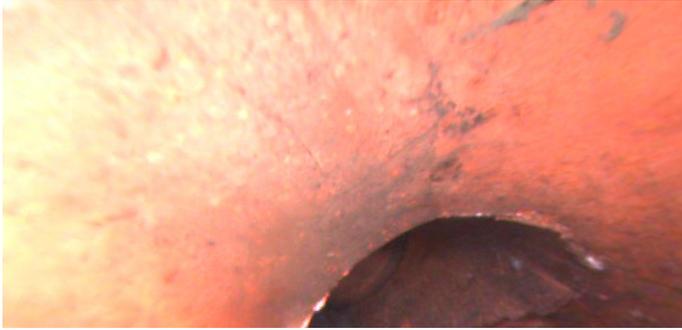
Code: **CL**
Description: **Crack Longitudinal**

Distance (ft): **197.2**
Structural Grade: **2**
O&M Grade: **0**
Clock Start/From: **1**
Clock To:
1st Value:
2nd Value:
Value Percent:
Continuous Index:
Within 8" of Joint:
Remarks:

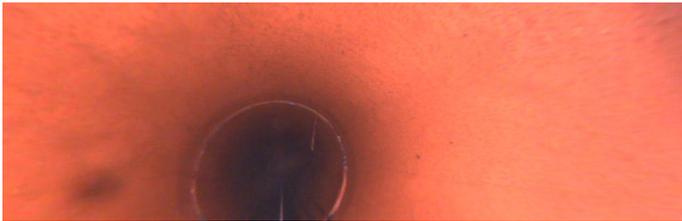
Code: **RFJ**
Description: **Roots Fine Joint**

Distance (ft): **238.5**
Structural Grade: **0**
O&M Grade: **1**
Clock Start/From: **1**
Clock To:
1st Value:
2nd Value:
Value Percent:
Continuous Index:
Within 8" of Joint: **YES**
Remarks:

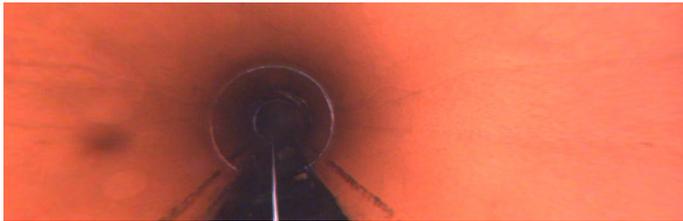
Code: **FL**
Description: **Fracture Longitudinal**

Distance (ft): **251.4**
Structural Grade: **3**
O&M Grade: **0**
Clock Start/From: **2**
Clock To:
1st Value:
2nd Value:
Value Percent:
Continuous Index: **S01**
Within 8" of Joint:
Remarks:

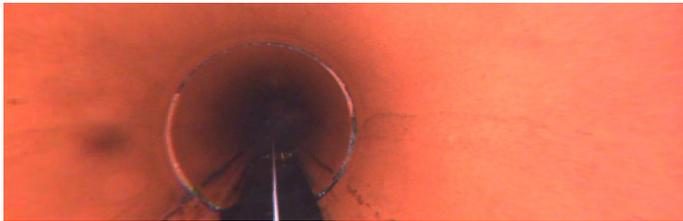
Code: **FL**
Description: **Fracture Longitudinal**

Distance (ft): **256.4**
Structural Grade: **3**
O&M Grade: **0**
Clock Start/From: **3**
Clock To:
1st Value:
2nd Value:
Value Percent:
Continuous Index:
Within 8" of Joint: **YES**
Remarks:

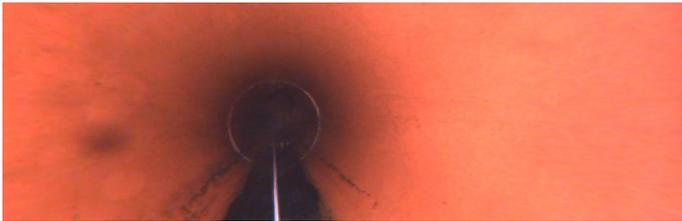
Code: **FL**
Description: **Fracture Longitudinal**

Distance (ft): **257.2**
Structural Grade: **3**
O&M Grade: **0**
Clock Start/From: **2**
Clock To:
1st Value:
2nd Value:
Value Percent:
Continuous Index: **F01**
Within 8" of Joint:
Remarks:

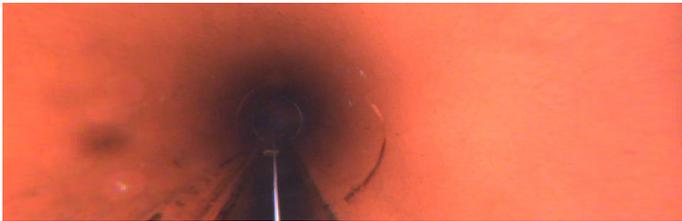
Code: **FC**
Description: **Fracture Circumferential**

Distance (ft): **258.6**
Structural Grade: **2**
O&M Grade: **0**
Clock Start/From: **7**
Clock To: **5**
1st Value:
2nd Value:
Value Percent:
Continuous Index:
Within 8" of Joint:
Remarks:

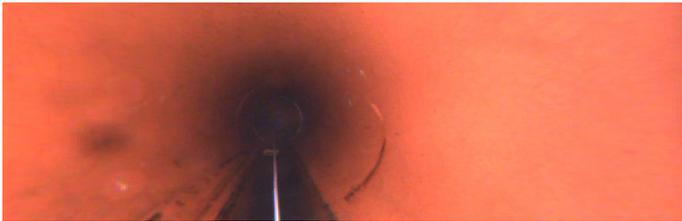
Code: **DAE**
Description: **Deposits Attached Encrustation**

Distance (ft): **258.6**
Structural Grade: **0**
O&M Grade: **2**
Clock Start/From: **3**
Clock To: **5**
1st Value:
2nd Value:
Value Percent: **5.000**
Continuous Index:
Within 8" of Joint: **NO**
Remarks:

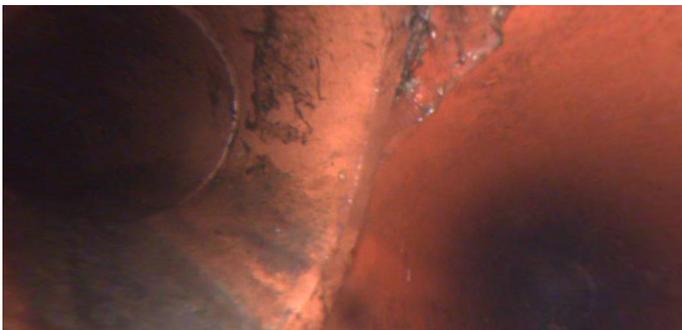
Code: **TBI**
Description: **Tap Break-in Intruding**

Distance (ft): **259.8**
Structural Grade: **0**
O&M Grade: **2**
Clock Start/From: **3**
Clock To:
1st Value: **4.000**
2nd Value: **1.000**
Value Percent:
Continuous Index:
Within 8" of Joint:
Remarks:

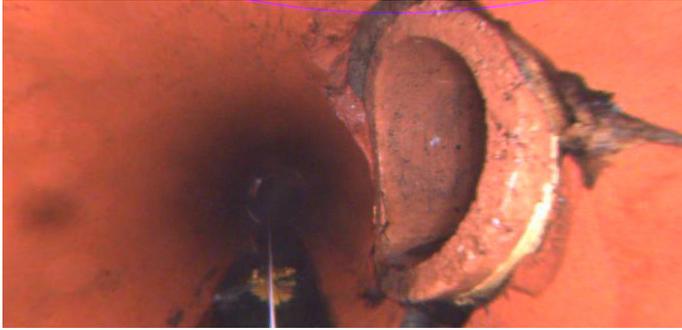
Code: **TBI**
Description: **Tap Break-in Intruding**

Distance (ft): **264.4**
Structural Grade: **0**
O&M Grade: **2**
Clock Start/From: **9**
Clock To:
1st Value: **4.000**
2nd Value: **1.000**
Value Percent:
Continuous Index:
Within 8" of Joint:
Remarks:

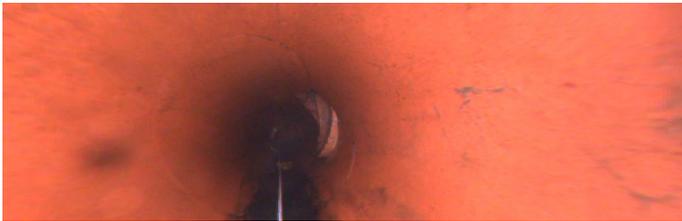
Code: **FC**
Description: **Fracture Circumferential**

Distance (ft): **265.4**
Structural Grade: **2**
O&M Grade: **0**
Clock Start/From: **3**
Clock To: **3**
1st Value:
2nd Value:
Value Percent:
Continuous Index:
Within 8" of Joint:
Remarks:
