## Profile/Photo Observation Report

Street:	<b>OFF E 38TH PL</b>	Flow Control:	<b>Not Controlled</b>
City:	<b>Hobart, IN</b>	Year Renewed:	
Location:	<b>Other</b>	Tape/Media #:	
Purpose:	<b>Not Known</b>	Dia/Height:	<b>10"</b>
Use:	<b>Sanitary</b>	Material:	<b>PVC</b>
Drain Area:	<b>NA</b>	Lining:	
Category:	<b>NA</b>		
Comment:

Location Details:		Direction of Survey:	<b>Downstream</b>
US MH:	<b>M-903-052</b>	DS MH:	<b>M-903-051</b>
		Total Length Surveyed (ft):	<b>136.4</b>

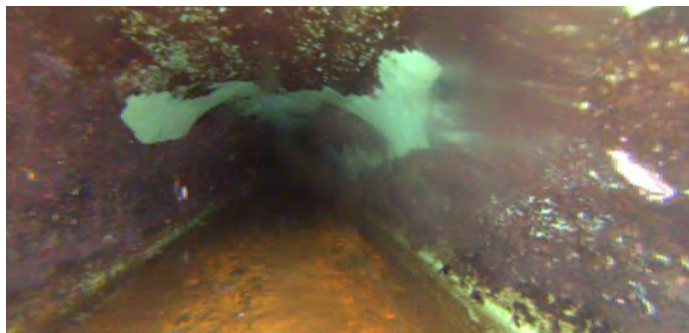
Code: **AMH**  
 Description: **Manhole**

Distance (ft): **.0**  
 Structural Grade: **0**  
 O&M Grade: **0**  
 Clock Start/From:  
 Clock To:  
 1st Value:  
 2nd Value:  
 Value Percent:  
 Continuous Index:  
 Within 8" of Joint: **NO**  
 Remarks: **M-903-052**

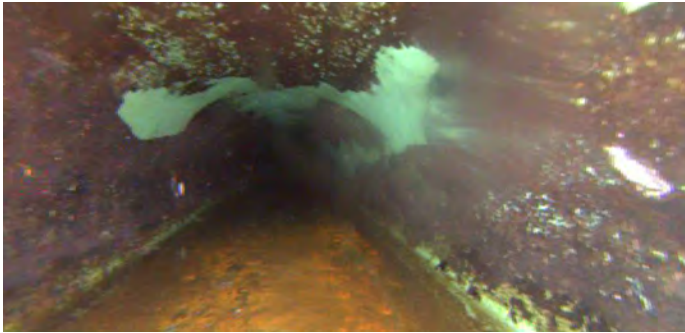
Code:	<b>MWL</b>
Description:	<b>Water Level</b>

Distance (ft):	<b>.0</b>
Structural Grade:	<b>0</b>
O&M Grade:	<b>0</b>
Clock Start/From:	
Clock To:	
1st Value:	
2nd Value:	
Value Percent:	<b>10.000</b>
Continuous Index:	
Within 8" of Joint:	<b>NO</b>
Remarks:

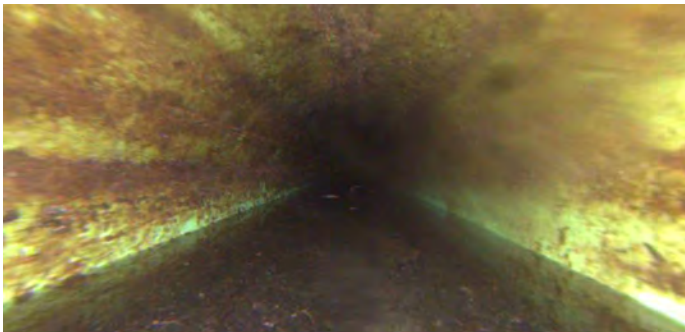
Code:	<b>MWL</b>
Description:	<b>Water Level</b>

Distance (ft):	<b>73.6</b>
Structural Grade:	<b>0</b>
O&M Grade:	<b>0</b>
Clock Start/From:	
Clock To:	
1st Value:	
2nd Value:	
Value Percent:	<b>25.000</b>
Continuous Index:	
Within 8" of Joint:	<b>NO</b>
Remarks:

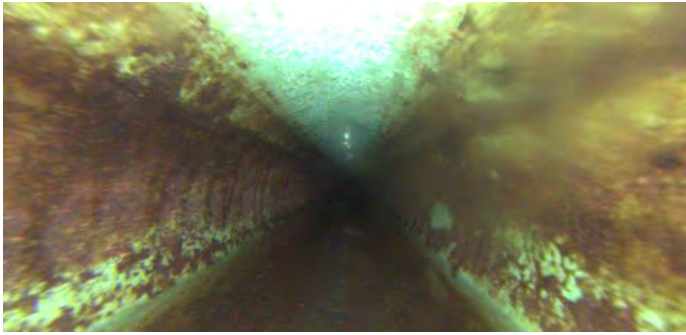
Code: **MGO**  
Description: **General Observation**

Distance (ft): **79.1**  
Structural Grade: **0**  
O&M Grade: **0**  
Clock Start/From:  
Clock To:  
1st Value:  
2nd Value:  
Value Percent:  
Continuous Index:  
Within 8" of Joint: **NO**  
Remarks: **possible debris below water level**

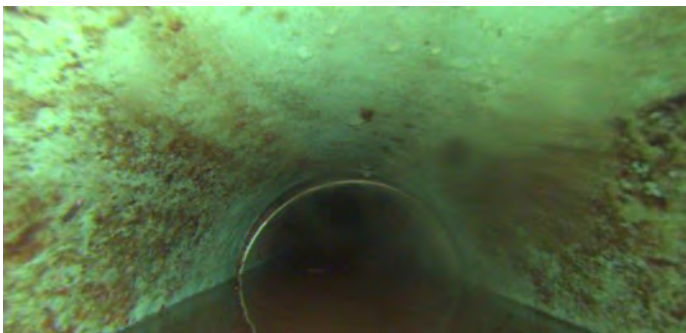
Code: **MWL**  
Description: **Water Level**

Distance (ft): **134.5**  
Structural Grade: **0**  
O&M Grade: **0**  
Clock Start/From:  
Clock To:  
1st Value:  
2nd Value:  
Value Percent: **40.000**  
Continuous Index:  
Within 8" of Joint: **NO**  
Remarks:

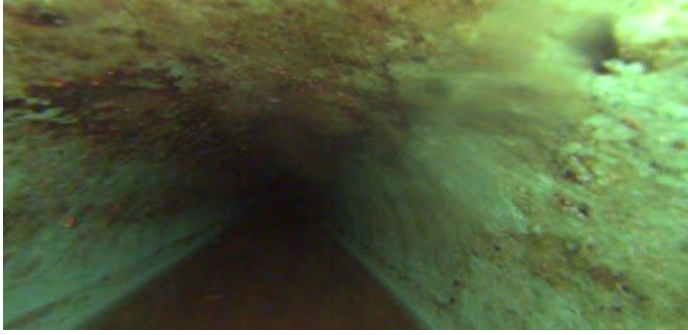
Code:	MSA
Description:	Abandoned Survey
Distance (ft):	136.4
Structural Grade:	0
O&M Grade:	0
Clock Start/From:	
Clock To:	
1st Value:	
2nd Value:	
Value Percent:	
Continuous Index:	
Within 8" of Joint:	NO
Remarks:	ROBOT HAS STOPPED
