Profile/Photo Observation Report

Date:	03/20/2018	Weather:		Coding:	PACP 6.0
Pipe Length (ft):	181.4	Owner:	NA	Pre Clean:	Not Known
P.O.#:		Surveyor:	Justin Gonzales	PSR:	P-903-051-052
Customer:		Clean Date:	01/01/1900	Shape:	C

Street:	37th ave	Flow Control:	Not Controlled
City:	Hobart, IN	Year Renewed:	
Location:	Other	Tape/Media #:	
Purpose:	Not Known	Dia/Height:	10"
Use:	Sanitary	Material:	PVC
Drain Area:	NA	Lining:	
Category:	NA		
Comment:

Location Details:		Direction of Survey:	Downstream
US MH:	M-903-052	DS MH:	M-903-051
		Total Length Surveyed (ft):	136.4

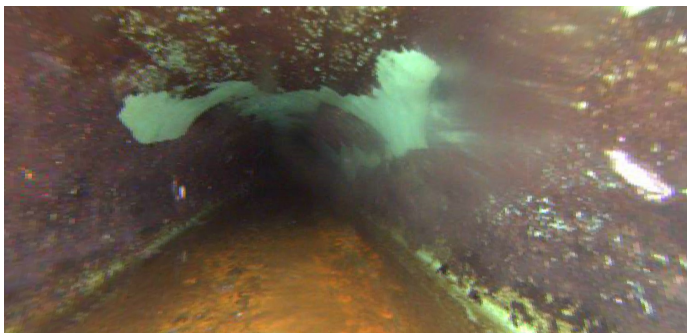
Code: **AMH**
Description: **Manhole**

Distance (ft): **.0**
Structural Grade: **0**
O&M Grade: **0**
Clock Start/From:
Clock To:
1st Value:
2nd Value:
Value Percent:
Continuous Index:
Within 8" of Joint: **NO**
Remarks: **M-903-052**

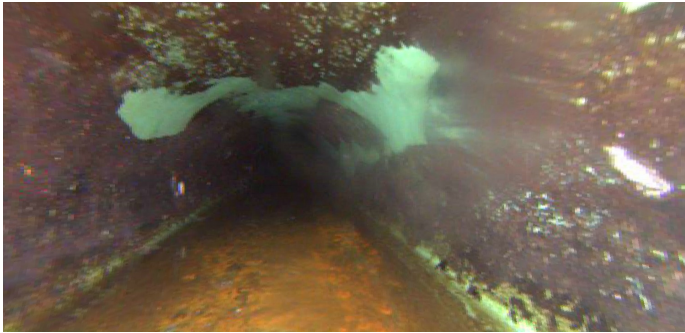
Code:	MWL
Description:	Water Level

Distance (ft):	.0
Structural Grade:	0
O&M Grade:	0
Clock Start/From:	
Clock To:	
1st Value:	
2nd Value:	
Value Percent:	10.000
Continuous Index:	
Within 8" of Joint:	NO
Remarks:

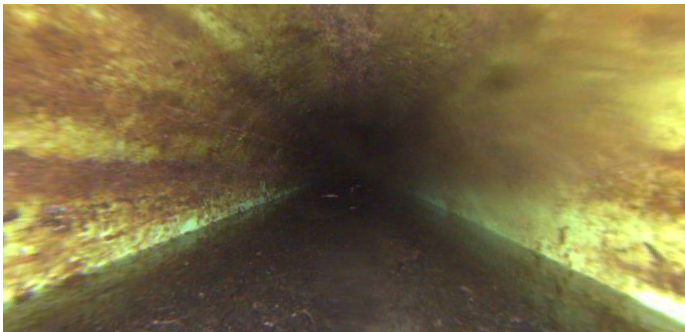
Code:	MWL
Description:	Water Level

Distance (ft):	73.6
Structural Grade:	0
O&M Grade:	0
Clock Start/From:	
Clock To:	
1st Value:	
2nd Value:	
Value Percent:	25.000
Continuous Index:	
Within 8" of Joint:	NO
Remarks:

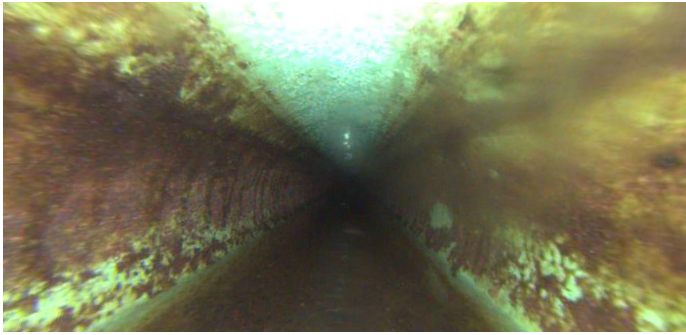
Code: **MGO**
Description: **General Observation**

Distance (ft): **79.1**
Structural Grade: **0**
O&M Grade: **0**
Clock Start/From:
Clock To:
1st Value:
2nd Value:
Value Percent:
Continuous Index:
Within 8" of Joint: **NO**
Remarks: **possible debris below water level**

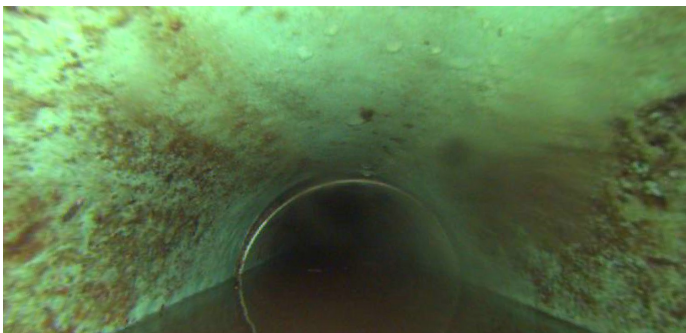
Code: **MWL**
Description: **Water Level**

Distance (ft): **134.5**
Structural Grade: **0**
O&M Grade: **0**
Clock Start/From:
Clock To:
1st Value:
2nd Value:
Value Percent: **40.000**
Continuous Index:
Within 8" of Joint: **NO**
Remarks:

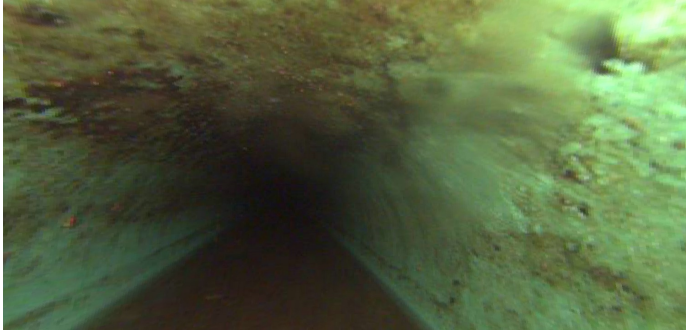
Code:	MSA
Description:	Abandoned Survey
Distance (ft):	136.4
Structural Grade:	0
O&M Grade:	0
Clock Start/From:	
Clock To:	
1st Value:	
2nd Value:	
Value Percent:	
Continuous Index:	
Within 8" of Joint:	NO
Remarks:	ROBOT HAS STOPPED
