## Profile/Photo Observation Report

Street:	<b>OFF E 38TH PL</b>	Flow Control:	<b>Not Controlled</b>
City:	<b>Hobart, IN</b>	Year Renewed:	
Location:	<b>Other</b>	Tape/Media #:	
Purpose:	<b>Not Known</b>	Dia/Height:	<b>10"</b>
Use:	<b>Sanitary</b>	Material:	<b>PVC</b>
Drain Area:	<b>NA</b>	Lining:	
Category:	<b>NA</b>		
Comment:

Location Details:		Direction of Survey:	<b>Upstream</b>
US MH:	<b>M-903-052</b>	DS MH:	<b>M-903-051</b>
		Total Length Surveyed (ft):	<b>197.8</b>

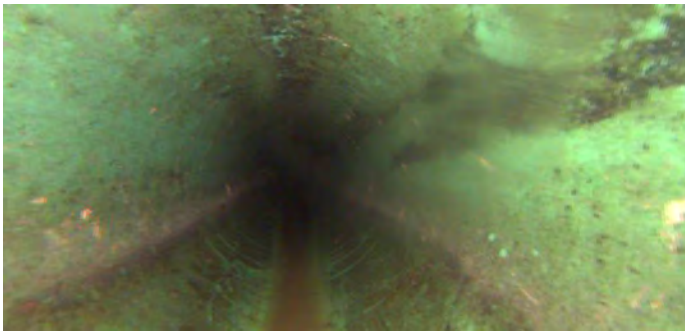
Code: **AMH**  
Description: **Manhole**

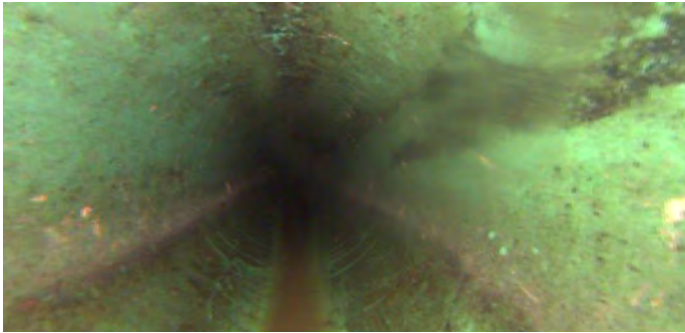
Code:	<b>MWL</b>
Description:	<b>Water Level</b>

Distance (ft):	<b>.0</b>
Structural Grade:	<b>0</b>
O&M Grade:	<b>0</b>
Clock Start/From:	
Clock To:	
1st Value:	
2nd Value:	
Value Percent:	<b>5.000</b>
Continuous Index:	
Within 8" of Joint:	<b>NO</b>
Remarks:

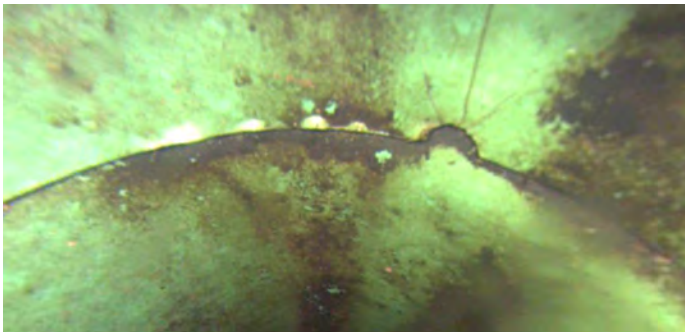
Code:	<b>CM</b>
Description:	<b>Crack Multiple</b>

Distance (ft):	<b>4.7</b>
Structural Grade:	<b>3</b>
O&M Grade:	<b>0</b>
Clock Start/From:	<b>12</b>
Clock To:	<b>1</b>
1st Value:	
2nd Value:	
Value Percent:	
Continuous Index:	
Within 8" of Joint:	
Remarks:

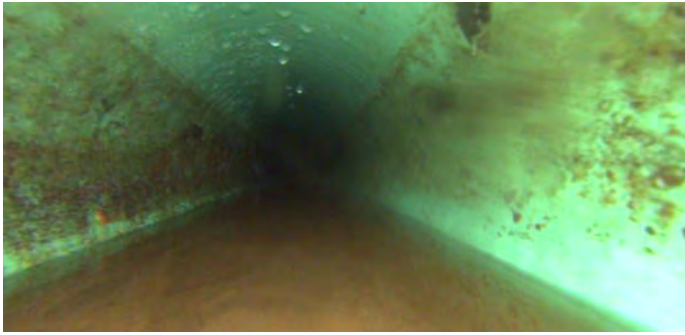
Code: **MWL**  
Description: **Water Level**

Distance (ft): **62.6**  
Structural Grade: **0**  
O&M Grade: **0**  
Clock Start/From:  
Clock To:  
1st Value:  
2nd Value:  
Value Percent: **20.000**  
Continuous Index:  
Within 8" of Joint: **NO**  
Remarks:

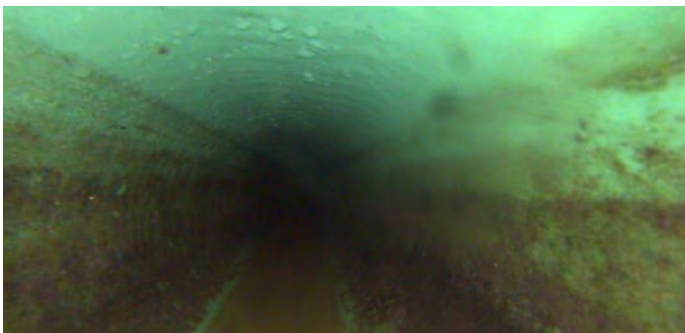
Code: **MWL**  
Description: **Water Level**

Distance (ft): **75.1**  
Structural Grade: **0**  
O&M Grade: **0**  
Clock Start/From:  
Clock To:  
1st Value:  
2nd Value:  
Value Percent: **5.000**  
Continuous Index:  
Within 8" of Joint: **NO**  
Remarks:

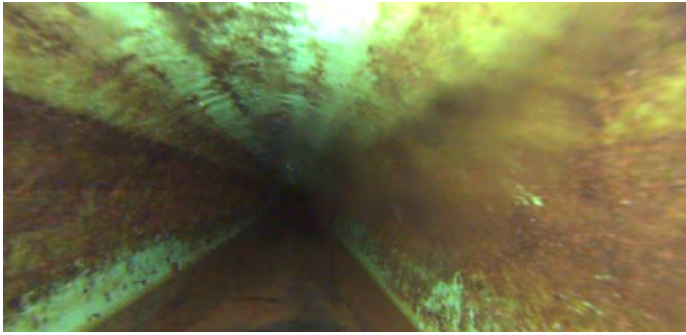
Code: **MWL**  
Description: **Water Level**

Distance (ft): **100.5**  
Structural Grade: **0**  
O&M Grade: **0**  
Clock Start/From:  
Clock To:  
1st Value:  
2nd Value:  
Value Percent: **10.000**  
Continuous Index:  
Within 8" of Joint: **NO**  
Remarks:

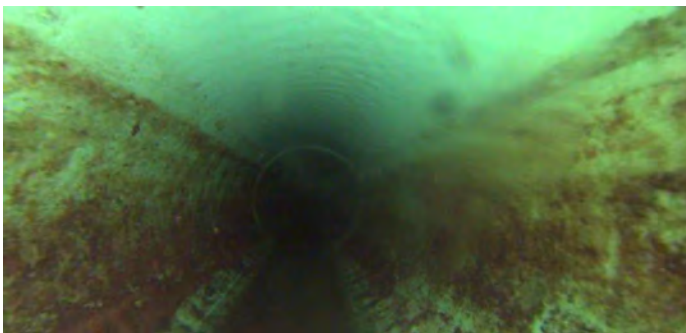
Code: **MWL**  
Description: **Water Level**

Distance (ft): **146.2**  
Structural Grade: **0**  
O&M Grade: **0**  
Clock Start/From:  
Clock To:  
1st Value:  
2nd Value:  
Value Percent: **5.000**  
Continuous Index:  
Within 8" of Joint: **NO**  
Remarks:

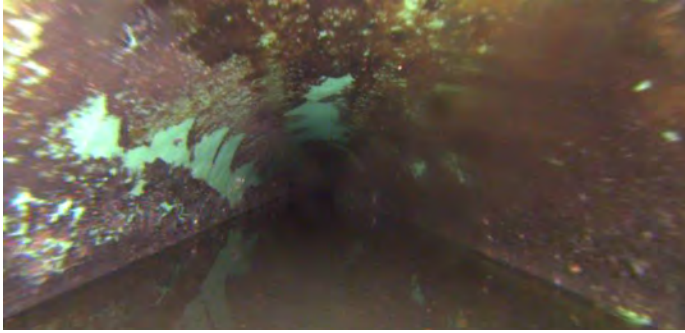
Code: **MWL**  
Description: **Water Level**

Distance (ft): **193.0**  
Structural Grade: **0**  
O&M Grade: **0**  
Clock Start/From:  
Clock To:  
1st Value:  
2nd Value:  
Value Percent: **30.000**  
Continuous Index:  
Within 8" of Joint: **NO**  
Remarks:

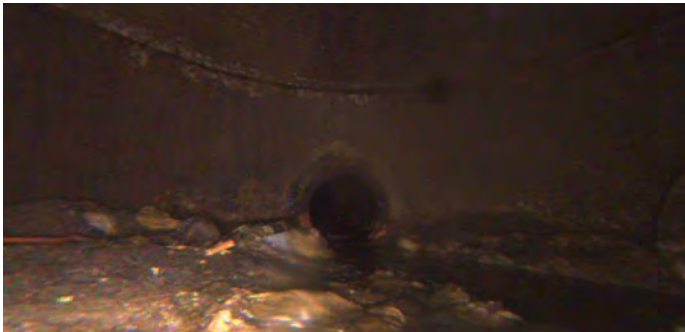
Code: **AMH**  
Description: **Manhole**

Distance (ft): **197.8**  
Structural Grade: **0**  
O&M Grade: **0**  
Clock Start/From:  
Clock To:  
1st Value:  
2nd Value:  
Value Percent:  
Continuous Index:  
Within 8" of Joint: **NO**  
Remarks: **M-903-052**
