Profile/Photo Observation Report

Date:	03/20/2018	Weather:		Coding:	PACP 6.0
Pipe Length (ft):	181.4	Owner:	NA	Pre Clean:	Not Known
P.O.#:		Surveyor:	JUSTIN GONZALES	PSR:	P-903-051-052
Customer:		Clean Date:	01/01/1900	Shape:	C

Street:	37th ave	Flow Control:	Not Controlled
City:	Hobart, IN	Year Renewed:	
Location:	Other	Tape/Media #:	
Purpose:	Not Known	Dia/Height:	10"
Use:	Sanitary	Material:	PVC
Drain Area:	NA	Lining:	
Category:	NA		
Comment:

Location Details:		Direction of Survey:	Upstream
US MH:	M-903-052	DS MH:	M-903-051
		Total Length Surveyed (ft):	197.8

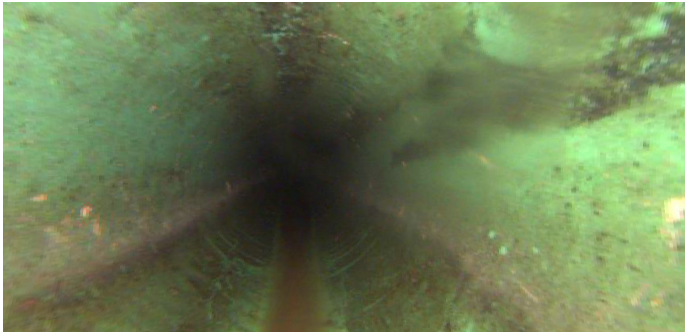
Code:	MWL
Description:	Water Level

Distance (ft):	.0
Structural Grade:	0
O&M Grade:	0
Clock Start/From:	
Clock To:	
1st Value:	
2nd Value:	
Value Percent:	5.000
Continuous Index:	
Within 8" of Joint:	NO
Remarks:

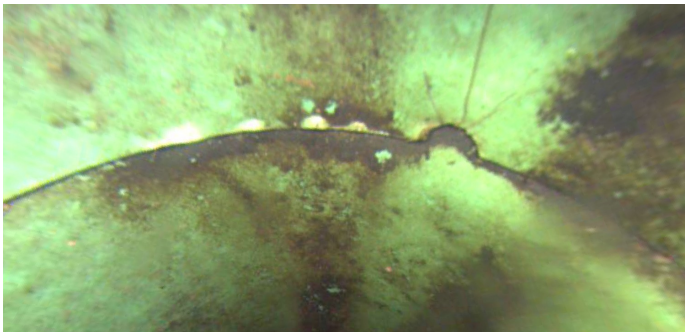
Code:	CM
Description:	Crack Multiple

Distance (ft):	4.7
Structural Grade:	3
O&M Grade:	0
Clock Start/From:	12
Clock To:	1
1st Value:	
2nd Value:	
Value Percent:	
Continuous Index:	
Within 8" of Joint:	
Remarks:

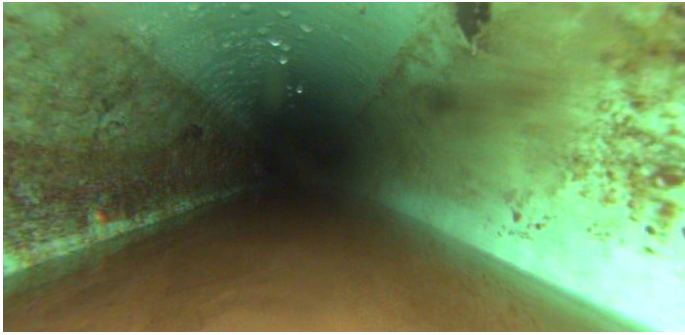
Code: **MWL**
Description: **Water Level**

Distance (ft): **62.6**
Structural Grade: **0**
O&M Grade: **0**
Clock Start/From:
Clock To:
1st Value:
2nd Value:
Value Percent: **20.000**
Continuous Index:
Within 8" of Joint: **NO**
Remarks:

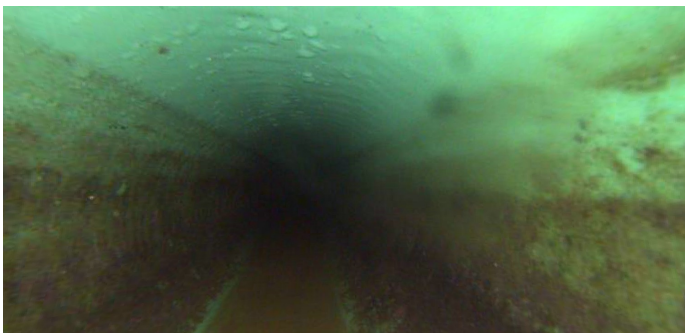
Code: **MWL**
Description: **Water Level**

Distance (ft): **75.1**
Structural Grade: **0**
O&M Grade: **0**
Clock Start/From:
Clock To:
1st Value:
2nd Value:
Value Percent: **5.000**
Continuous Index:
Within 8" of Joint: **NO**
Remarks:

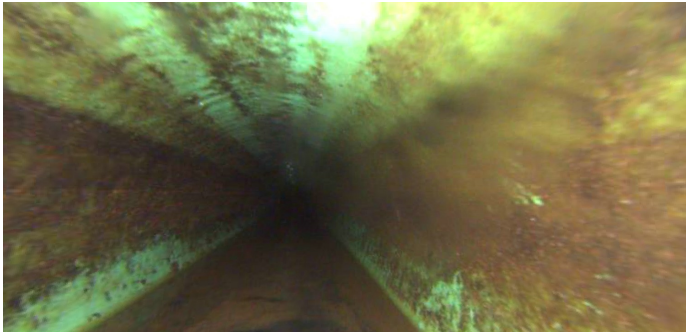
Code: **MWL**
Description: **Water Level**

Distance (ft): **100.5**
Structural Grade: **0**
O&M Grade: **0**
Clock Start/From:
Clock To:
1st Value:
2nd Value:
Value Percent: **10.000**
Continuous Index:
Within 8" of Joint: **NO**
Remarks:

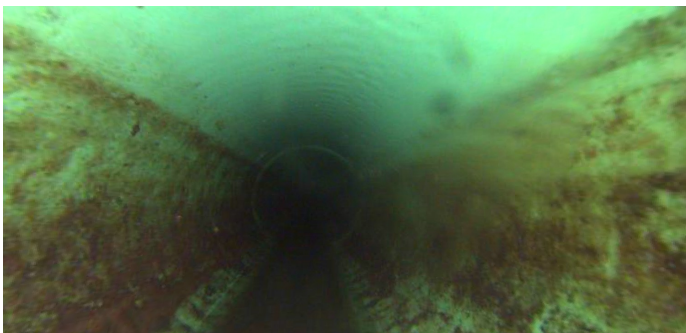
Code: **MWL**
Description: **Water Level**

Distance (ft): **146.2**
Structural Grade: **0**
O&M Grade: **0**
Clock Start/From:
Clock To:
1st Value:
2nd Value:
Value Percent: **5.000**
Continuous Index:
Within 8" of Joint: **NO**
Remarks:

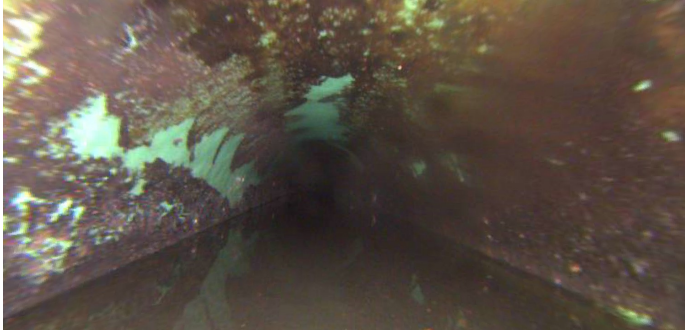
Code: **MWL**
Description: **Water Level**

Distance (ft): **193.0**
Structural Grade: **0**
O&M Grade: **0**
Clock Start/From:
Clock To:
1st Value:
2nd Value:
Value Percent: **30.000**
Continuous Index:
Within 8" of Joint: **NO**
Remarks:

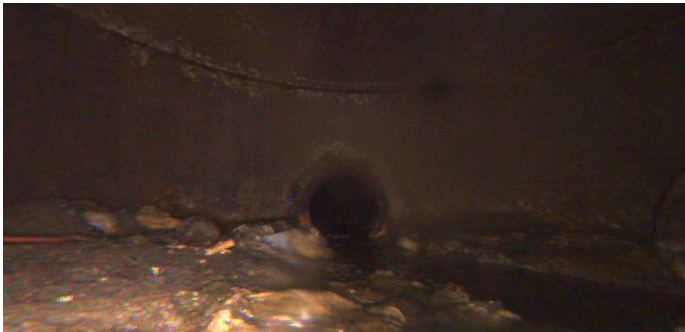
Code: **AMH**
Description: **Manhole**

Distance (ft): **197.8**
Structural Grade: **0**
O&M Grade: **0**
Clock Start/From:
Clock To:
1st Value:
2nd Value:
Value Percent:
Continuous Index:
Within 8" of Joint: **NO**
Remarks: **M-903-052**
